# 十一面観音菩薩像

平成15年度修復事業

# 修理報告

(有)山口墨仁堂  
山口聰太郎

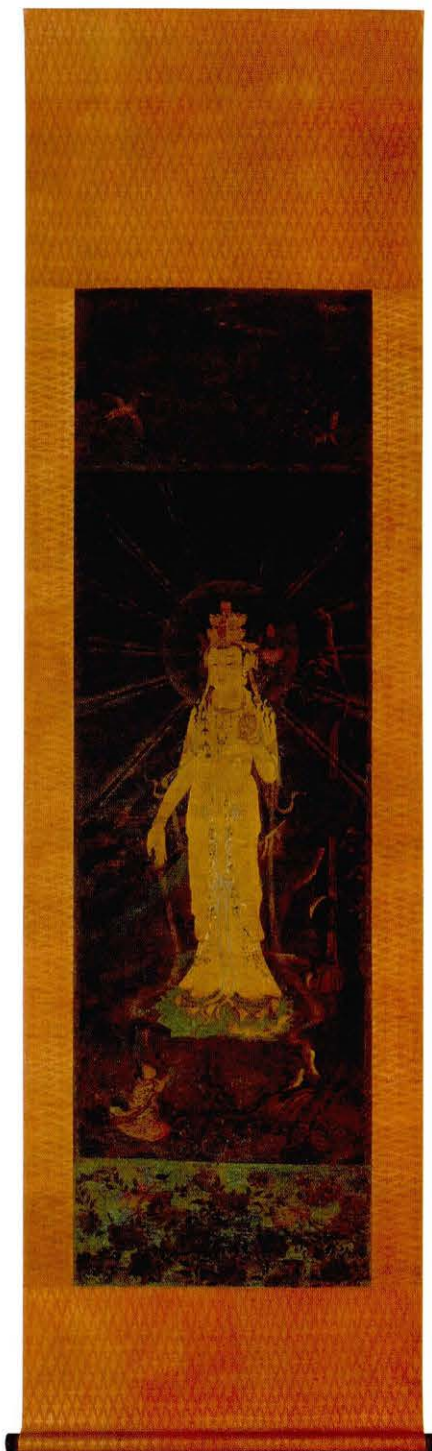
5 十一面観音菩薩像 修理前  
 (サンフランシスコ東洋美術館)  
 Eleven-headed Kannon (Ekadaśamukha) <Before Treatment>  
 (Asian Art Museum of San Francisco)

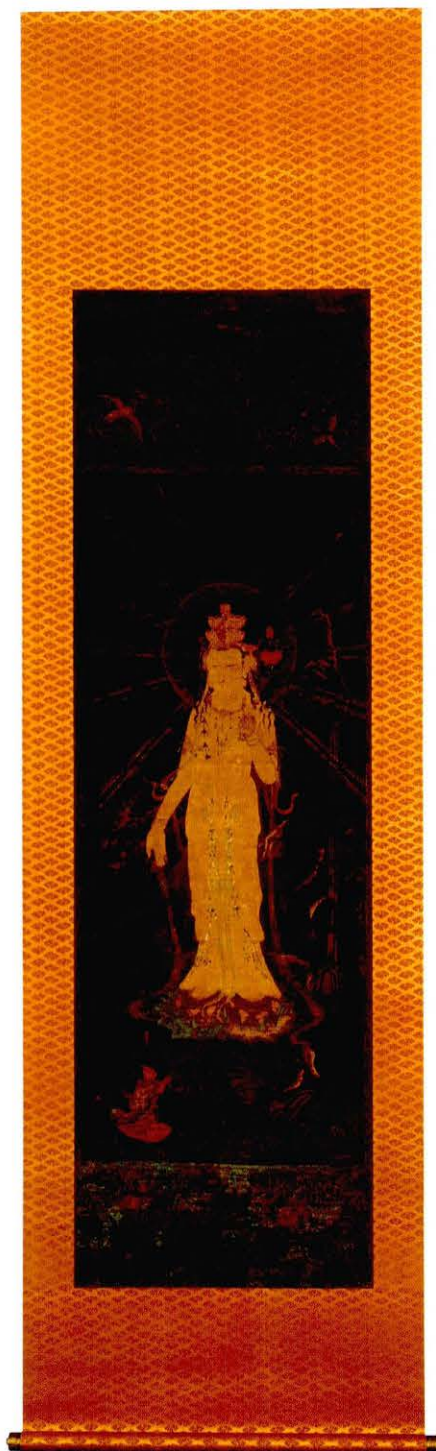
6 修理後  
 <After Treatment>

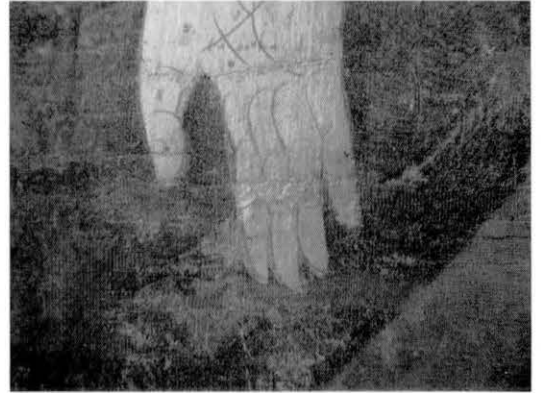
観音像の肉身の金泥部分に施された補絹には、厚く金泥が塗り込められていた。除去する場合には、オリジナル部分を傷つける恐れがあるため、除去せずそのまま残した。(図59~64)

図61 修理前  
Before treatment.

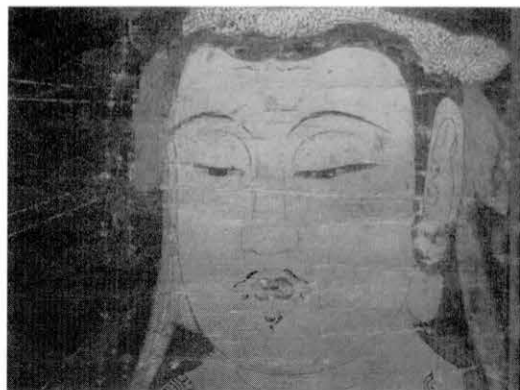
図63 修理前  
Before treatment.

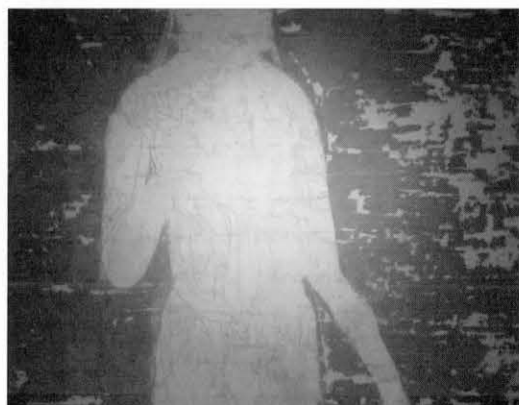
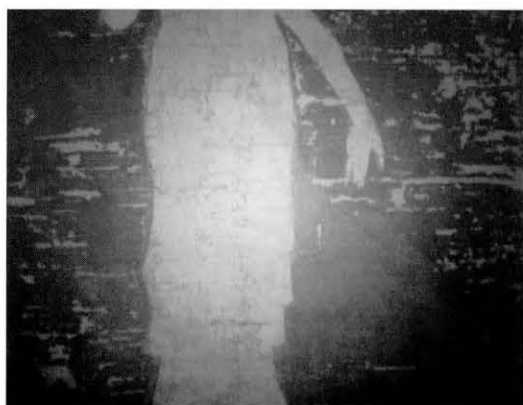
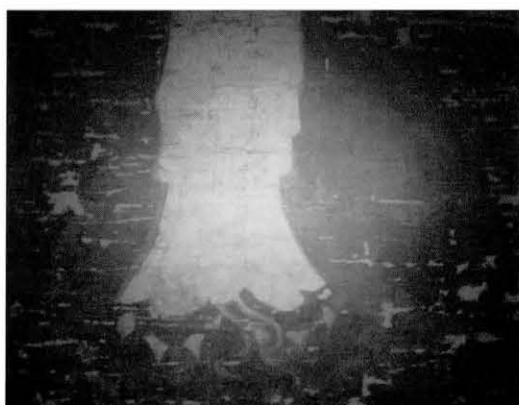
### 3. 本紙裏面に下書きの線を発見した。(図65~68)

図66 裏面 赤外線写真  
Reverse side, infrared photograph.

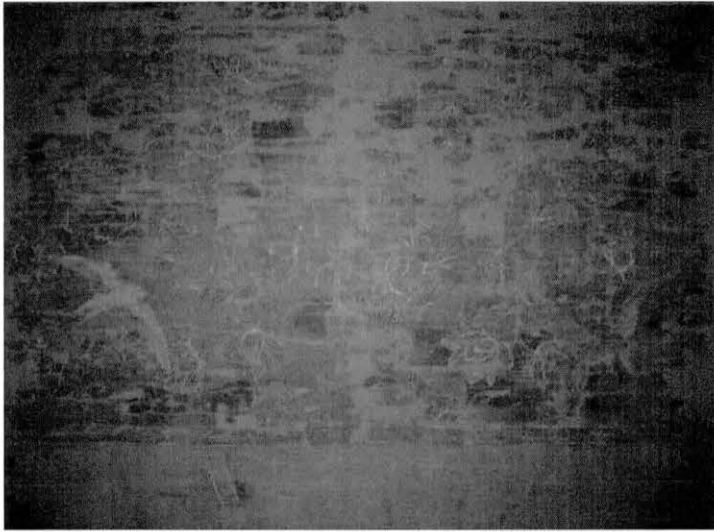
水平線部分と光背中の一部分が、裏彩色が無くなっているかのように、透けていた。状態を記録するため、写真撮影を行った。(図69～76)

修理前の赤外線写真から、光背内の透けている部分は、山のような絵が描かれていた。水平線の部分は、裏面の顕微鏡写真から、絵具がほとんどのっていないことがわかった。

図69 赤外線写真  
Infrared photograph.

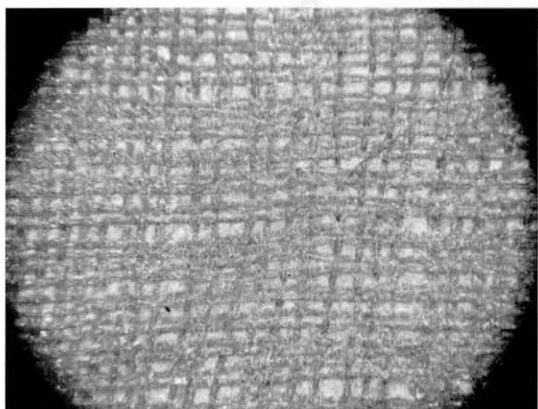
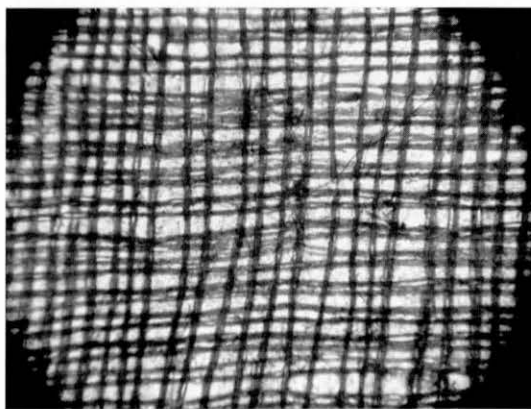
図72 朝焼け (ポイント1) 顕微鏡写真 ×25  
Morning glow. (Point1) Photomicrograph×25 magnification

図73 朝焼け (ポイント1) 顕微鏡写真 透過光 ×25  
Morning glow (Point1) Photomicrograph, transmitted  
light×25 magnification

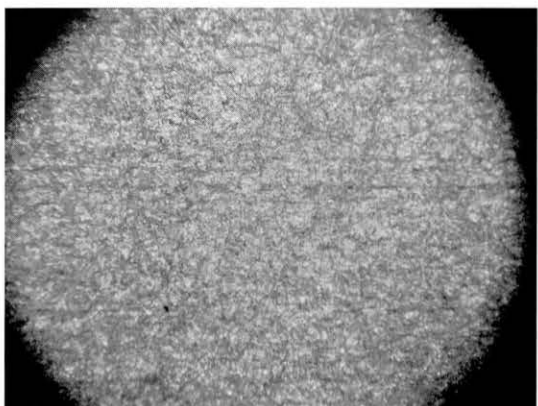
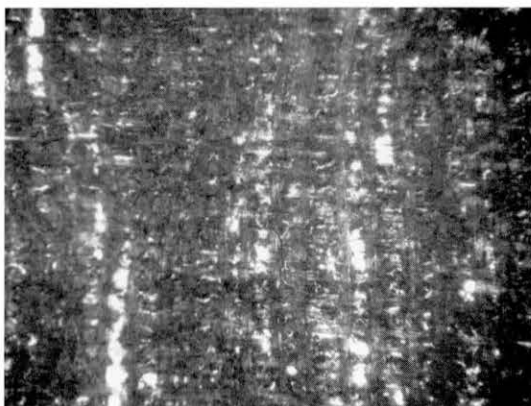
図74 海の部分 (ポイント2) 顕微鏡写真 ×25  
Sea. (Point2) Photomicrograph×25 magnification

図75 海の部分 (ポイント2) 顕微鏡写真 透過光 ×25  
Sea. (Point2) Photomicrograph, transmitted light×25 mag-  
nification

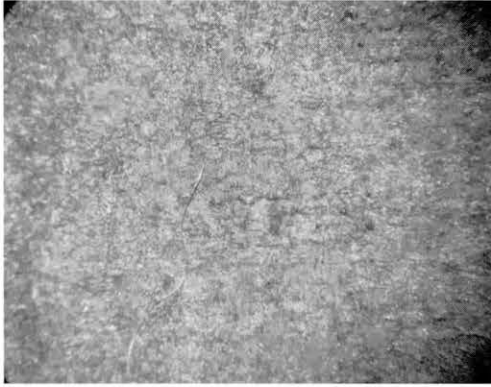
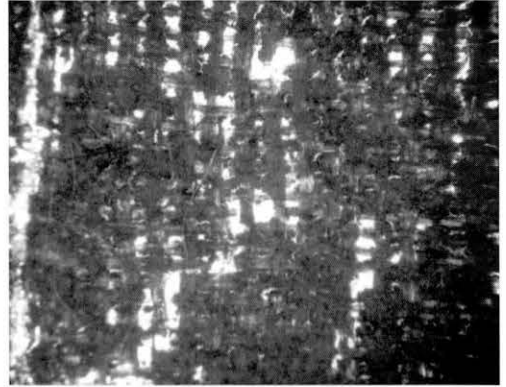
図76 空、暗闇 (ポイント3) 顕微鏡写真 ×25  
Dark sky. (Point3) Photomicrograph ×25 magnification

図77 空、暗闇 (ポイント3) 顕微鏡写真 透過光 ×25  
Dark sky. (Point3) Photomicrograph, transmitted light ×25 magnification

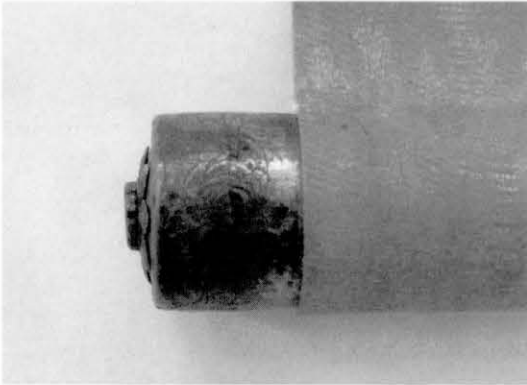
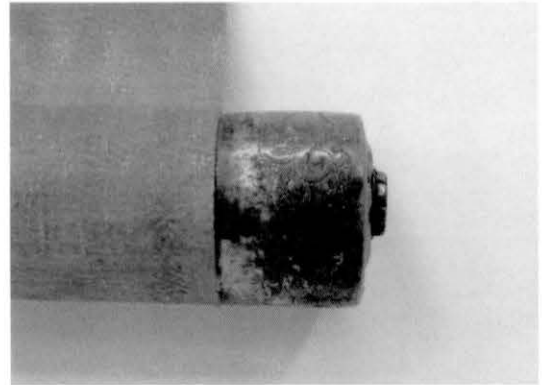
## 5. 金軸は元使いとした。(図78～82)

図78 金具 修理前  
Metal fittings, before treatment.

図79 金具 修理前  
Metal fittings, before treatment.

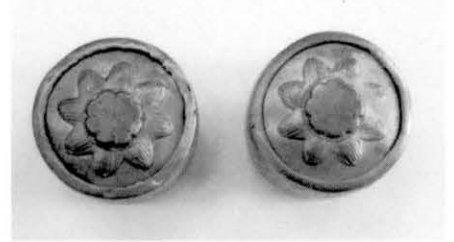
図81 金具 修理後  
Metal fittings, after treatment.

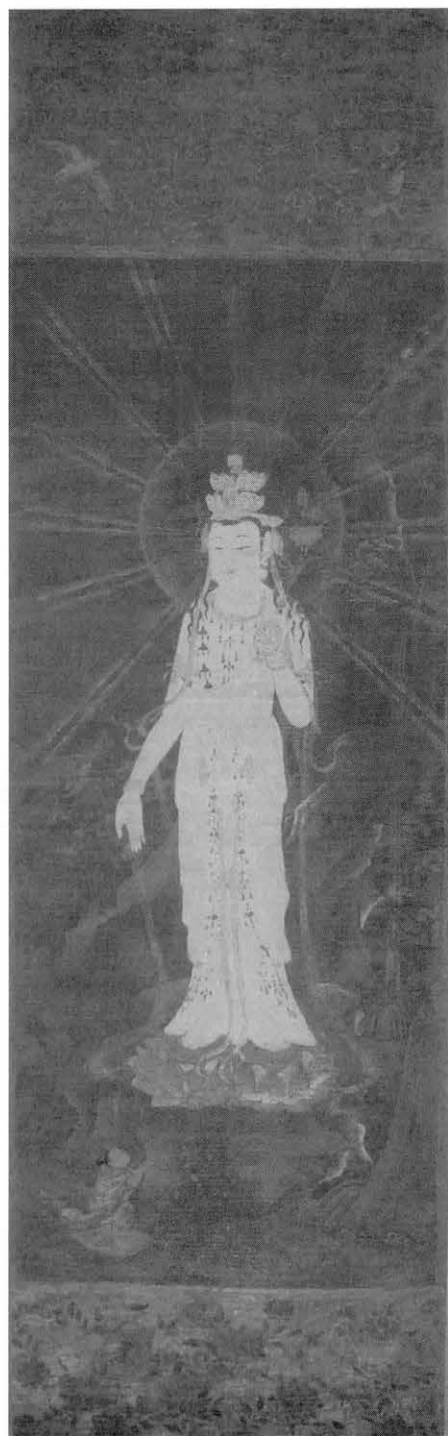
図96 修理後  
After treatment.
