# 源平合戦図屏風

平成 18 年度修復事業

品名：源平合戦図屏風  
所蔵：オーストリア応用美術館

# 修理報告

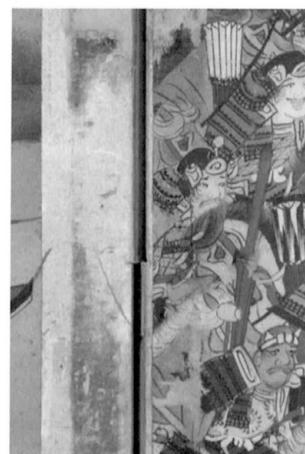
図14 修復後  
 Fig. 14 After treatment

- (1) 第1・2扇間の蝶番が完全に破れ、屏風の形態を維持することが困難になっていた。  
蝶番の破れに伴い、縁裂の破れを併発していた。(図11, 12)
- (2) 台紙である金箔押し紙の破れ、虫害による欠失、擦れ等による金箔の欠失が確認できた。台紙の割れ・破れは特にオゼ付近に見られた。(図13, 14)
- (3) 本紙に着色されている絵具の剥落・擦傷が確認できた。特に青色顔料に関しては、擦傷・剥落を多数確認できた。
- (4) 本紙に多数の染みが確認できた。  
染みは散見し、金箔・絵具層を茶色く変色させていた。特に前オゼ付近は黒く変色しているのが確認できた。
- (5) 第1扇本紙中央右に突き傷が確認できた。
- (6) 縁裂の糊浮きが多数確認できた。

(2) Parts of the gold leaf mounting paper were found torn or missing due to insect damage or abrasion. Many cracks and tears on the mounting paper were found particularly in the area around the hinges (Figs. 13, 14).

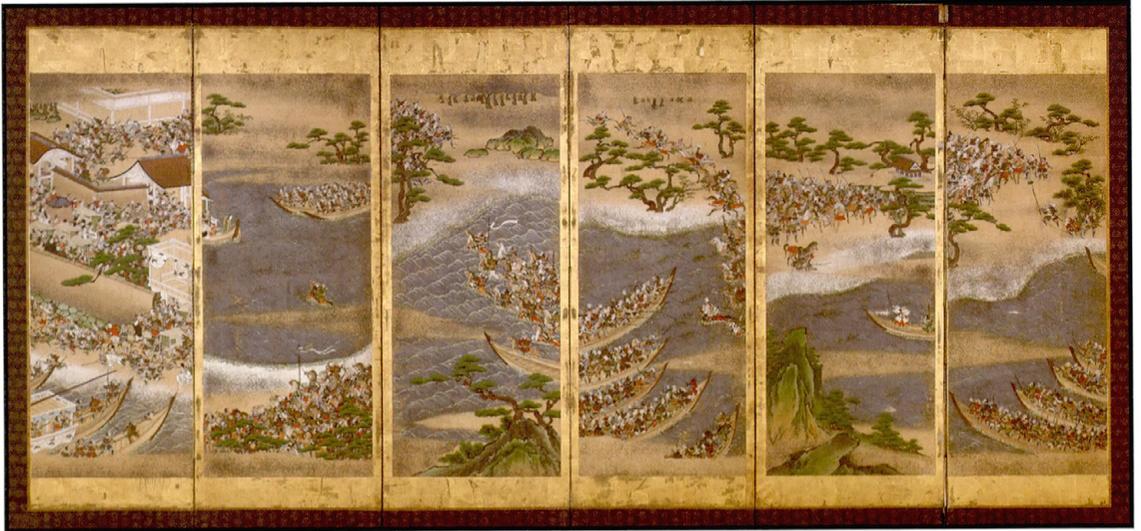
1 - 1. 源平合戦図屏風 修理前 (オーストリア応用美術館)

*War of the Genji and Heike Clans (Before Treatment)* (Österreichisches Museum für angewandte Kunst, Wien)

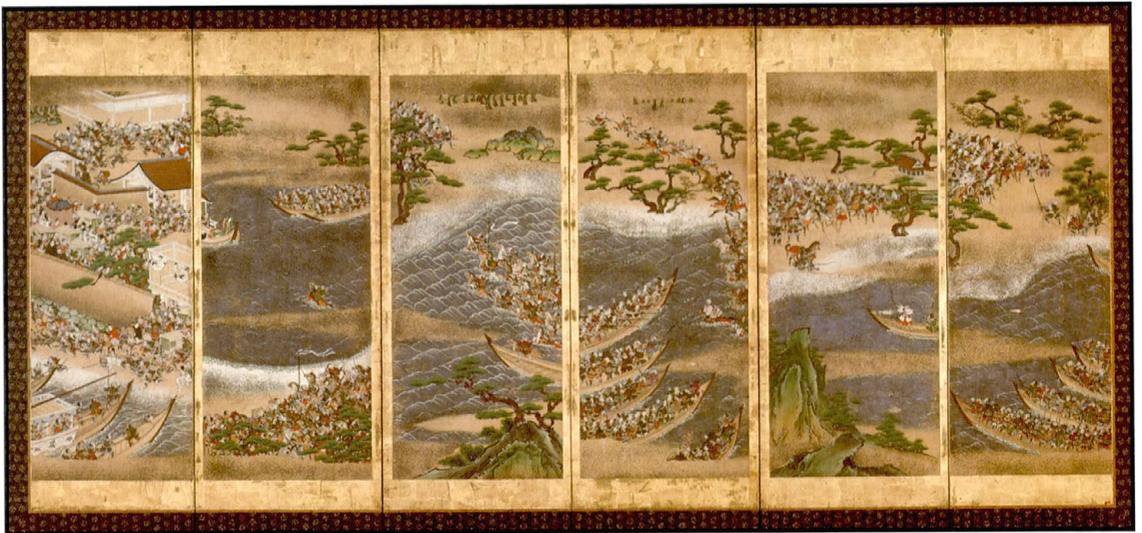
2 - 1. 修理後

*(After Treatment)*
