山水人物蒔絵箆笥 (スペイン国立装飾美術館)

Makie Decoration Cabinet with Landscape and Human
(Museo Nacional de Artes Decorativas)

平成 17・18 年度修復事業

On the Restoration of *Makie Decoration Cabinet with Landscape and Human* in the Collection of Museo Nacional de Artes Decorativas

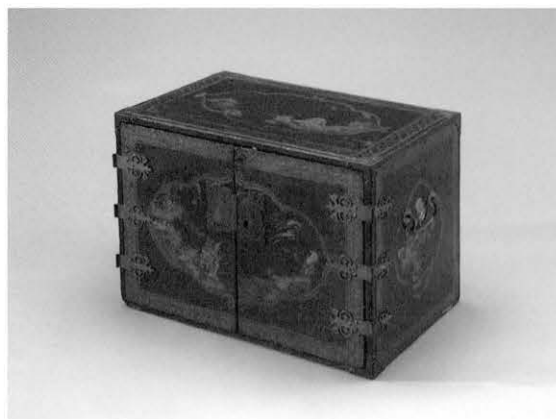
图1 修復前 全景
Fig. 1 Before restoration, overview

- ・箆筒の内外全体には、後補の塗料が塗られ全体が黒ずんで見える。
- ・正面扉の文様は擦れて欠失した部分が多く、特に高蒔絵部分は欠損が多い。
- ・両扉の端喰部分や素地の接ぎ目と思われる部分の内外に、亀裂が入っている。(図12.14)
- ・正面扉の左右6個の蝶番は後補であり、蝶番下の塗膜には制作当初の釘穴が確認できる。(図11.25)
- ・正面右下の隅金具は後補であり、残り3ヶ所の隅金具は付いていない。
- ・両側面の天板角部分の塗膜は欠損が多く素地が露出し、周辺塗膜は剥離し剥落の恐れのある危険な状態である。(図13)
- ・天板部分の文様は擦れて欠失しているが、文様の置目や高上した下地の形跡が確認できる。
- ・右側面の天板と側面板の素地接合部や端喰部分に亀裂がある。
- ・右側面の伏彩色された螺鈿は剥離、剥落があり、欠失した部分には伏彩色の塗料が露出している。(図8)

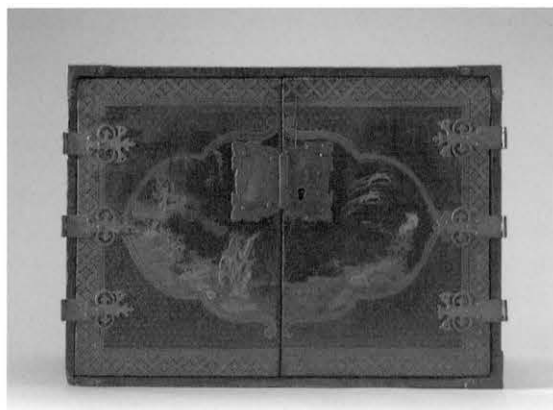
图2 修復前 正面
Fig. 2 Before restoration, front

- A great amount of the decoration on the front of the door was missing due to abrasion; this was particularly visible on the areas decorated with *takamakie*.

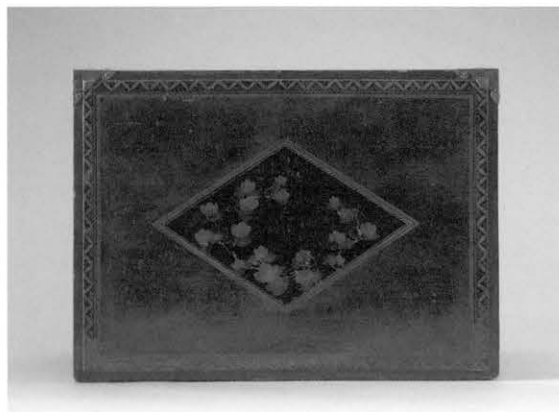
図6 修復前 背面
Fig. 6 Before restoration, back

- ・背面の黒漆塗り塗膜に施された、銀の研出蒔絵の地文様は擦れによる欠失が多い。
- ・右側の内扉には、釘が塗膜から突き出した状態である。
- ・内部、引出の正面や内側には塗料が全体に塗られている。
- ・内部、引出の内側の塗膜に剥離部分があり、制作当初のものと思われる下地が確認できる。

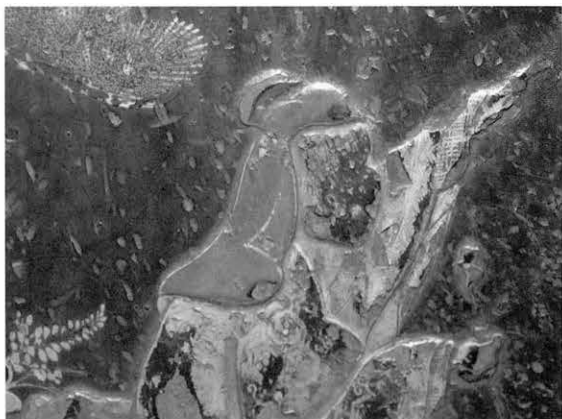
扉表には窓枠を設け、2羽の鶴を指差した人物を錆上高蒔絵、松、柳、菊など草樹文様は、錆上高蒔絵、研出蒔絵、平蒔絵などの技法で表現される。(図7) また、菊の花部分は鮑貝の裏に朱漆を塗った伏彩色が施されている。扉裏には、左右1羽ずつ鳳凰が描かれ、研出蒔絵、平蒔絵で表される。

図7 正面左扉 錆上高蒔絵部分
Fig. 7 Front, left door panel *sabiage takamakie*

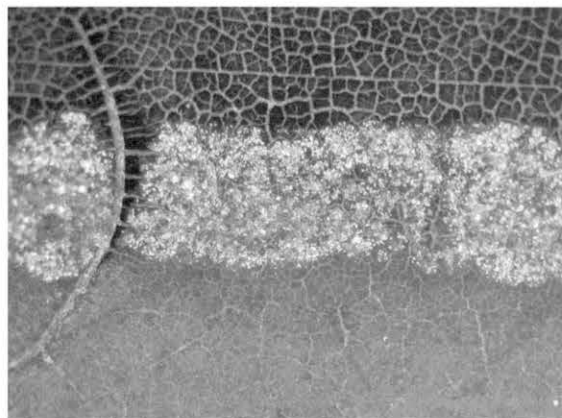
本資料の漆塗膜は、紫外線や経年劣化により艶の無くなった塗膜の復元の為、数回塗料が塗られていた。また、亀裂部分や塗膜の損傷部分にも塗料が充填されており、このままでは漆による修復が困難になる為、塗料の除去が必要になった。

図 36 修復前 表面塗膜の拡大画像 (50 倍)

漆固めは、塗膜表面の細かな断文に漆を含浸し、塗膜強化と艶を取り戻すために行った。漆固めに使用した漆は、木地呂漆+梨子地漆+生正味漆を 5:4:1 の割合で配合し、精製石油系溶剤のペトロロールで 4 倍~6 倍に希釈し漆固めを行った。含浸した漆は断文に染み込ませるだけにし、蒔絵部分や螺鈿に残留が無いよう溶剤で丁寧に拭き取った。なお、漆固めは 2~3 回に止め、損傷部分の修復が終了後、再度行うことにした。

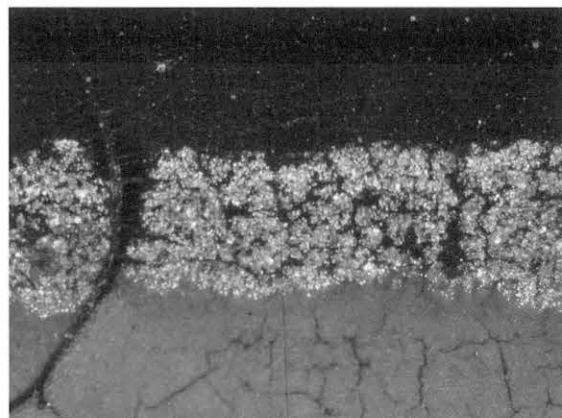
図 37 修復後 表面塗膜の拡大画像 (50 倍)

塗膜表面の艶の復元と修復した部分の固めとして漆固めを行った。漆固めは、木地呂漆と梨子地漆を 3:7 の割合で混ぜ合わせ、溶剤で希釈して行った。漆固めは、各面損傷状態が異なるため、溶剤の希釈濃度を変え 4~6 回行った。なお、高蒔絵部分や螺鈿に余分な漆が残らないよう丁寧に拭き取った。(図 29, 30)
