花樹鳥獸蒔絵螺鈿洋櫃

平成 18 年度修復事業

資料名称：花樹鳥獸蒔絵螺鈿洋櫃
 所 蔵：ケルン東洋美術館（ドイツ）
 時 代：17世紀 江戸時代
 法 量：横 117.0cm 奥行 47.5cm 高さ 57.5cm
 修復者：松本達弥 北村 繁
 修復場所：ドイツ・ケルン東洋美術館 修復アトリエ内
 修復期間：1ヶ月

On the Restoration of
Ornamental Coffers with Flower and Bird Design in Makie and Raden Techniques
 in the Collection of Museum für Ostasiatische Kunst Köln

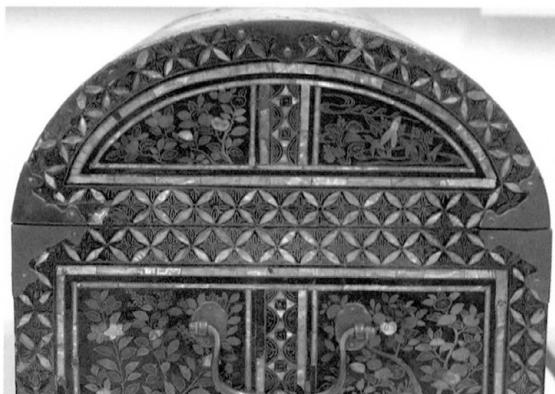
図8 修復前 左側面 上部
Fig. 8 Before restoration, upper left side

金具は一部を除き全て銅製の無地、表面に金鍍金は確認できない。左右側面の提環止めと身の内部側面の釘隠しには菊文様の金具が付く。(図7.8) 提環と釘隠しを除き全て後補のものである。

With the exception of some, the metal fittings are all made of copper with no designs on the surface. Gold gilding is not observed on the surface. A chrysanthemum motif is used on the metal fitting that protects the part where the handle comes in contact with the Coffer and the nail cover on the inner side of the body (Figs. 7, 8). All the metal fittings except the handles and nail covers are later additions.

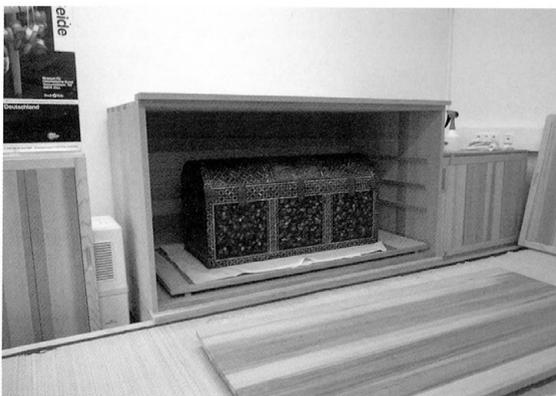
図17 修復作業台及び漆風呂内部
Fig. 17 Working table and the inside of the *urushi* humidifying chamber

修復品を損傷なく安全に修復作業を進められるよう設置台とキャスター付き移動台を制作した。また、剥離した漆塗膜や貝の圧着作業に使用する芯張り用木枠も制作した。(図 17)

A working table and another table with wheels were made so that restoration work might proceed safely without causing further damage to the object. *Shimbari* frame was also made to be used in press stabilizing the lifted urushi coating film and shell pieces (Fig. 17).

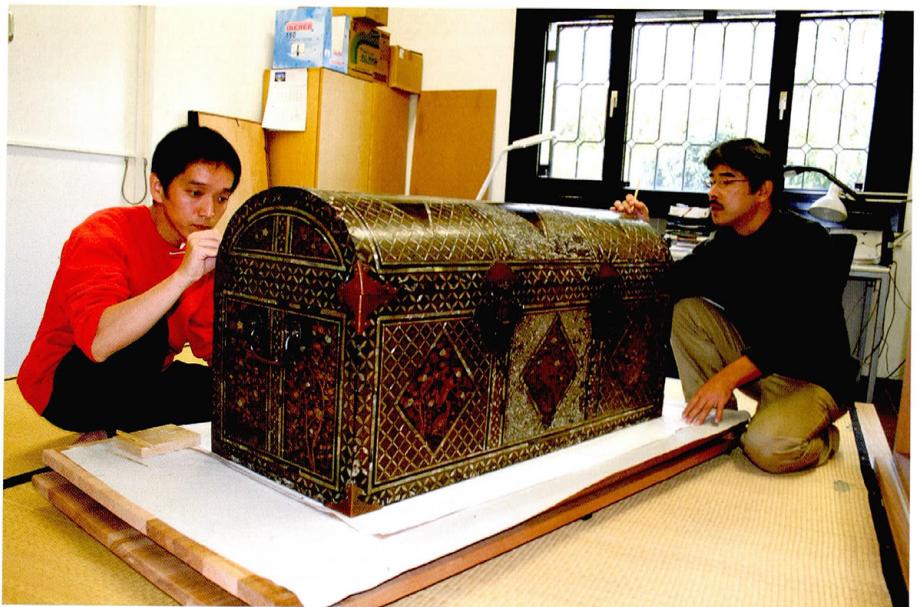
仮止め養生作業

Temporary facing

洋櫃の表面塗膜や蝶紐は、作業中剥落しそうな危険な状態にあるため、細かく切った雁皮紙を糊
