楼閣山水螺鈿筆筒

平成 18・19 年度修復事業

所蔵：キョッソーネ東洋美術館

勝又智志

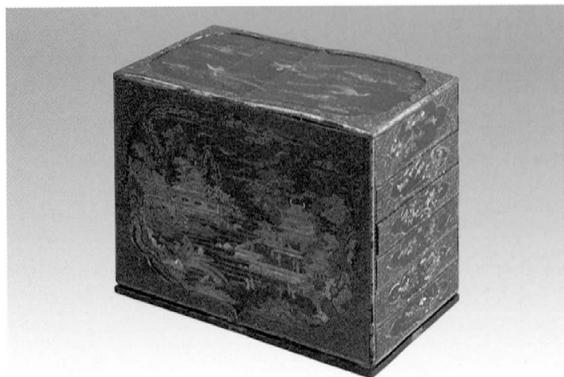
图1 修復前 全景
Fig. 1 Before restoration, overall view

木製黒漆塗り、薄貝螺鈿、指物造、六段抜き通し形式の引き出しが付く小箆筒、底裏に円形二段型の脚が付く、総体を黒漆で塗り、正面及び背面に楼閣山水の図、天板は雲に鳳凰、引き出しの両面には四季花鳥図が薄貝の螺鈿で表され、貝表面には繊細な針描が施されている。薄貝に使用される貝は輝きの強い鮑貝とおだやかな色調の夜光貝の2種類を使用し、雲や楼閣には金箔、花鳥には銀箔の裏彩色を施した薄貝を使用しており、華やかな輝きの箆筒である。（図1. 2. 3. 4. 5）

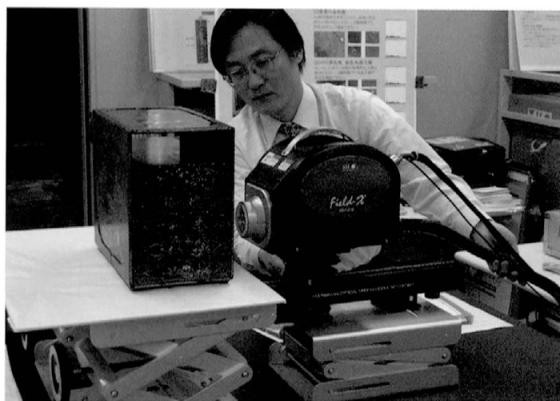
图33 蛍光X線分析
Fig. 33 Preparing for X-ray fluorescence analysis

本作の螺鈿の特徴として裏彩色による金銀の薄貝の使用が認められるが、薄貝の裏に施された箔の成分を分析するため蛍光 X 線分析を行った。(図 33) 分析は東京文化財研究所において、早川泰弘氏によって行われた。

- 測定箇所1,2,4の金色部分から検出されたのは、Caと少量のFeおよびAuだけである。Caは最上層の貝殻、Feは下地や黒漆中に含まれている鉄分に由来していると考えられる。これらの箇所からAgやCuはほとんど検出されず、純度の高いAuが使われていると判断できる。ファンダメンタル・パラメータ法を用いて定量計算を行うと、これらの箇所のAu純度は98-99%以上、厚みは0.2-0.4 μ m程度と計算される。
- 測定箇所3,6,9,10の銀色部分から検出されたのは、Caと少量のFeおよびAgだけである。これらの箇所からAuやCuはほとんど検出されず、純度の高いAgが使われていると判断できる。Agの検出強度が低いため銀の純度および厚みを精度よく計算することはできなかった。
- 測定箇所7,8の金色部分からは、Ca、FeとともにAuおよびAgの両元素が検出された。ファンダメンタル・パラメータ法を用いて定量計算を行うと、これらの箇所の材料はAu85-90%（残りはAg）、厚みは0.2-0.3 μ m程度と計算された。

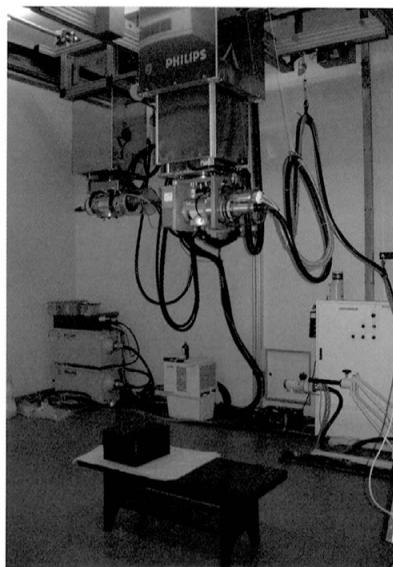
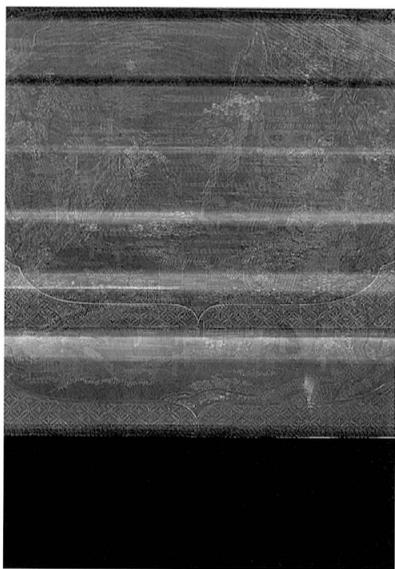
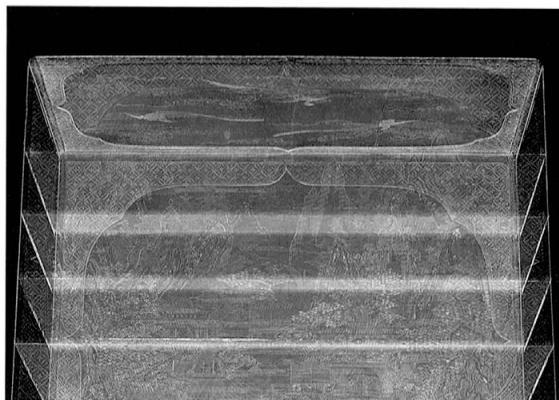
更に木地の構造を分析するため透過 X 線撮影を行った。(図 34. 35. 36) 撮影は東京文化財研究所において、松島朝秀氏によって行われた。

破損した部分を観察すると、木口部分に見られる春材と秋材が明快で、緻密な材料であることがわかる。このことから使用された木材は、針葉樹材であり、漆塗りの素地として一般的に使用されていた檜材であると考えられる。小箆筒の木取りは箱の場合と異なり、各面の木口同士を接合し木地が収縮した際、引き出しが抜けやすいよう配慮されている。上下とも角部分には 7 本の木釘が見られ、側板を底板と天板で挟み込むように、28 本の木釘で固定していることが解った。又、天板と正面及び背面の窓状の枠は薄い檜材を本体に貼り付けたものであり、本体の木地収縮に対し破損しやすい構造となっていることが解った。
