# 花樹鳥獸蒔絵螺鈿洋櫃

平成 18・19 年度修復事業  
(3 年計画の 2 年目)

所蔵：ケルン東洋美術館

松本達弥

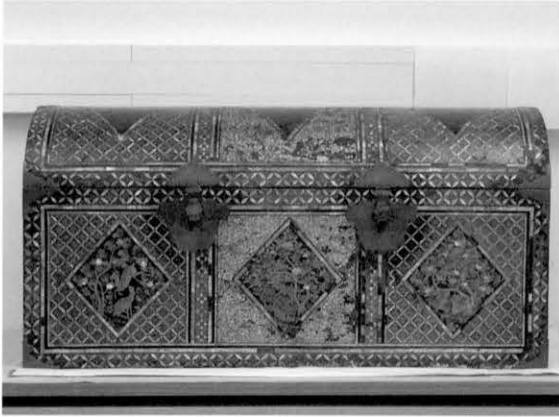
図1 修復前(正面)  
Fig. 1 Before restoration (front)

全ての面に窓枠を設け、正面、両側面、蓋甲板には紅葉、橘、椿、桐、桔梗などの樹木や草花文、鹿、蝶、鳥、獅子などの鳥獣文が付く（図1. 5）。背面には葛、朝顔の文様、蓋内部には桜、柳に3羽の鳥が描かれている（図2）。窓枠の仕切りには片輪車繫文、周りには七宝繫文を廻らす（図3. 4）。

There are cartouches on all the sides. On the front and side cartouches are motifs of trees and flowers like maple, orange, camellia, paulownia and Chinese bellflower as well as those of birds and animals like deer, butterflies, birds and Chinese style lions (Fig.1). The designs on the back are those of arrowroot and morning glory, while on the inner side of the lid is a design of a cherry tree and flowers, a willow tree and three birds (Figs.2, 5). Cartouches are partitioned with a consecutive half-wheel pattern and surrounded by interlinking circles (Figs.3, 4).

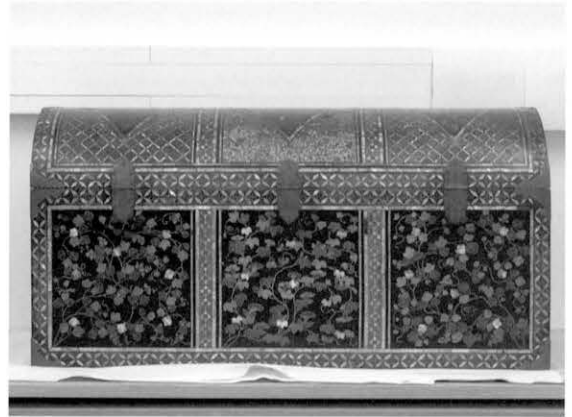
図2 修復前(背面)  
Fig. 2 Before restoration (back)

- ・蓋部分には、塗膜及び貝の剥落が多くあり、一部ヨーロッパ製塗料で修復されている。
- ・蓋の両端部分の塗膜は剥離剥落が多くあり状態は悪い。
- ・身の左側には、木地の接合部に亀裂がある。
- ・右側の蝶番の銅釘3本が紛失している。

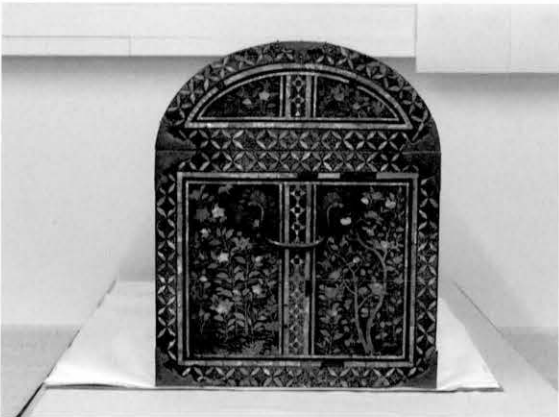
図3 修復前(右側面)  
Fig. 3 Before restoration (right side)

- ・側面の表面塗膜には、塗られた塗料の影響で全体に黒ずみ、特に提環周辺の塗膜は状態が悪い。
- ・蓋の角部分の塗膜及び貝は剥離剥落が多く、貝の剥落した部分には銀色の塗料で塗られている(図13)。
- ・身の側面下には木地の接合部に亀裂があり、その周辺塗膜は剥離剥落が多くある。

- The surface coating film has become dark and its condition is bad especially around the handle.
- There is much lifting and detachment of the coating film and the shells on the corner of the lid. Parts where the shell pieces have fallen are coated with a silver coating material (Fig.13).
- There are cracks on the joint of the substrate on the lower side face of the body. The coating film around the crack have become lifted or detached.

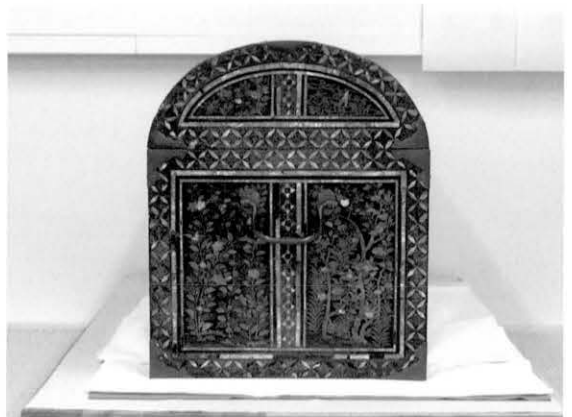
図4 修復前(左側面)  
Fig. 4 Before restoration (left side)

- ・表面塗膜は、何層も塗られた塗料の影響で蒔絵の金色が黒味を帯びている。
- ・塗膜及び貝は剥離剥落が多く目立ち、対面の右側面より状態が悪く、触れるだけで剥落しそうな危険な状態である。
- ・側面下の塗膜は殆ど剥離し、木地接合部には亀裂を生じている。

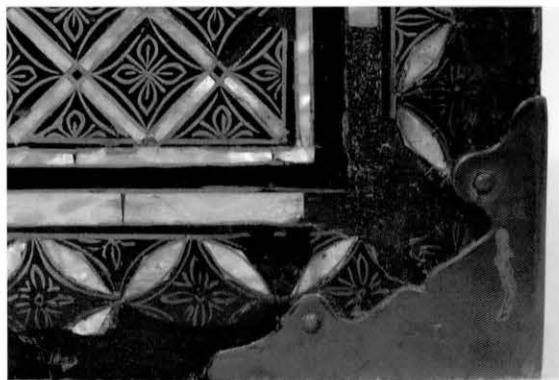
図 22 修復後 角金具の周辺部分  
Fig. 22 After restoration (area around a corner metal fitting)

- ・蓋の正面左側の角金具周辺は、漆塗膜や貝の剥落が多くあり木地が露出している(図7)。
- ・身の正面、中央及び左側の表面塗膜は、後補で塗られた塗料の劣化により白濁化している(図6)。
- ・身の正面下の塗膜や貝は剥離剥落が多く、剥落した塗膜が下に落ちている。
- ・正面右下の角金具の銅釘が3本紛失している。

今年度の修復作業工程を終え、修復後の記録写真撮影を行った（図19. 20. 21. 22. 23. 24）。

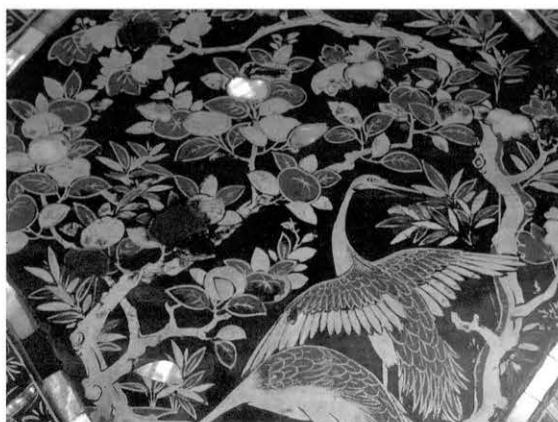
図 23 後補塗料の除去後  
Fig. 23 After removal of a coating material applied in the past

昨年度に行った後補塗料を除去する溶剤テストを基に再テストを行い、除去する溶剤を決定した。今年度は左右側面を重点的に後補塗料の除去を行い、表面漆塗や貝の剥落しそうな危険な場所を避けて塗料除去作業を進めていった。

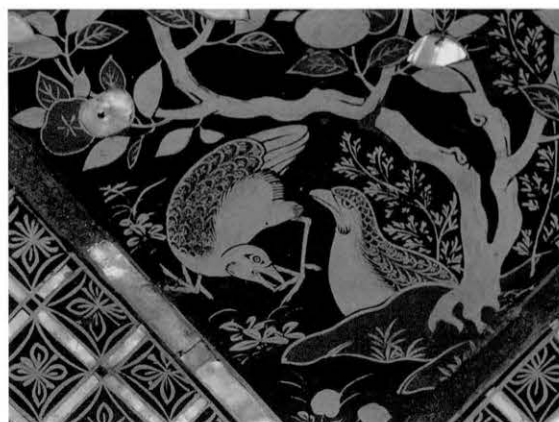
図 24 後補塗料の除去後  
Fig. 24 After removal of a coating material applied in the past
