松に孔雀図屏風

平成20年度修復事業

修復報告

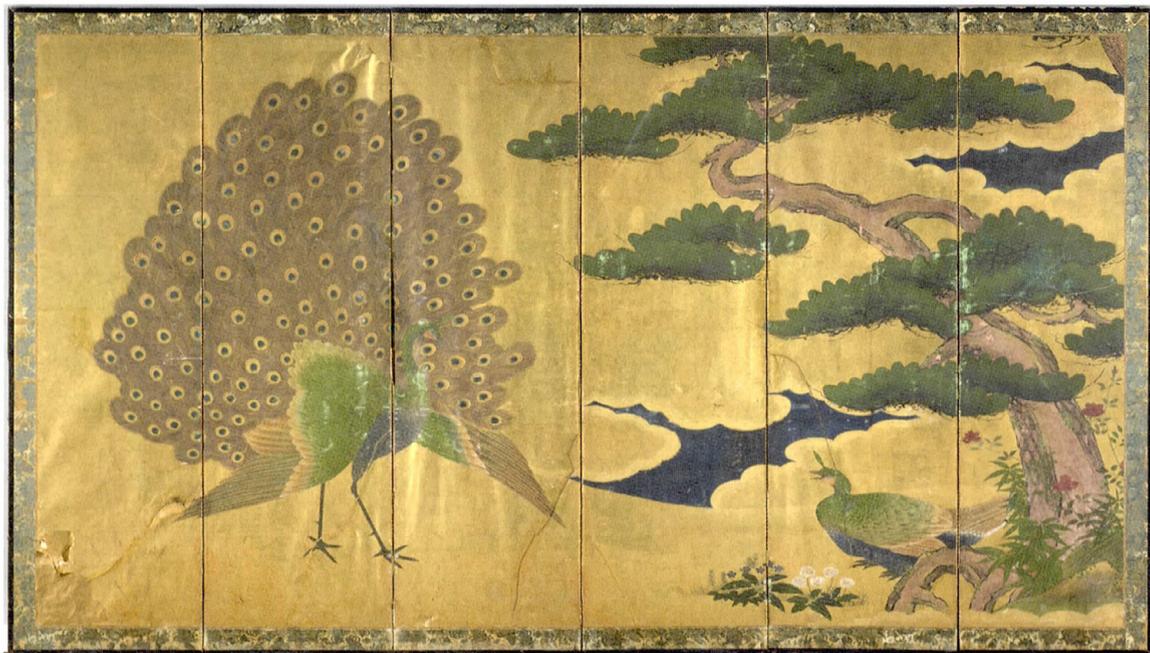
(1)-1 修復前 Before treatment

- ・蝶番金具が取り付けられていた。そして、その取り付け方は折り方が逆になっていた。そのため、長期間露出していた第1扇と第6扇は特に傷みが進んでいた。
- ・下地は経年のため、また木材の伸縮によりに歪みが生じていた。そのため、下地四隅はしきみ、本紙表面が波打っていた。
- ・全体に多数の亀裂や大きな破れが見られた。亀裂は応急的に紙の帯や糊差しによって止められており、また破れには大きな金紙が貼られている箇所があった。場所によっては、無理に糊を差して止めたため、その部分が引きつれて表面に波打ちが起き、その相対する表面同士がこすれて、絵具が剥落していた。（図1、3、5）
- ・大きな亀裂部分では、合成接着剤を亀裂から下地内部に入れ込み、表面をビニルテープによって接着していた。
- ・全体的に絵具の剥落、擦れが見られた。特に緑青部分の劣化は激しく、本紙基底料紙も緑青による酸化によって、薄片状に細かく剥離しており、大変危険であった。また松が描かれた部分では、下地絵具の部分で接着強度の劣化が見られ、ところどころで浮き上がりが生じていた。
- ・過去の修理において、補修紙が当てられていた。そこには補彩がされていたが、本紙にまではみ出していた。
- ・樹脂が塗布されているような、てかりが見られた。
- ・全体に汚れを吸着し、黒くくすんでいた。
- ・縁裂の傷みが著しかった。
- ・屏風裏の唐紙に、汚れや破れが見られた。
- ・襲木に傷みが見られた。また、金具が欠失していた。

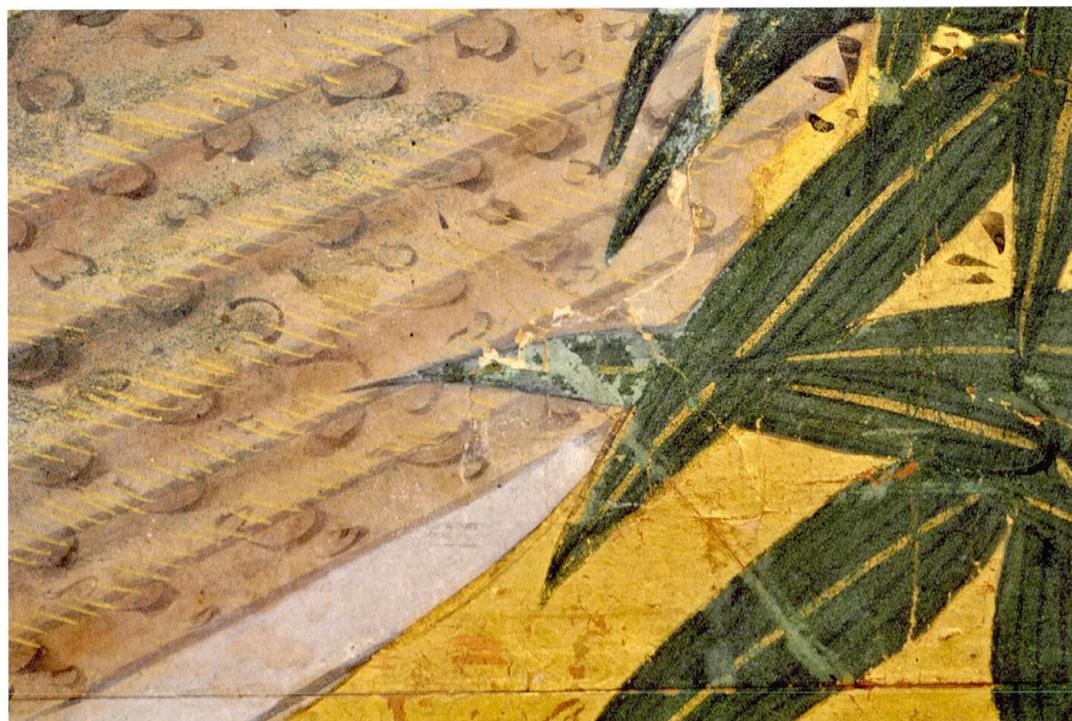
(2)-2 修復後 (同上)
After treatment (Detail of the same area)
