楼閣山水蒔絵箱

平成19・20年度修復事業

所蔵：オーストリー応用美術館

山下 好彦

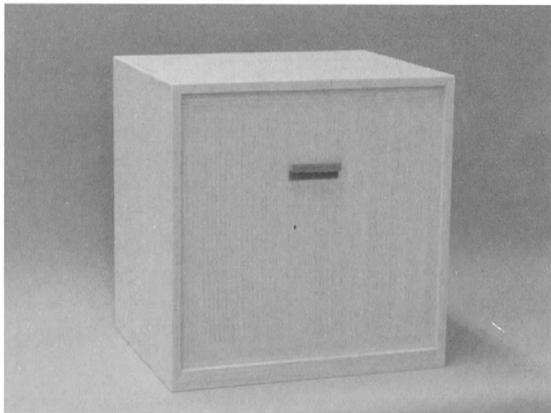
桐箱
Paulownia box

釘で打ち直していた柱は釘を取り外し、可逆的な合成樹脂で再接着した。高台を除く下地が欠損した部分や亀裂部分は形状を復元し、周囲に色合いを合わせた。色合せには金粉、錫粉、真鍮粉を使用した。桐製の保存箱と絹の外覆を作製した。修復前と修復後の写真撮影を行った。

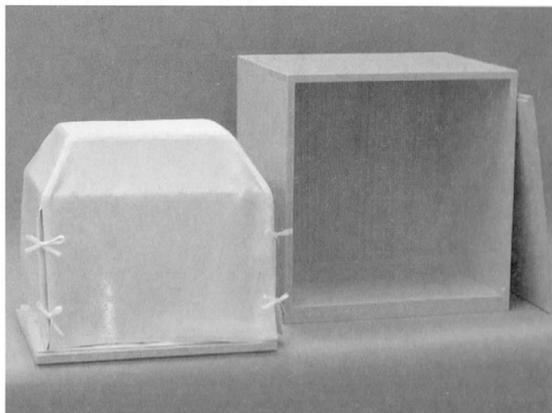
桐箱と外覆
Paulownia box and a wrapping cloth
