花樹鳥獸蒔絵螺鈿洋櫃 (ケルン東洋美術館)

*Ornamental Coffin*

Museum für Ostasiatische Kunst, Köln

平成18・19・20年度（3年計画の3年目）修復事業

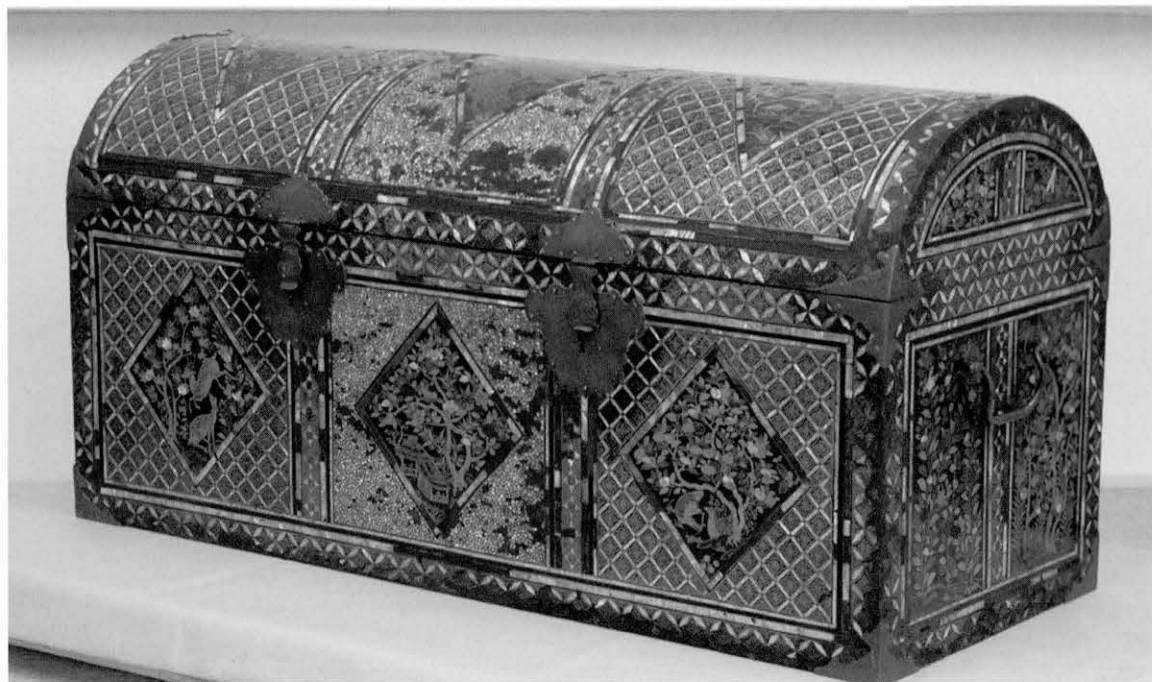
修復後  
After restoration, 2008

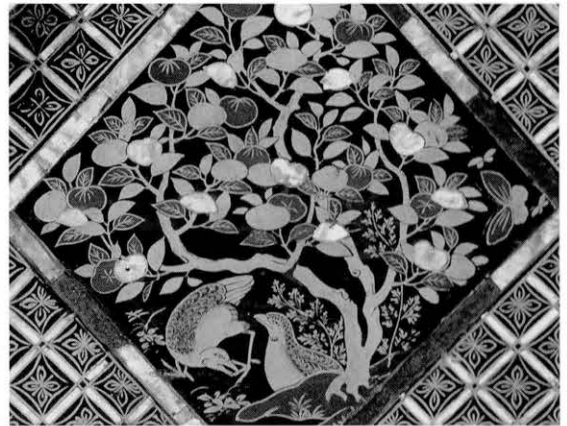
後補塗料の除去後  
After cleaning

昨年度にクリーニング作業の終わっている左右側面、正面蓋の一部と正面身の一部を除いて、全面にわたり可能な限り後補塗料の除去を行った。なお、除去作業においては表面漆塗や螺鈿の剥落しそうな危険な場所は慎重に塗料除去作業を進めた。

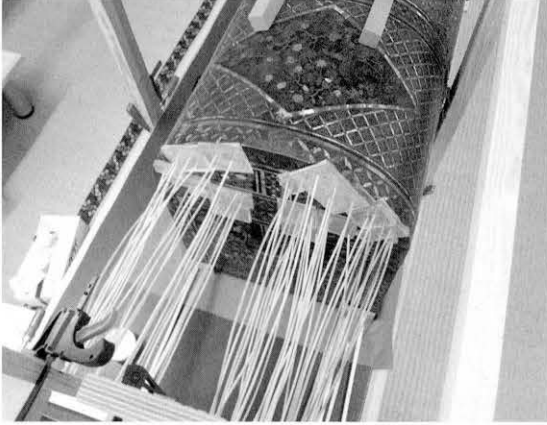
芯張り圧着用木枠  
Wooden frame for *shimbari*

芯張り圧着  
Press-stabilizing, *shimbari* technique

芯張り圧着 (正面)  
Press-stabilizing, *shimbari* technique (front)

芯張り圧着（側面）  
Press-stabilizing, *shimbari* technique (side)

芯張り圧着（蓋甲面）  
Press-stabilizing, *shimbari* technique (lid)

洋櫃の表面漆塗膜や螺鈿はかなり多く剥離剥落が生じている。本来であれば後補塗料の除去を行った後で剥離した漆塗膜や貝の圧着を行うべきであるが、現状では後補塗料の除去作業によって剥離した部分の損傷を拡大する恐れのある箇所が多かった。したがって、損傷を与えてしまう箇所は先に剥離部分を膠で接着して安定を計り、その上で後補塗料の除去作業を行うことにした。圧着作業は昨年度と同じく、洋櫃を木枠内に設置し、竹ひごの弾力を利用した芯張りによる方法を用いた。先ず、剥離した漆塗膜下や螺鈿の下にエタノールを含浸して膠の浸透を良くしてから、筆に含ませた膠を含浸した。なお、膠にも少量のエタノールを加え浸透力を良くして剥離部分に含浸し接着を行った。

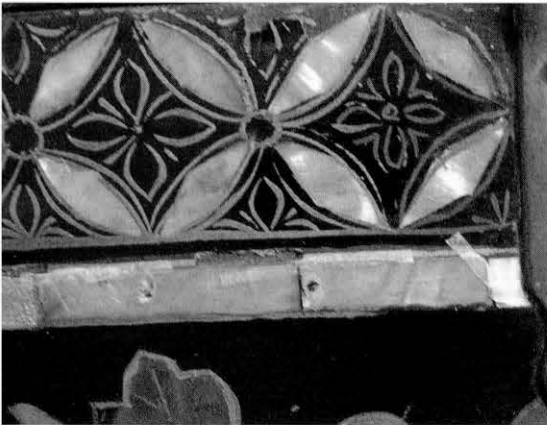
圧着前  
Before press-stabilization

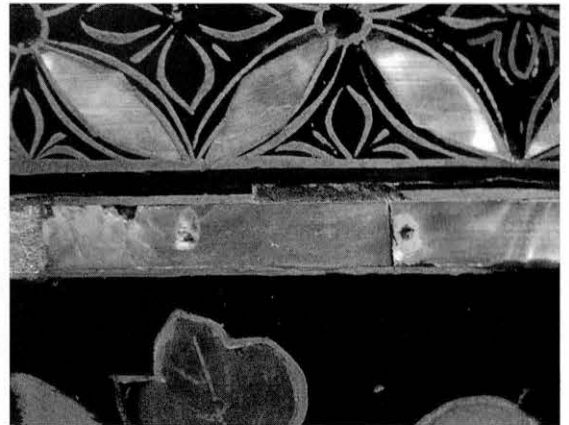
圧着後  
After press-stabilization

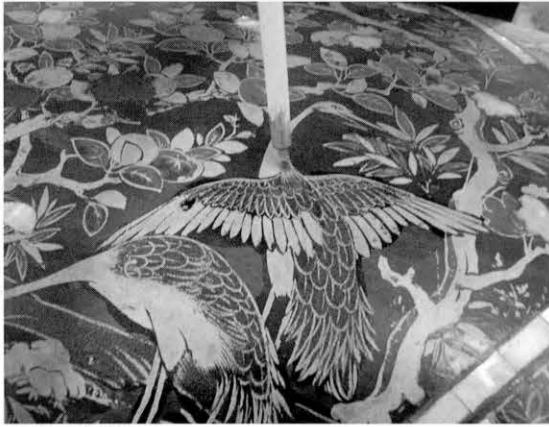
漆固め (蒔絵部分)  
Consolidating urushi (*makie* portion)

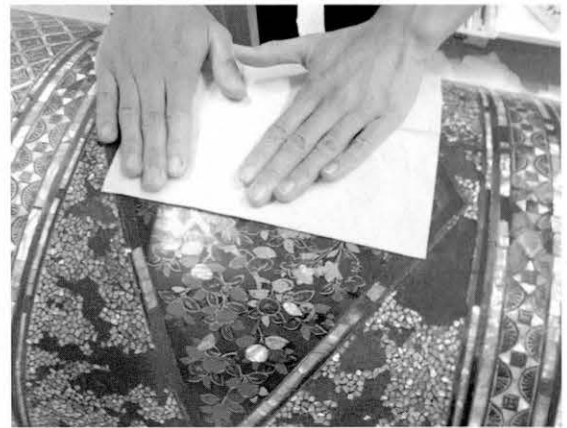
漆固めの拭き取り  
Wiping off excess urushi after consolidating
