## 5. 菱繫文螺鈿箆笥

### 5. *Cabinet with Lozenge Design*

国立ナープルステク博物館（チェコ共和国）所蔵  
Náprestek Museum, National Museum, Prague (Czech Republic)

## 5.1. Restoration Report

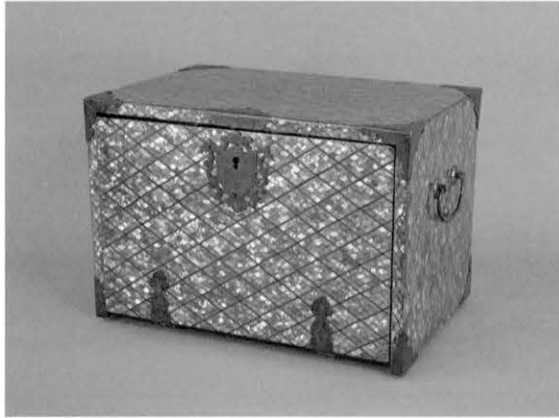
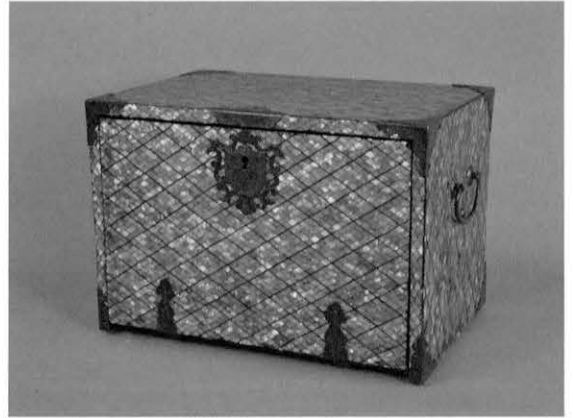
Fig. 5.1 全体 Whole

a 修復前 Before restoration

b 修復後 After restoration

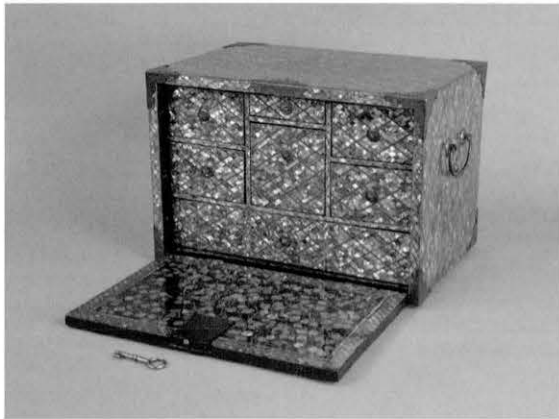
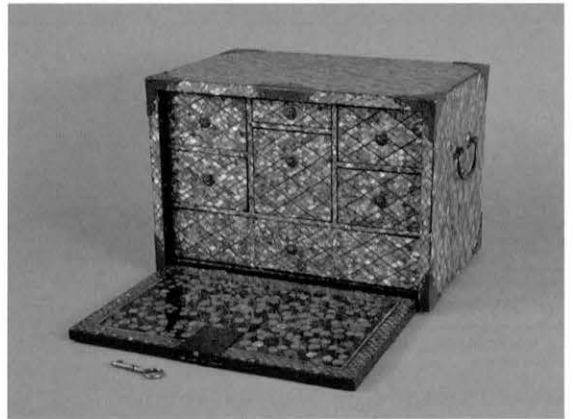
Fig. 5.2 全体 Whole

a 修復前 Before restoration

b 修復後 After restoration

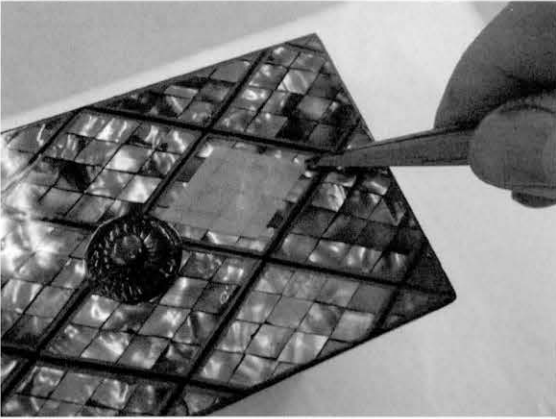
Fig. 5.9 西洋塗料の除去 不織布とエタノールによる塗料の膨潤 修復中  
Removing Western coating materials, swelling coating materials with nonwoven cloth and ethanol, during restoration

As a result of the test on solvents, ethanol for disinfection and absolute ethanol were used to remove the yellow coating material. Nonwoven cloth cut to a size slightly smaller than the size of the lozenge and immersed in ethanol for disinfection was put on places where the coating material was to be removed. After having waited for the coating material to become swollen, a tortoise shell spatula was used to remove it. So as not to damage the *tsukegaki* lines on the shell pieces, coating material around

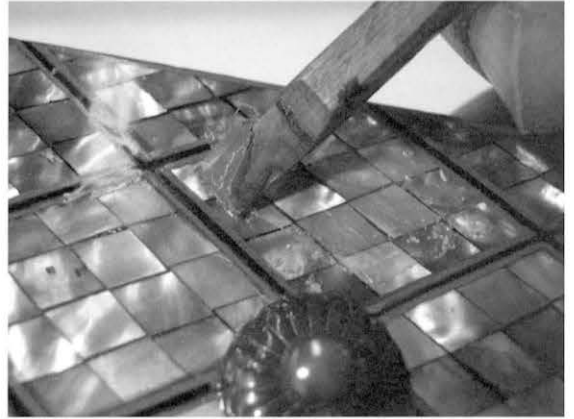
Fig. 5.10 西洋塗料の除去 亀甲筥による塗料の除去 修復中  
Removing Western coating materials with a tortoise spatula, during restoration

the edges of gold lines were carefully removed with a cotton cloth moistened with absolute ethanol. The coating material on the *makie* on the inner side of the fall front was also carefully removed with a tortoise shell spatula, as was in the case of *raden*. Since two types of drawing material had been used on the original gold lines, ethyl acetate was used after absolute ethanol.

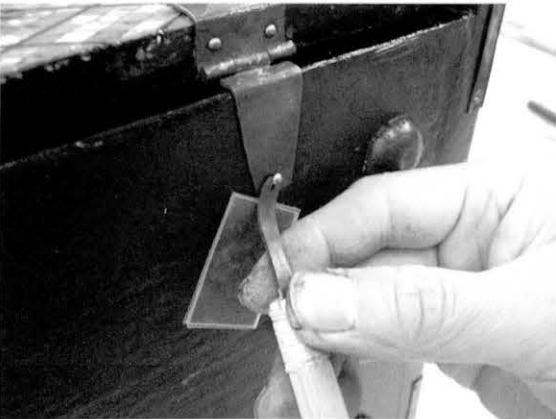
Fig. 5.11 金具の取り外し 蝶番裏の釘 修復中  
Removing a metal fitting, removing a nail on the reverse side of a hinge, during restoration

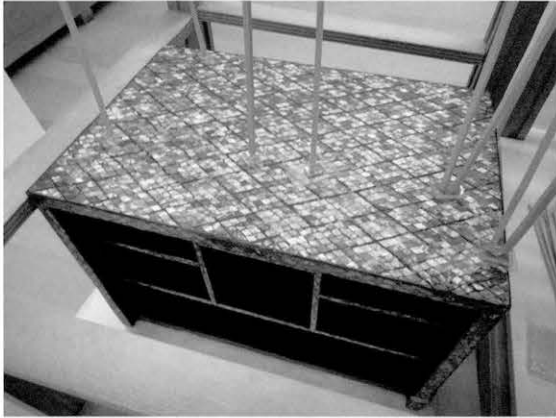
Fig. 5.13 膠水溶液による螺鈿の剥落止め 天板部分 修復中  
Consolidating *raden* by using animal glue solution, top board, during restoration

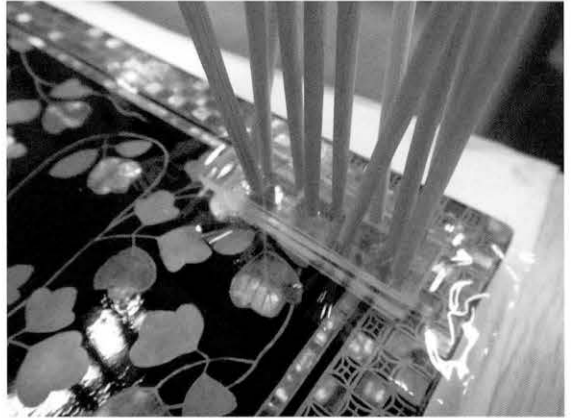
Fig. 5.14 漆塗膜の剥落止め 蓋裏部分 修復中  
Consolidating urushi coating film, inner side of the fall front, during restoration

*Suki-urushi* was applied to the deteriorated coating film and the *makie* portions for consolidation. For *urushigatame*, *kijomi urushi* diluted with Cleansol G and *suki-urushi* were mixed. Excess urushi was wiped off with ligroin.

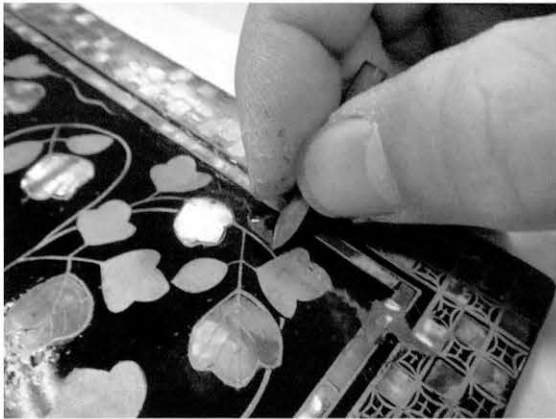
Fig. 5.15 亀裂箇所の下地の充填と調整 扉内側部分 修復中  
Filling a crack with foundation and making adjustment, inner side of the fall front, during restoration

Cracks on the joints of the substrate were reinforced by impregnating *mugi-urushi* that had been adjusted.

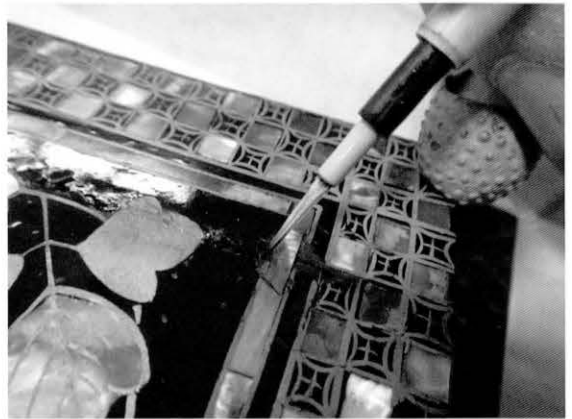
Fig. 5.16 亀裂箇所の漆による色調整 扉内側部分 修復中  
Adjusting the color of a crack with urushi, inner side of the fall front, during restoration

The color of the urushi coating film was adjusted by applying urushi to the parts where the foundation had been filled and grinding the surface with charcoal. This was repeated several times.

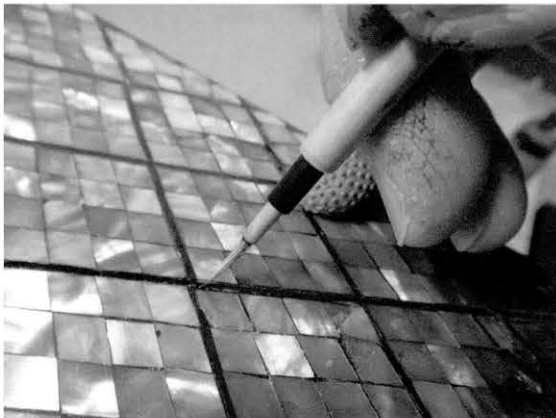
Fig. 5.17 漆塗膜と蒔絵の補強 右側面部分 修復中  
Reinforcing the urushi coating film and *makie*, right side, during restoration

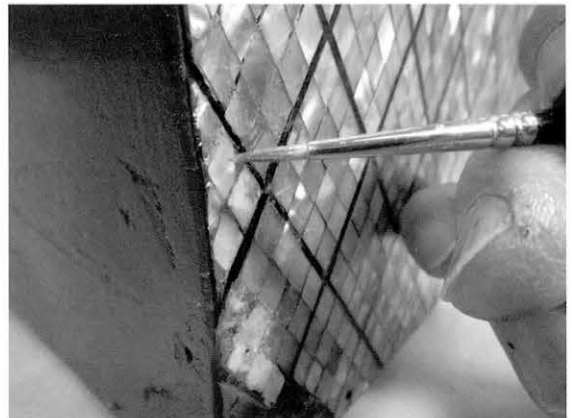
Fig. 5.18 後世修復時に新補された螺鈿の色調整 右側面部分 修復中  
Adjusting the color of *raden* applied in a past restoration, right side, during restoration

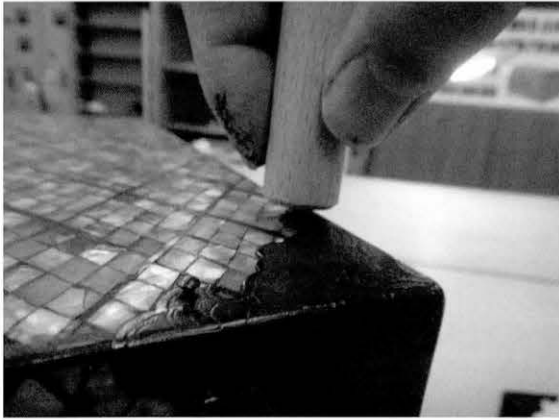
Fig. 5.19 隅金具と取り付け 修復中  
Attaching a corner metal fitting, during restoration

Warping of the metal fittings was simply corrected and the metal lock plate, corner metal fittings and the hinges were returned to their original positions. Nail holes that were loose were filled with *kokuso* and the metal fittings were nailed down. Since the right hinge was warped severely, causing a problem opening and closing the fall front, adjustment was made by removing the foundation under the hinge.
