6. 花樹鳥蒔絵螺鈿箆笥

6. *Cabinet with Floral Design*

アシュモリアン博物館（英国）所蔵

6.1. 修復報告

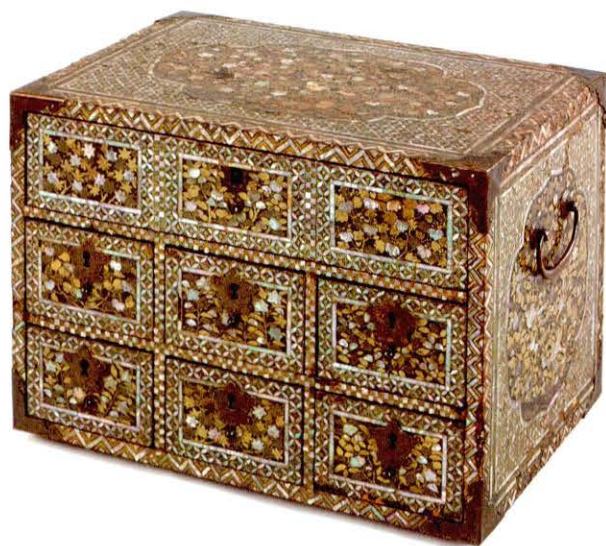
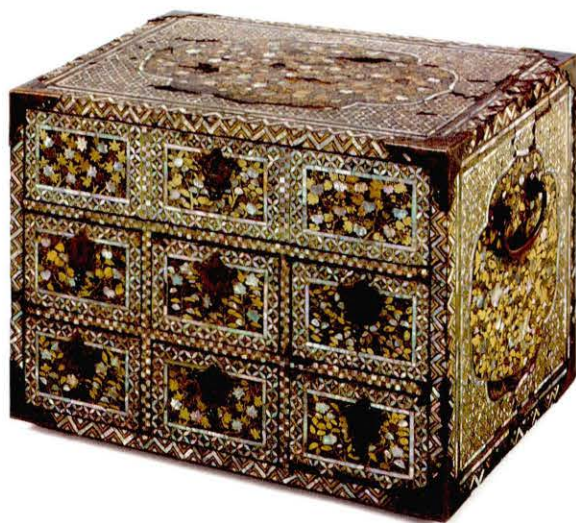
C6.1 花樹鳥蒔絵螺鈿筆筒
Cabinet with Floral Design

a 修復前
Before restoration

b 修復後
After restoration

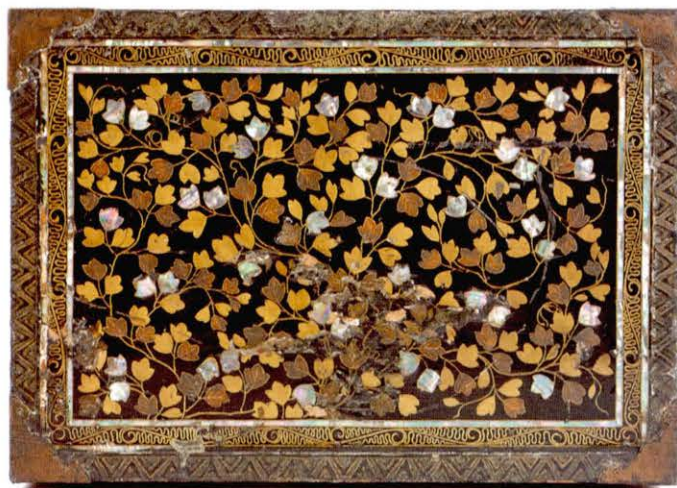
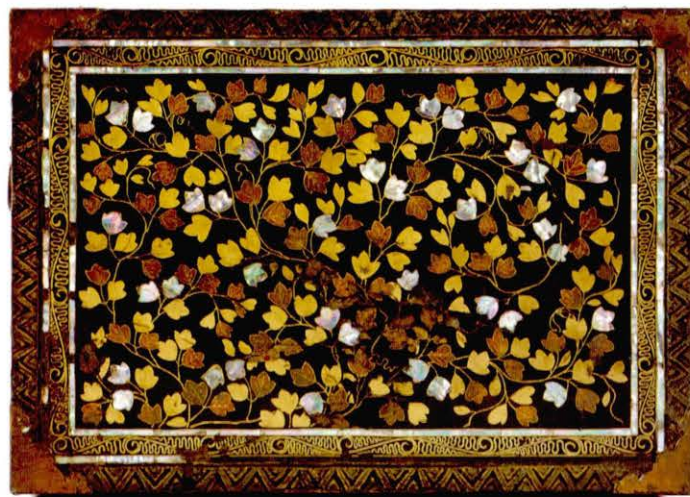
a 修復後
Before restoration

b 修復後
After restoration

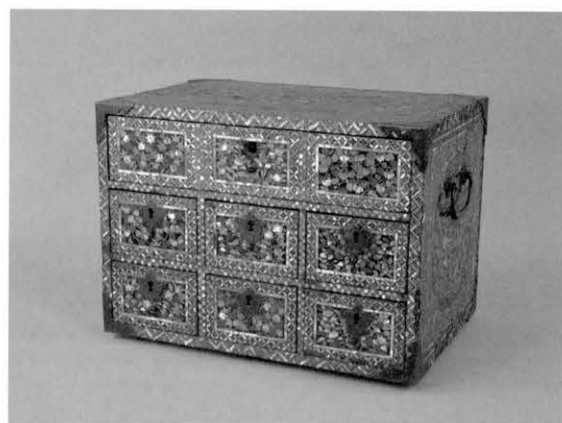
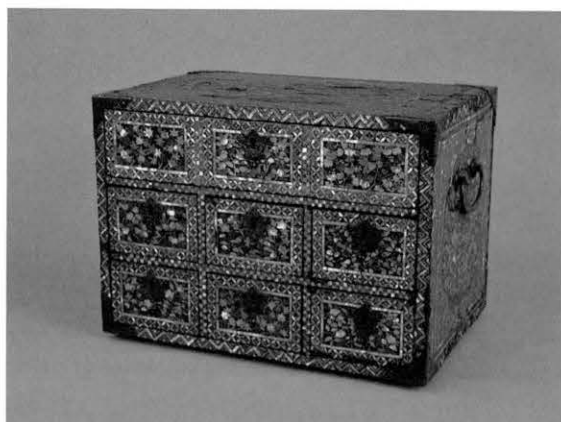
Fig. 6.1 全体 Whole

a 修復前 Before restoration

b 修復後 After restoration

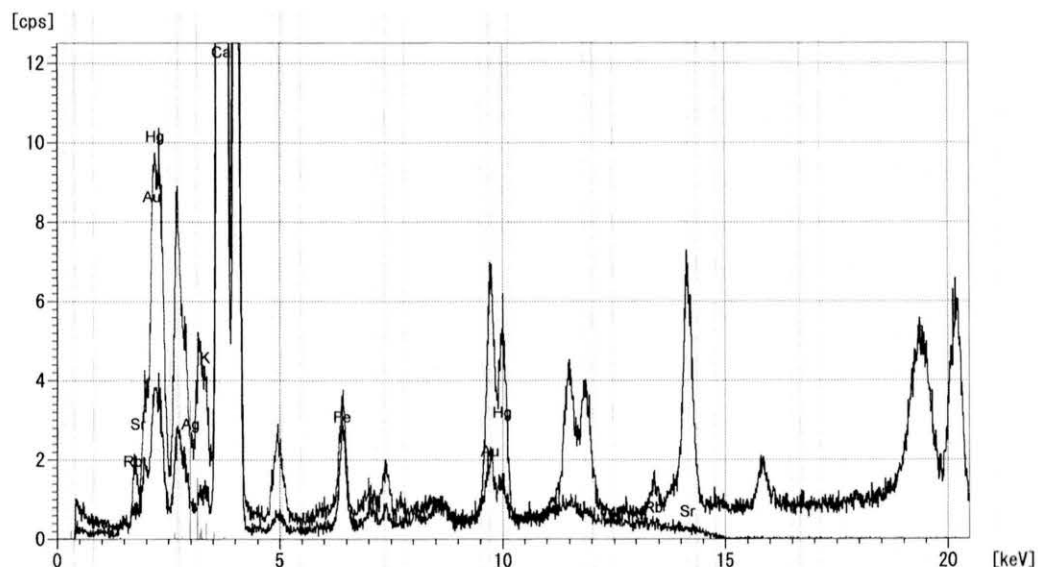
Fig. 6.28 蒔絵粉の蛍光X線分析結果
Result of X-ray fluorescence analysis of makie powder

- (5) 回収した漆塗膜破片の蒔絵部分を蛍光X線分析した結果、金 (Au) とともに水銀 (Hg) やごく微量の銀 (Ag) が検出された (Fig. 6.28)。そのため、下描の赤色漆はベンガラ漆ではなく朱漆であること、金蒔絵粉にはごく微量の銀が混入していること、などが確認された。これは、本報告書に所収されている早川泰弘氏による分析結果とも齟齬がないほぼ同様の内容である。

- (5) As a result of X-ray fluorescence analysis of the *makie* parts on the fragments of urushi coating film that were collected, gold (Au), mercury (Hg) and a very small amount of silver (Ag) were detected (Fig. 6.28). For this reason, it was confirmed that *bengala urushi*, which is red urushi, and not *shu-urushi* was used for the draft drawing and that a very small amount of silver was mixed into the gold *makie* powder. This corresponds almost completely with the results of analysis performed by Yasuhiro Hayakawa of the Institute.

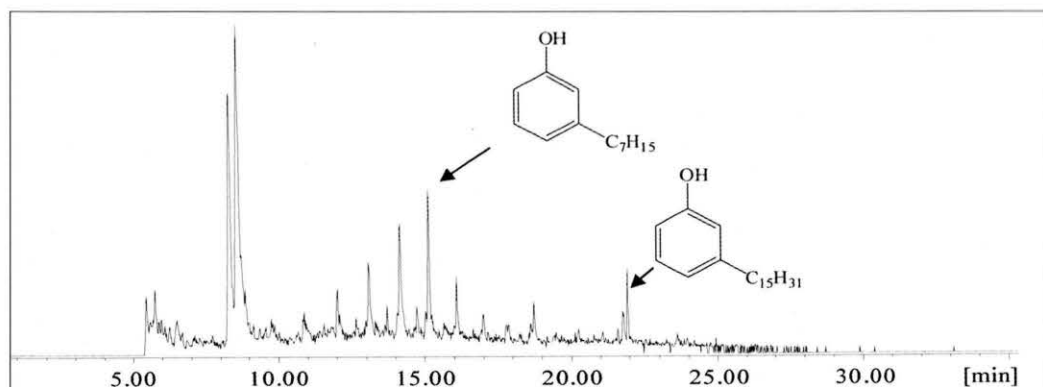
Fig. 6.29 塗膜破片試料のPY-GC/MS分析結果
Result of PY-GC/MS analysis of a sample fragment of the coating film

- (6) 回収した漆塗膜破片の PY-GC/MS 分析を行った結果、チチオールやラッコール成分ではなく、ウルシオールに由来するピークが確認された (Fig. 6.29)。そのため、この資料の地の黒漆には、タイ・ビルマ・カンボジア産やベトナムなどの東南アジア産輸入漆塗料ではなく、国産の日本産もしくは中国産漆塗料が用いられているものと理解した。

- (6) As a result of PY-GS/MS analysis of the fragment of the urushi coating film, a peak that is derived from urushiol, rather than from thitsiol or laccol, was confirmed (Fig. 6.29). For this reason, it is understood that the black urushi used for the ground of this object is not urushi produced in and imported from Thailand, Burma, or Cambodia or in Southeast Asian countries like Vietman but domestic urushi or urushi coating material produced in China.

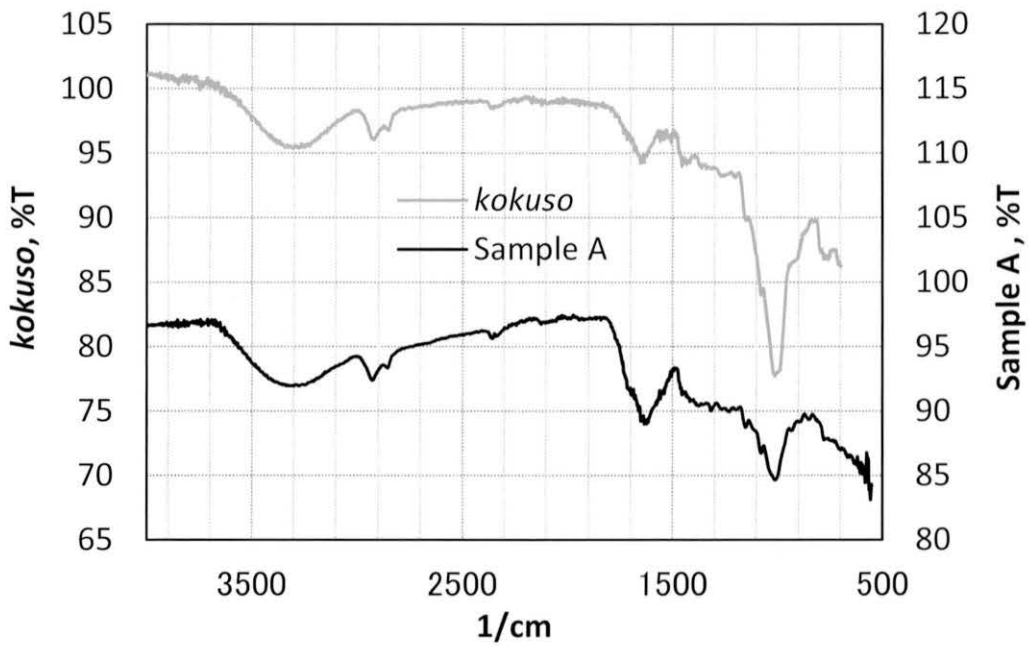
Fig. 6.30 赤外線スペクトル分析 試料 A
Fourier transform infrared spectroscopy, Sample A

- 得られたスペクトルを Fig. 6.30 ～ Fig. 6.32 に示す。
- 試料 A のスペクトルからは 1630cm^{-1} と 1010cm^{-1} に強い吸収が得られ、これはエーテルの炭素-酸素結合と考えられる。また、水酸基由来と考えられる 3000cm^{-1} 付近の吸収も得られた。スペクトルはほぼ完全に参照試料 (a) の刻苧と一致した。
- 試料 B のスペクトルは参照試料 (b) シェラックと一致した。
- 試料 C からは C-H の伸縮振動による 2920cm^{-1} と 2850cm^{-1} と C=O 由来と思われる 1700cm^{-1} の吸収が得られた。当初、試料 C はその色や状態から刻苧と考えられたが、IR スペクトルは刻苧とは一致しないため、他の材料である可能性が高い。

- The spectra are shown in Fig. 6.30 - Fig. 6.32.
- Spectrum of sample A had three strong absorptions : 1630 cm^{-1} ; 1010 cm^{-1} that was assigned to C-O of ether, and around 3000 cm^{-1} that was assigned to O-H group. The spectrum pattern of sample A was similar to reference (a) *kokuso*.
- Spectrum of sample B showed the same pattern as that of reference (b) shellac.
- Spectrum of sample C had two sharp absorptions at 2920 cm^{-1} and 2850 cm^{-1} that were assigned C-H to stretching vibration. Absorption band was also detected around 1700 cm^{-1} suggesting C=O bond. Sample C had been thought *kokuso* because of its conditions, but the spectrum of this sample did not correspond to *kokuso* spectrum.
