Project for Investigation of Damage Situation of Cultural Heritage in Nepal

Structural Survey of Historic Buildings

October 2016

Tokyo National Research Institute for Cultural Properties

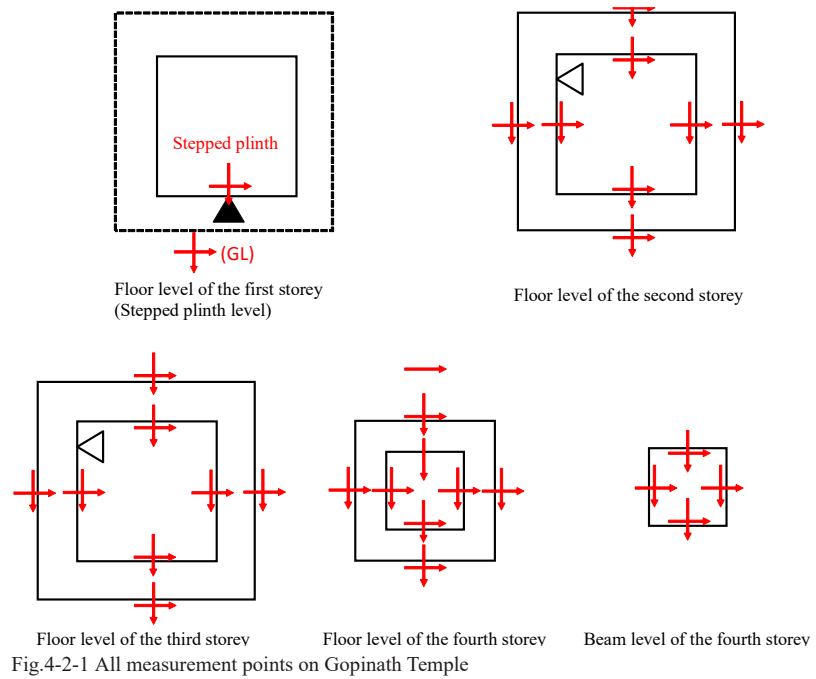
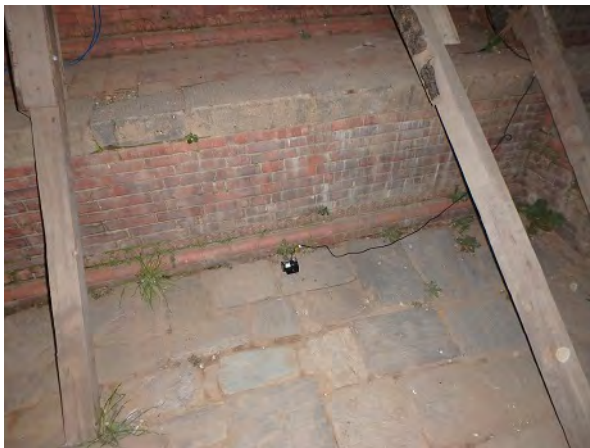
(a) On the free ground

All measurement points are shown in Fig.4-2-1. All measurement points were monitored by dividing into 20 cases shown above. Multiple measurements were taken: one on free ground, and several inside the buildings. The measurement point on free ground was at the front of the building, shown in Pic.4-2-2(a). The measurement point on the stepped plinth was also intended to confirm the amplification of the vibration by the stepped plinth. Measurement points inside the building were at the top of the wall, on the beam, and on each floor close to a structural wall. Since it was difficult to put the sensor on the top of the wall at the top storey, we placed it on top of the window sill in the opening as shown in Pic.4-2-2(b).

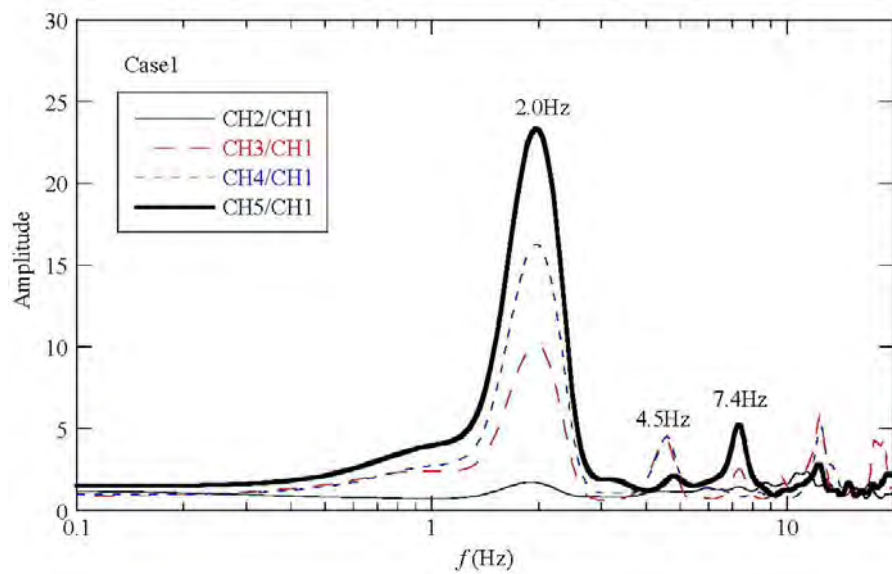
Fig.4-2-2 Representative fourier amplitude ratio for Gopinath temple (EW direction)

The transfer function, shown in Fig. 4-2-2, was obtained by dividing the Fourier spectrum of building vibration monitored inside the building by the Fourier spectrum of ground vibration. The peak frequencies of the transfer function—2.0 Hz, 4.5 Hz, and 7.4 Hz—were estimated to be first, second, and third natural frequencies of the building.

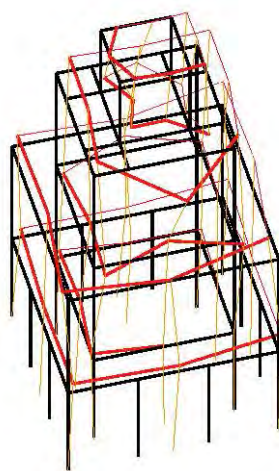
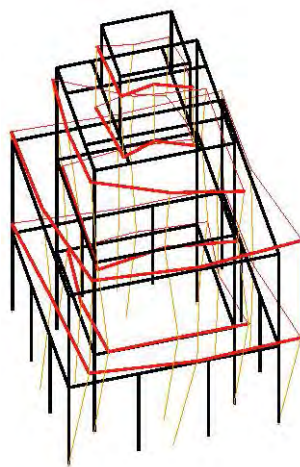
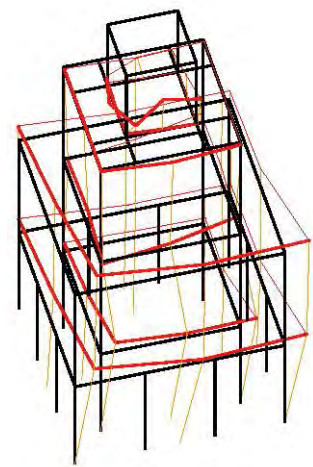
Fig.4-2-3 Representative vibration mode for Gopinath Temple

The vibration mode of elevation obtained by Transfer Function and phase information corresponding to the first, second and third natural frequencies in EW direction are shown in Fig.4-2-3. At the first vibration mode, the amplitude of out-of-plane direction on top of inner periphery is large. At the second and third vibration modes, the amplitude of northern structural plane is large.

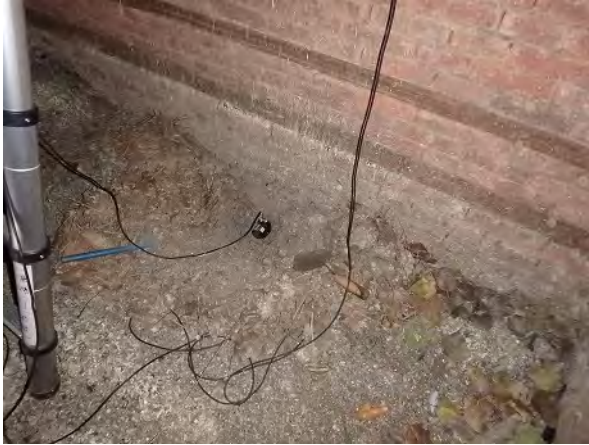
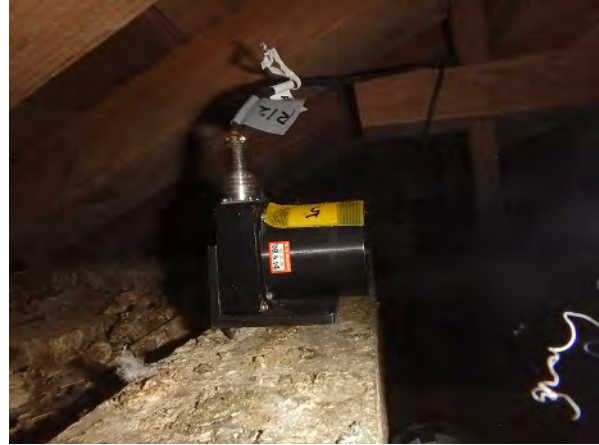
Pic.4-2-3 Placed sensors

Pic.4-2-3 shows the placed sensors. Ch4 was placed on the floor beside wall, and Ch5 was placed on the on top of the wall in the measurement.

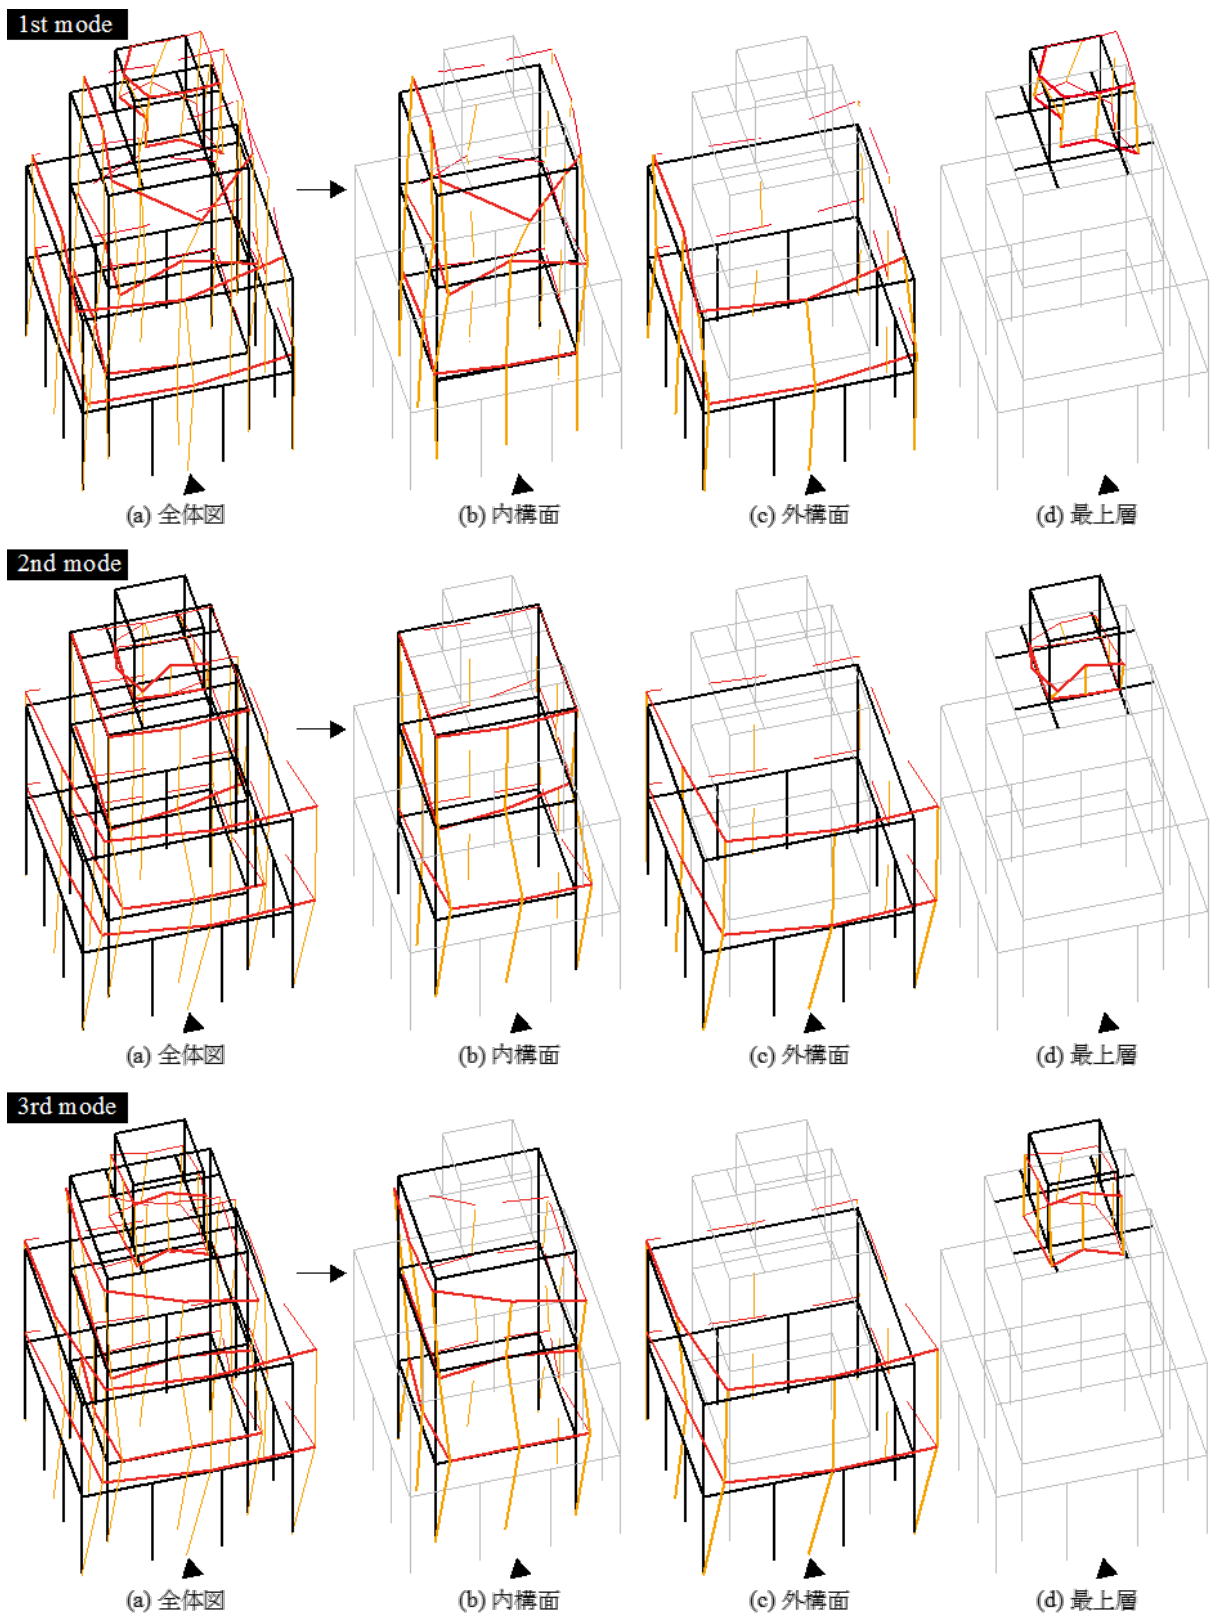
Fig.4-2-4 Vibration mode for Gopinath Temple

Fig.4-2-4 shows the vibration modes obtained by other measurements. The roof shape is removed to simplify the figure. Since the mode figure is complex and difficult to distinguish, the vibration mode of inner structural plane, outer structural plane and structural plane of the top storey were drawn dividedly.

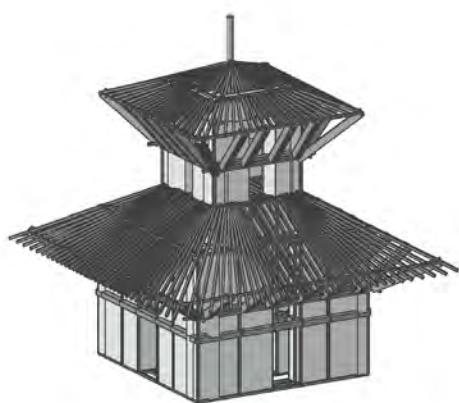
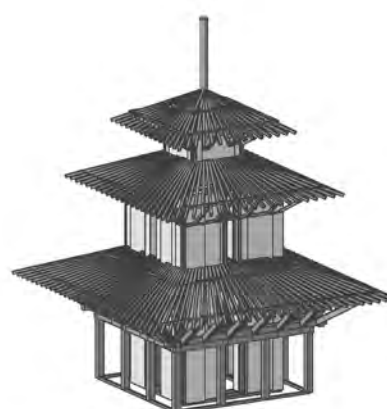
Fig.5-1-1 Examples of the 3D analysis model

At the occasion of evaluating the seismic performance of buildings, it is preferable to create a 3D analysis model using line, surface and joint elements as shown in Fig. 5-1-1. These models can better apply to the building conditions that may include non-true vertical planes (e.g. a wall is not straight between upper and lower storeys), insufficient rigidity in horizontal planes (e.g. floor beams and roof trusses are not sufficient), or unconfirmed rigid floor assumptions. This analysis considered performance against input earthquake vibration in conjunction with the previously developed mass point model that considers building weight and height, and previously reported performance results for brick structure (sufficient original data could not be collected within the scope of this survey). The analysis results were intended to support future reinforcement of historical buildings in Nepal.

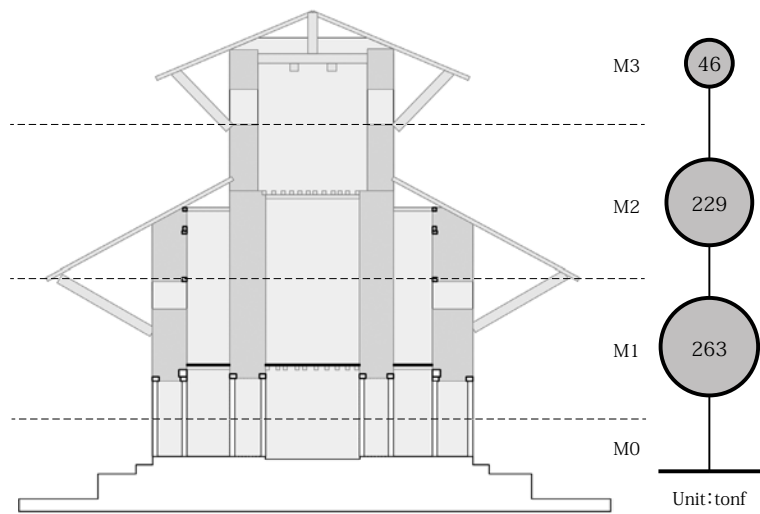
Fig.5-2-1 Mass point model weights for Jagannath Temple

Fig. 5-2-1 shows the weight of each mass point in the Jagannath Temple analysis model. Rooftop pinnacles, small openings, and wall thickness differences were ignored in the weight calculation. Table 5-2-2 lists the A_i distribution obtained from this weight calculation. Fig. 5-2-2 shows the A_i distribution when $C_b=0.1$.

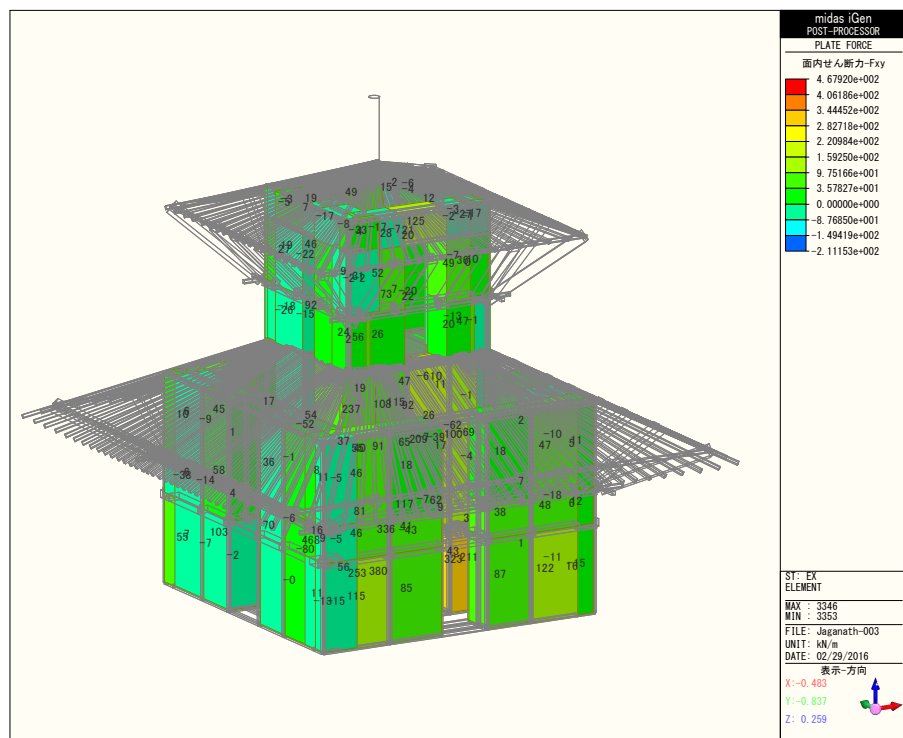
Fig.5-2-2 Shear force distribution (Cb=0.1)

Assuming that the A_i distribution is equal to the acceleration distribution, an input acceleration of 0.25 G ($C_1 = 0.25$) resulted in an output acceleration at the top storey of 0.482 G. Thus the output acceleration may exceed 0.5 G, namely the external force may be larger than the friction resistance between bricks ($\mu=0.5$) at the top storey. This assumption corresponds with the field survey results for the Jagannath Temple that noted the earthquake damage concentrated at the top storey. A similar tendency is likely observed for buildings with upper storey walls that continue straight to the first storey.

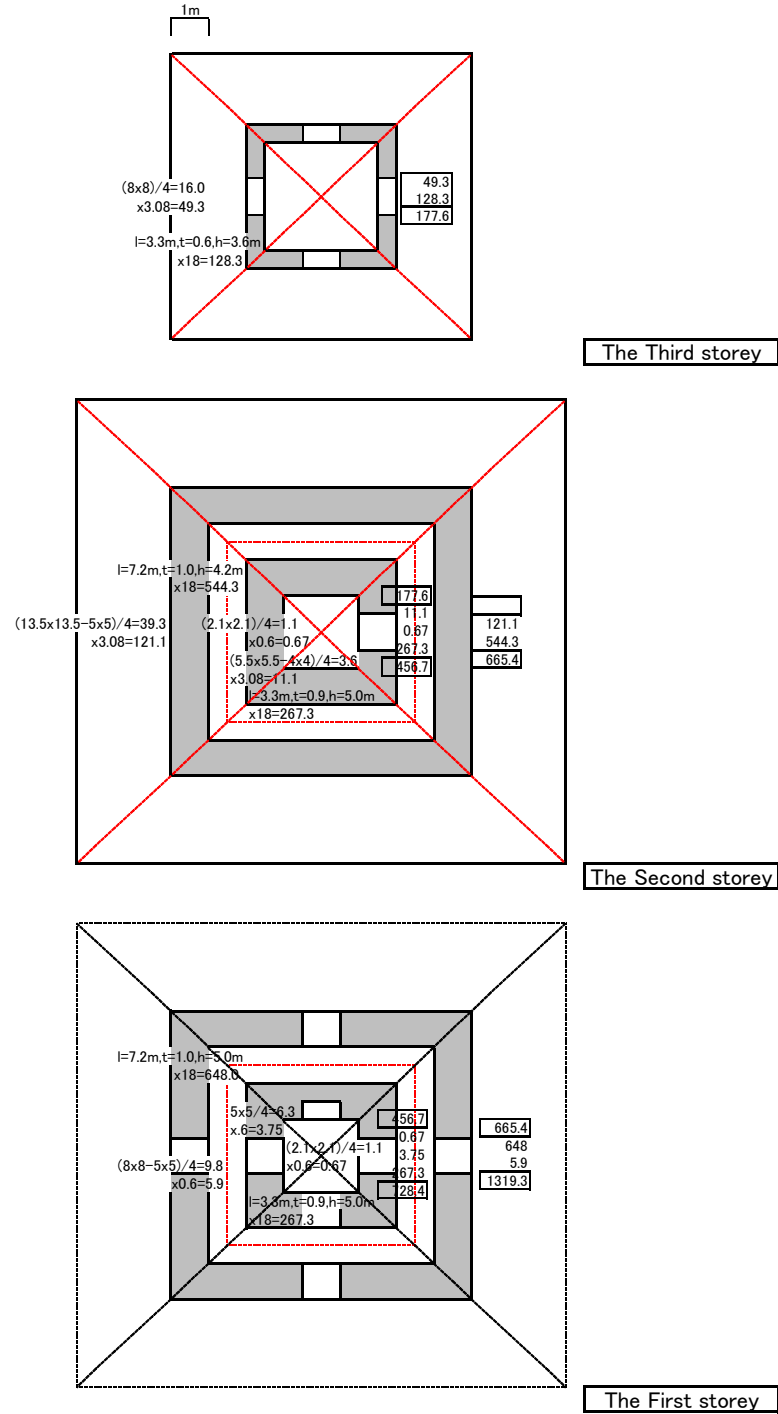
Fig.5-2-3 Distribution of compressive force for vertical load (Left: w_j , Right: Σw_j) of Jagannath Temple

Fig. 5-2-3 shows the calculation result for the distribution of compressive force of each wall in each storey for vertical load. The number in the figure shows the weight at one-fourth of the plan. The number in the left shows the weight of its story (w_j), and right shows the weight which that story sustains (Σw_j).

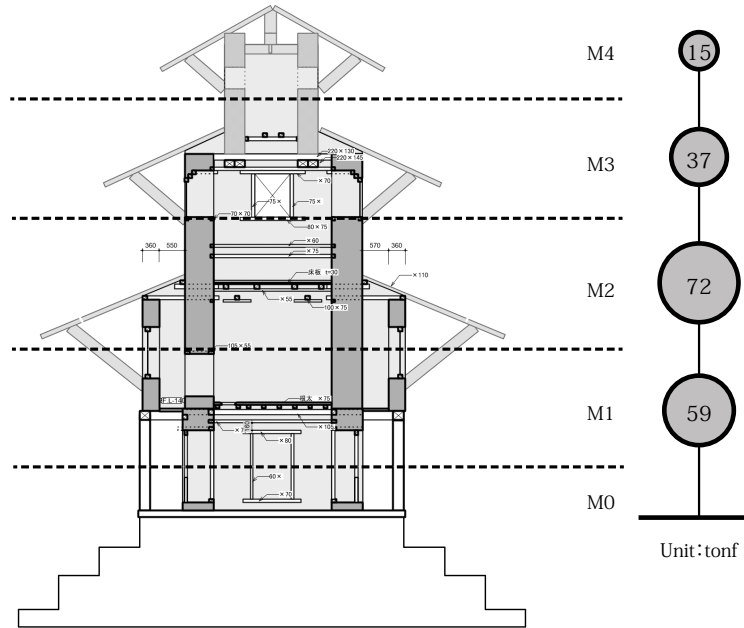
Fig.5-3-1 Mass point model weights for Gopinath Temple

Fig. 5-3-1 shows the weight of each mass point in Gopinath Temple analysis model. Again, rooftop pinnacles, small openings, and wall thickness differences were ignored in the weight calculation. Table 5-3-2 lists the A_i distribution obtained from this weight calculation.

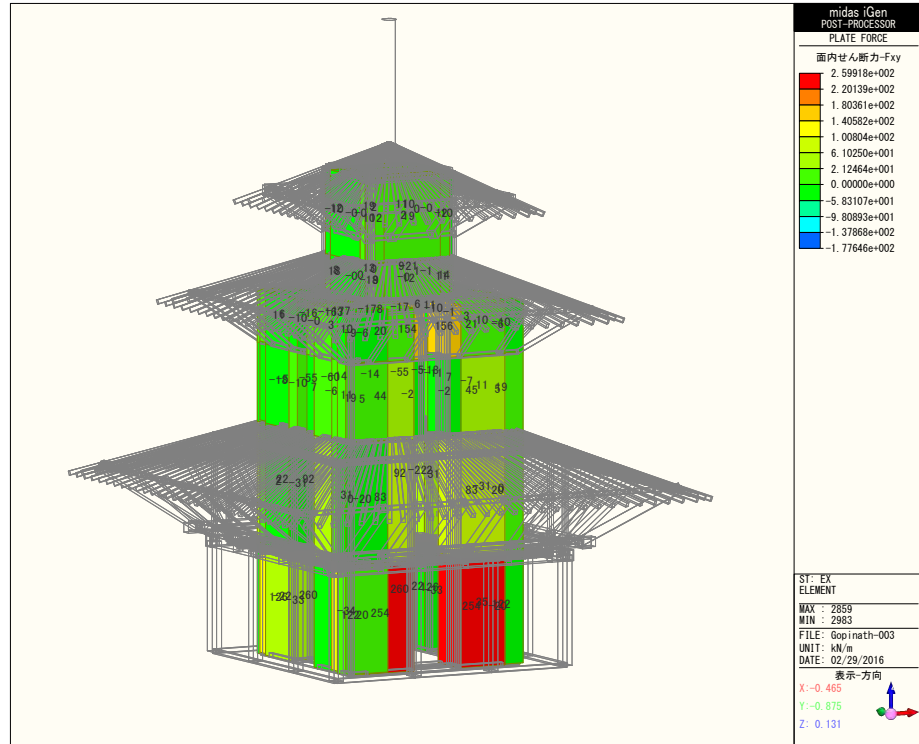
Fig.5-3-2 Shear force distribution ($C_b=0.1$)

This assumption corresponds with the field survey results for Gopinath Temple that noted earthquake damage concentrated at the first storey. A similar tendency is likely observed for buildings with upper storey walls that do not continue straight to the first storey or with smaller cross-sectional brick wall areas at the lower storey compared with the upper storey cross-sectional areas.

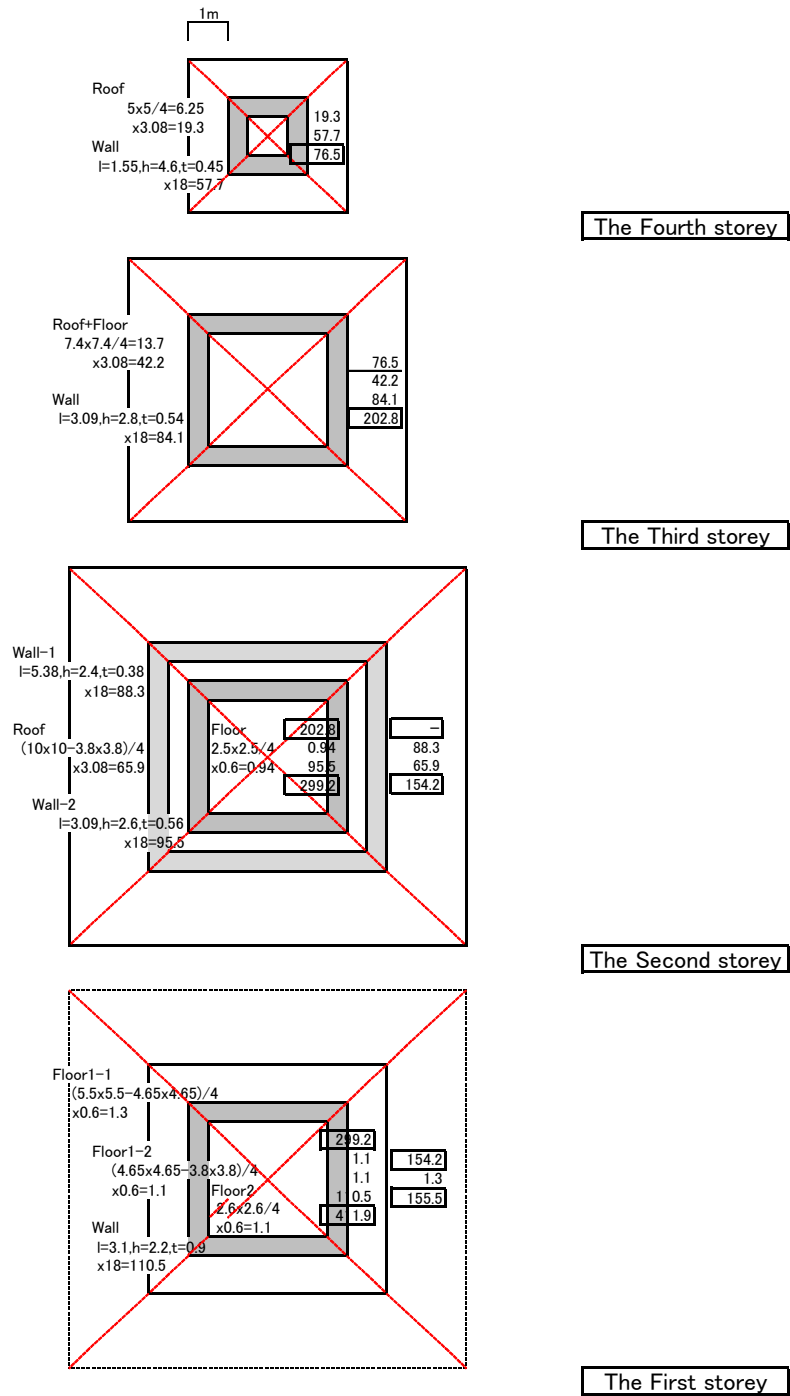
Fig.5-3-3 Distribution of compressive force for vertical load (Left: w_j , Right: Σw_j) of Gopinath Temple

Fig. 5-3-3 shows the calculation result for the distribution of compressive force of each wall in each storey for vertical load. The number in the figure shows the weight at one-fourth of the plan. The number in the left shows the weight of its story (w_j), and right shows the weight which that story sustains (Σw_j).

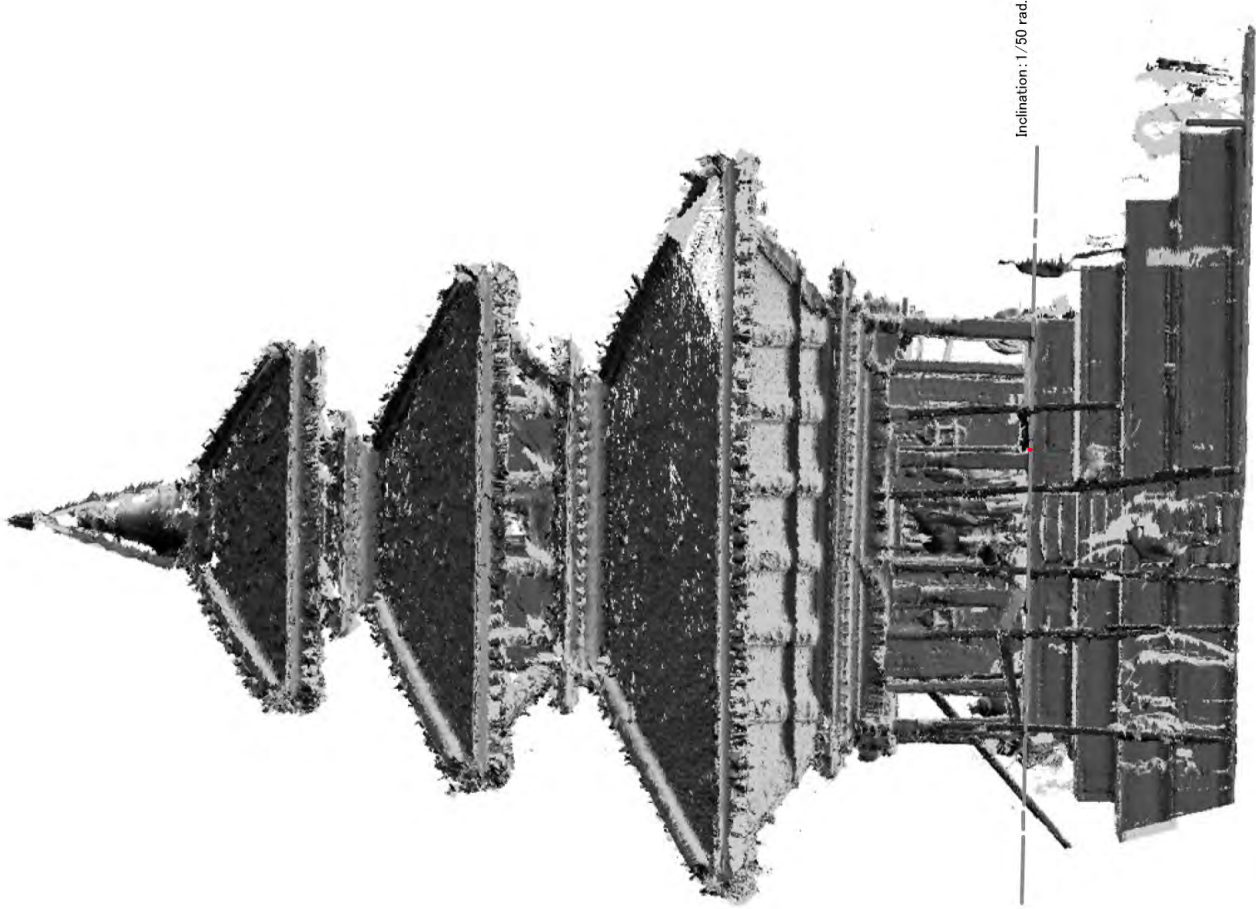
Project Title	Project for investigation of damage situation of cultural heritage in Nepal			
	Name		Gopinath Temple	
	Drawing Title		East Elevation	
	Scale		1:100 (A4)	
	Researcher		Koshihara lab	
	Day of Research		4 - Dec -2015	
G12

Inclination : 1/50 rad.
