2015 Project for International Contribution to Cultural Heritage Protection

Project for Investigation of Damage Situation of Cultural Heritage in Nepal

Survey of Historic Settlement

National Research Institute for Cultural Properties, Tokyo

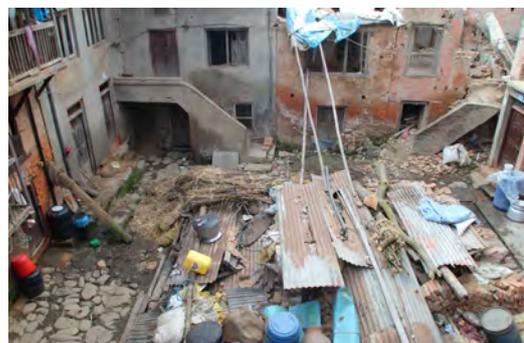
Fig. 2-2-9 Remains of debris from the earthquake at a courtyard (Taken in Nov. 2015)

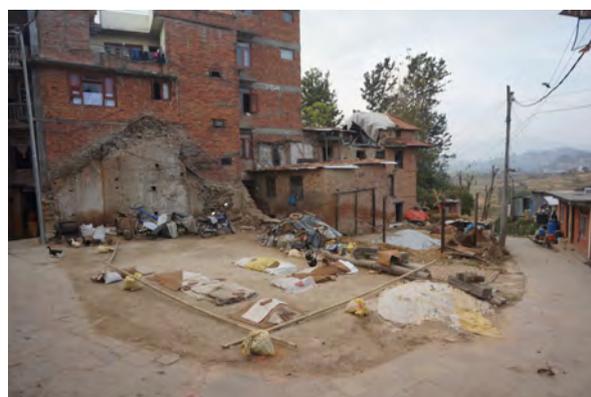
Fig. 2-3-5 Nhyabu Mill (Collapsed)

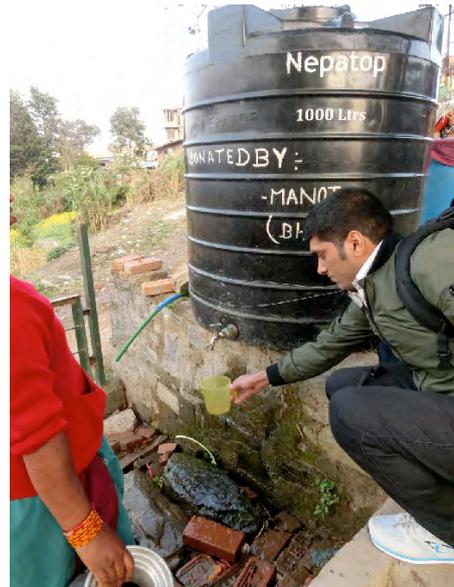
T1 and T6 are plastic water supply tanks (Fig. 2-4-2) that are surmised to have been donated in response to the earthquake damage, but both were positive for coliform groups, suggesting the need for appropriate maintenance management methods. In the pond test samples, colibacilli density was markedly high in the pond (P2) located at the centre of the village and used in ritual ceremonies, leading to the proximate presence of faecal pollution being surmised. The tap water from the supply tank (T4) installed next to this pond (P2) was polluted with the highest density levels of colibacilli among the tap water test samples, emphatically verifying the inferior quality of the sanitary environment surrounding the pond. At the time the water samples were taken, abnormal levels of algae were proliferating (Fig. 2-4-3) in this pond (P2), and contamination by not only faecal matter but also nutrient salts originating in domestic wastewater, such as nitrogen and phosphate, was also strongly suspected. By contrast, while high density levels of coliform groups were detected for the test samples of the other ponds (P1 and P3), colibacilli was not detected, suggesting the possibility of little direct inflow of faeces. Among the well water test samples, W1 and 2W1 had high colibacilli density and faecal pollution was strongly suspected. According to the residents, this well water is not used for drinking, but the concerns they raised about the risk of microbiological infection through water splashing in daily life activities, such as washing vegetables and laundry (Fig. 2-4-4), should not be ignored.

Fig. 2-4-2 Water tank located in earthquake victim camps (T6)

This survey has indicated the extent of the microbiological pollution of tap, pond, and well water in Khokana Village. As noted above, while the detection of coliform groups and colibacilli does not, without more, necessarily mean there is an immediate risk of infectious disease, considering the fact that high density levels of colibacilli were also detected for tap water that is supposed to be used for drinking, we consider that there is an urgent need to implement immediate remedial measures. It is also desirable that the marked faecal pollution and abnormal algae proliferation in the pond used as a symbol of the village for ritual ceremonies be improved immediately. Specific measures that may be deployed include separating domestic wastewater (particularly polluted water) from the water environment, primary treatment of sewage water through septic tanks, and implementing sanitary education.

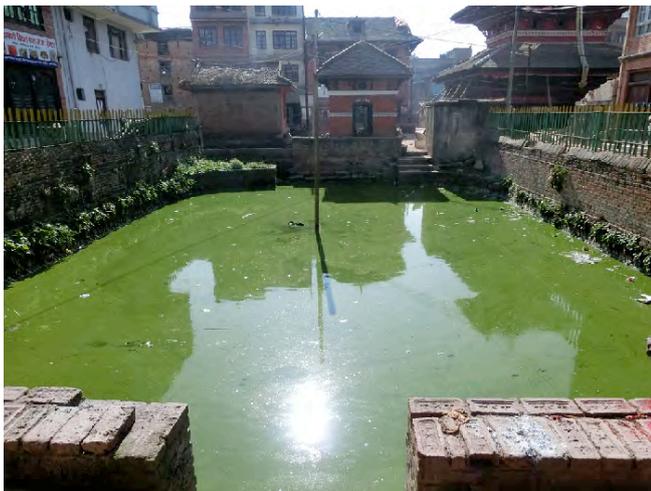
Fig. 2-4-3 The pond located in the center of the village, in which the ritual is performed (P2)

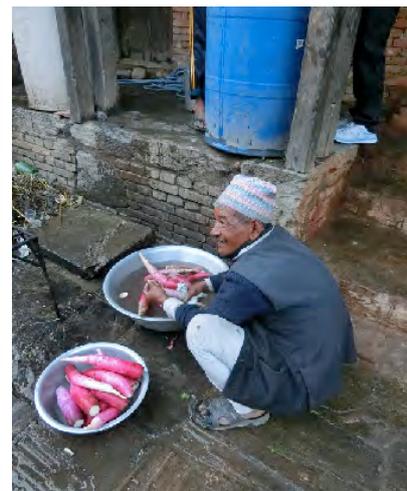
Fig. 2-4-4 Washing vegetables by the well located in the plaza (W1)

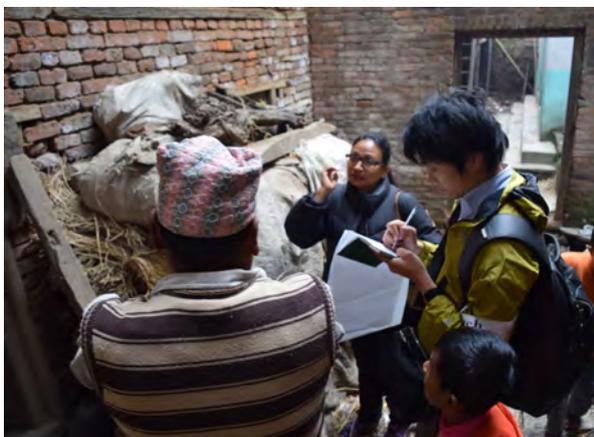
Fig. 2-6-5 Interview inside of the damaged house

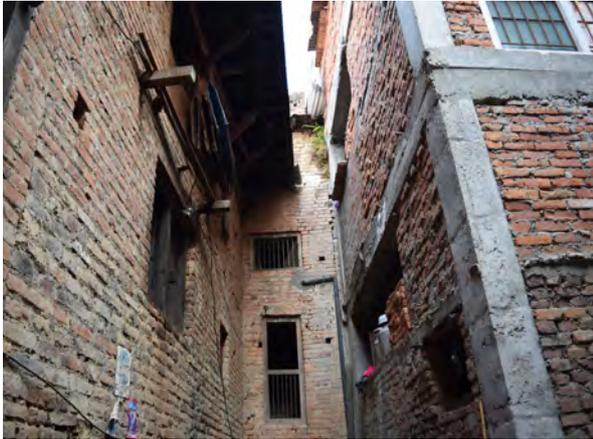
Fig. 2-6-40 Courtyard becomes smaller as houses around were extended in reinforced concrete in the inside courtyard (rearside of S15)

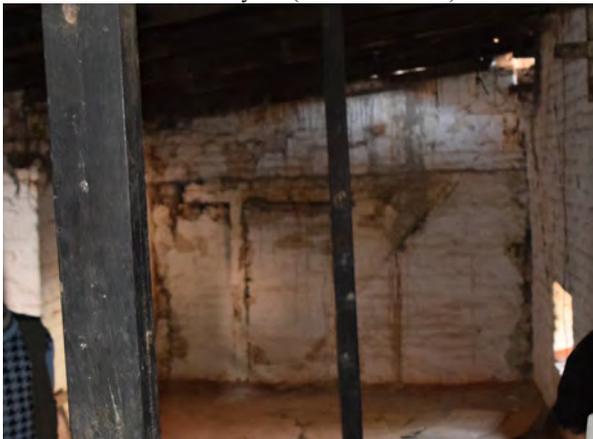
Fig. 2-6-42 Window faced to the courtyard was filled with bricks for extension (S14b)

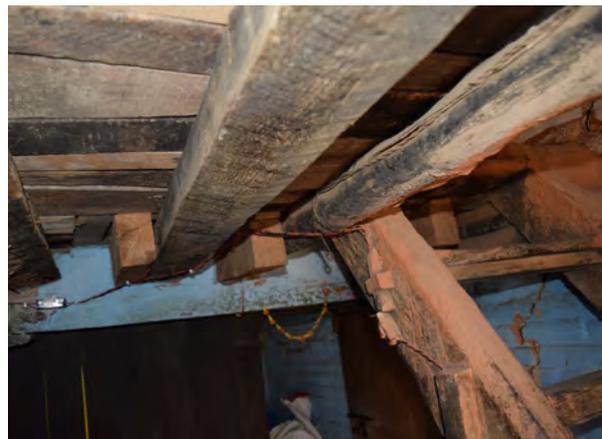
Fig. 2-6-43 Beams of different members were poasted in line. Some of them were put on the former renovation. (S10b02)

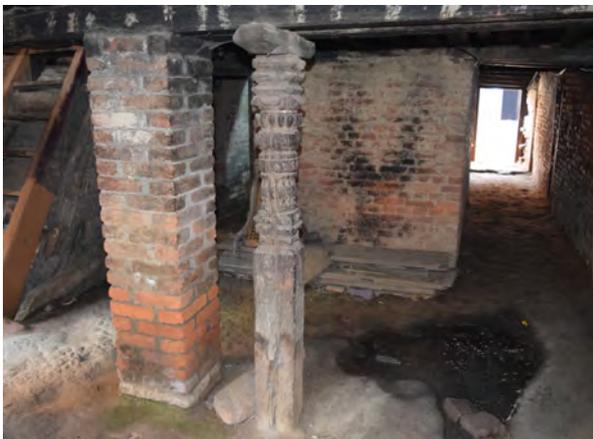
Fig. 2-6-44 Example of installation of brick post for reinforcement (S11)

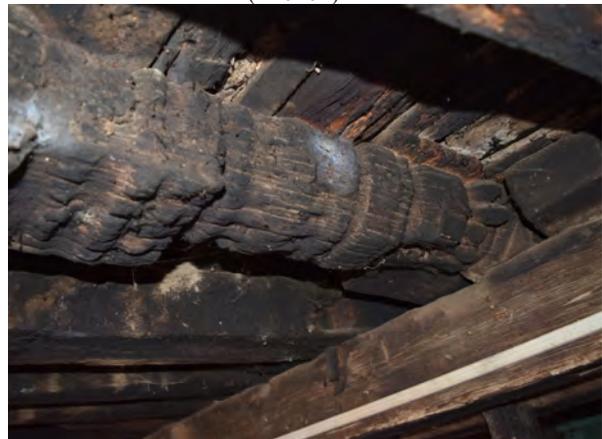
Although we cannot identify it as a common characteristic, there are various renovation cases due to the necessity of life. In the case of Building S11, engraved pillars, which are very important elements for the historical succession of traditional house, are reused without documentation at different position. We need to investigate this matter in detail in near future.

Fig. 2-6-45 Engraved pillar reused as a beam of the ground floor (S11)

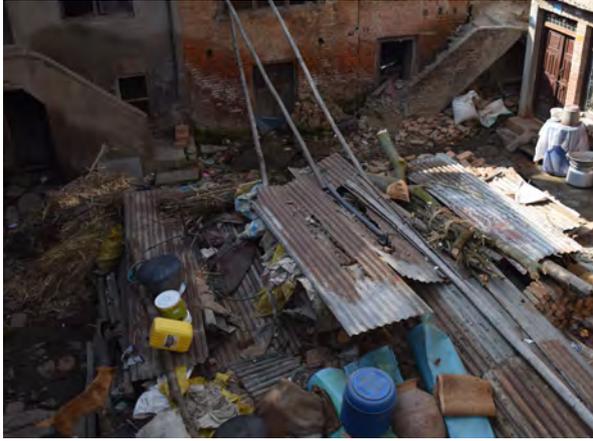
Fig. 2-6-52 After the disaster of 2015, lots of materials in the courtyard disturb its use. (Courtyard at the back of S08 and S09)

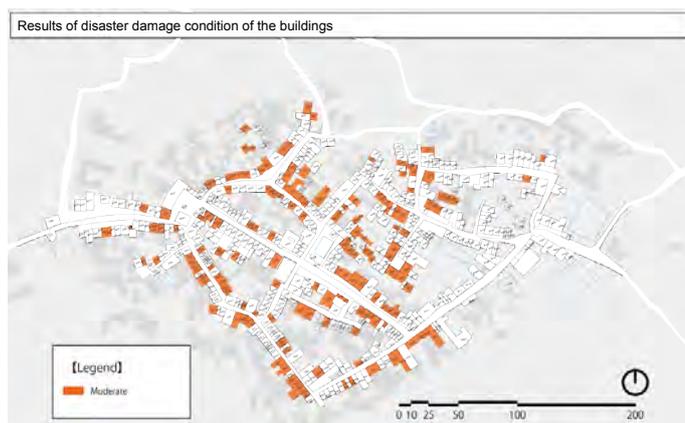
Because this survey strictly concentrates on disaster circumstances pertaining to the external appearance of buildings, it is taken as a premise that its results will not match those of a structural survey. However, based on our observations approximately 15% of the traditionally constructed buildings were totally destroyed, half were partially destroyed, and approximately 40% were slightly damaged or undamaged (Fig. 3-1-5,6). Regarding the disaster circumstances for the 232 non-traditionally constructed buildings, approximately 96% were slightly damaged or undamaged (Fig. 3-1-9), but we also learned through the interviews that there were cracks inside the buildings and curving in the floors. The detail of this damage is a subject to be addressed in the future.

Fig. 3-1-5 Disaster damage condition of traditionally constructed buildings in the southern settlement area

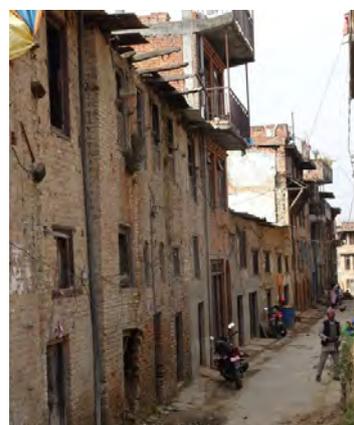
Besides the issue of the reconstruction method to be used for the 52 totally destroyed buildings, it is also necessary to establish whether existing repair reinforcement construction is possible for the 163 traditionally constructed buildings (Fig. 3-1-7) that have been partially destroyed, and the necessity of a fixed and specific presentation of methods. The residents of these partially destroyed buildings have dismantled the upper floor part of their collapsed houses and have covered the ceiling with zinc-coated steel (Fig. 3-1-8); they continue living bi-local lives, using the toilet facilities and storage spaces of their houses during the day, and sleeping in temporary residences at night.

Fig. 3-1-8 Half-collapsed traditionally constructed buildings

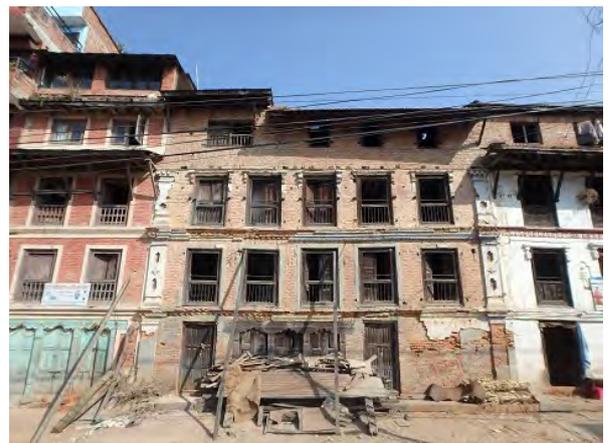
In the traditional houses in Khokana, the buildings extended by brick on the top floor are seen as shown in Pict. 3-2-2. Fig. 3-2-3 shows the disaster damage condition by the presence or absence of extension to the buildings: 165 buildings are non-extended, 77 are extended, and 117 are 'unknown'. Since most buildings with a heavy degree of damage fall within this last category, it is impossible to judge the relation between degree of damage and the presence or absence of extension to the buildings.

Pict. 3-2-2 Extension at the fourth floor

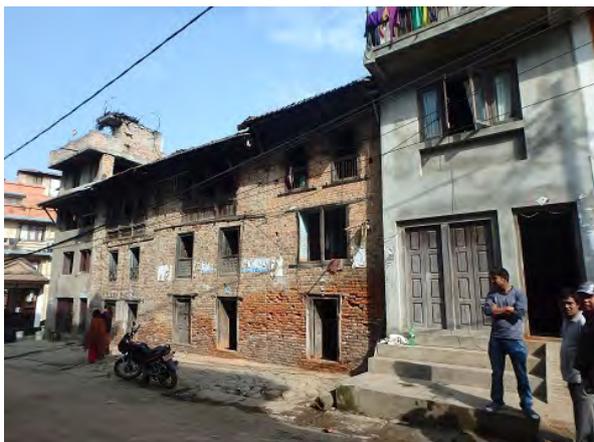
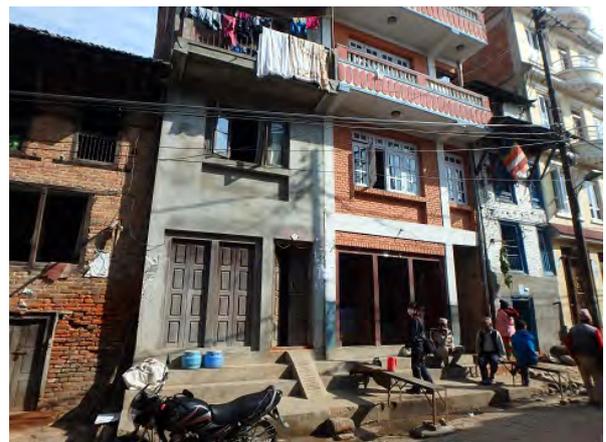
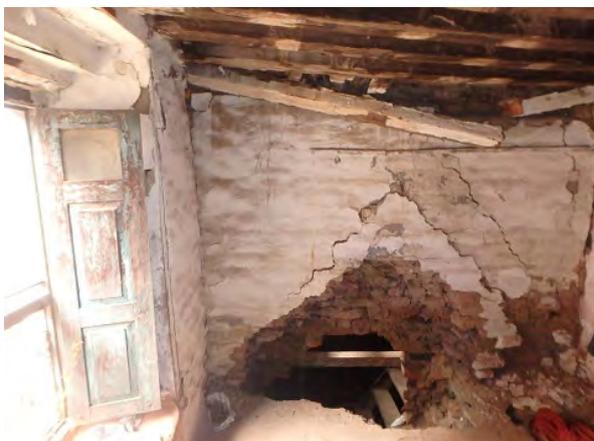
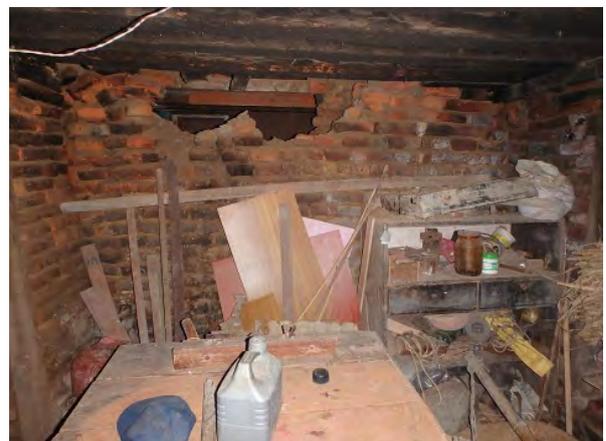
Microtremor measurements were conducted on the traditional houses in Khokana (shown in Fig. 3-3-1) on November 29 and 30 2015. To confirm the coupled vibration effect of interconnected houses, the measurements were performed at the same height for each house, monitoring two horizontal components. The measurements were performed four times. There was no external damage from by the earthquake, but several inside partition walls were collapsed.

Fig. 3-3-1 Traditional houses of Khokana

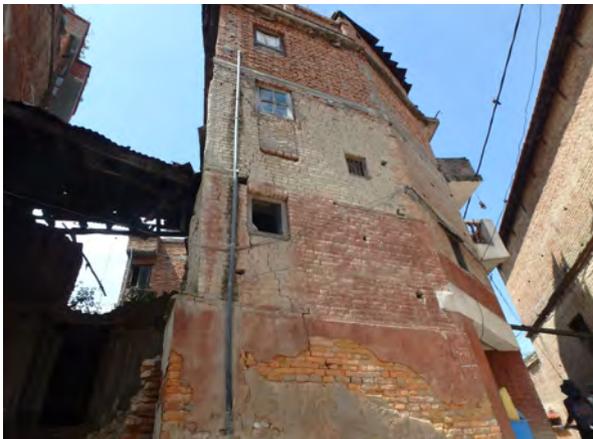
Fig. 3-4-4 Example extension of reinforced concrete on the houses (An example from outside of the investigated site)

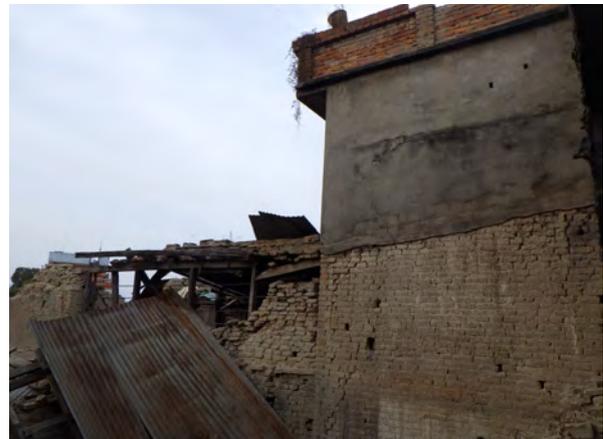
Fig. 3-4-5 Example of extension of reinforced concrete on upper floor

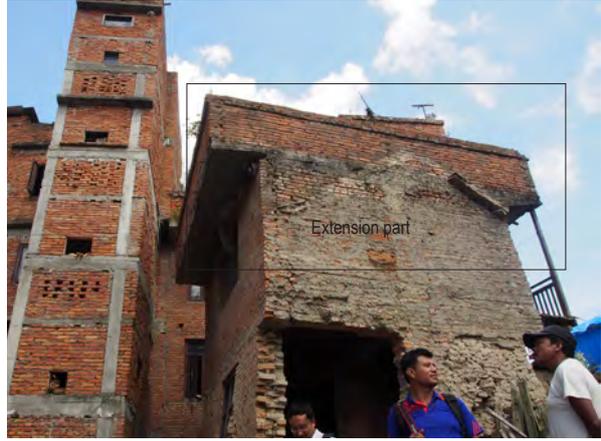
Fig. 3-4-7 Example of extension of brick and reinforced concrete on the brick house (An example from outside of the investigated site)

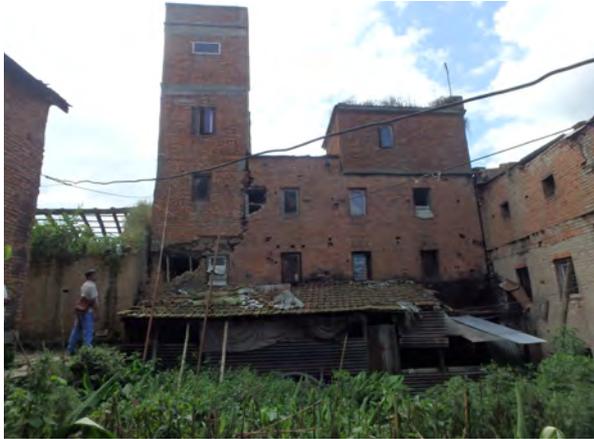
After the distribution of property from parents to children (i.e. conversion to more than one household), houses are divided by household and each then extends their own space. There are some traditional houses with parts which were intensively damaged because those houses were partially extended, thus causing their loads to become unbalanced (Fig. 3-4-8 and Fig. 3-4-11).

Fig. 3-4-8 Example of disproportional extension. The two houses are not structurally unified. (An example from the outside of the investigated site)

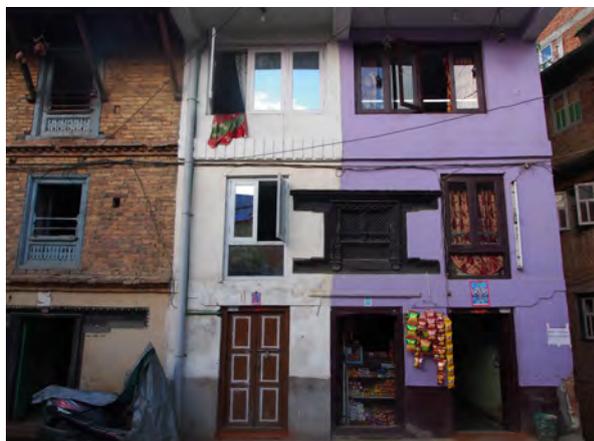
Partitions of wooden boards or bamboo were installed in the centre of rooms (for the division of borders of properties) and staircases for each household were constructed after the distribution of property. There are some houses whose horizontal rigidities at the corners were reduced by those works.

Fig. 3-4-10 Example of segmentation each divided parts due to the inheritance (Kirtipur), taken by author on 18th Sep. 2015

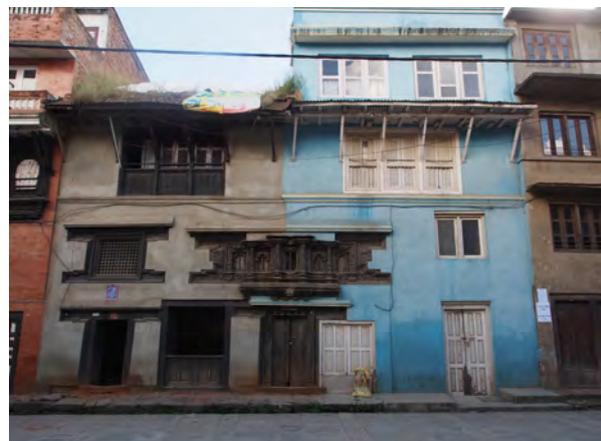
Fig. 3-4-11 Example of extension after segmentation extension by each heir after property distribution (Kirtipur), taken by author on 18th Sep. 2015

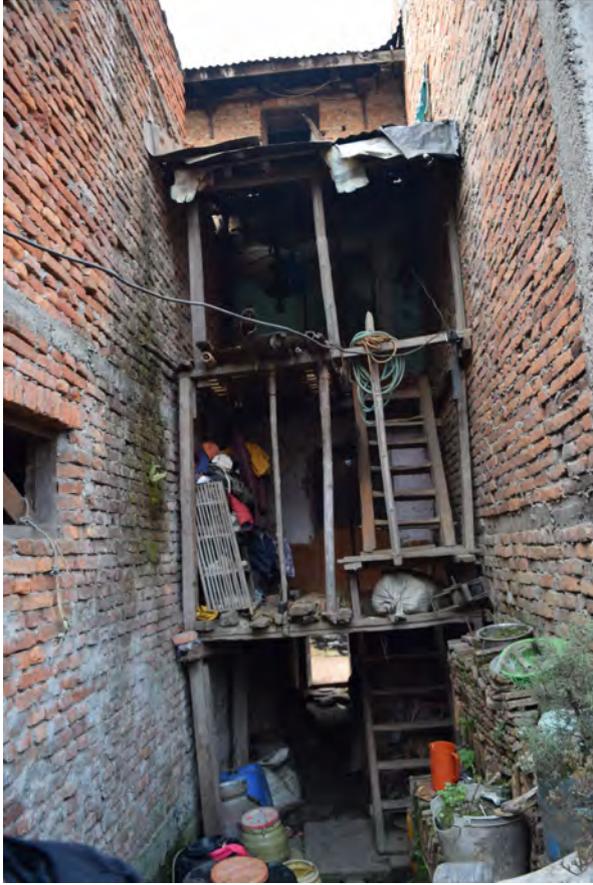
Fig. 3-4-13 Outside staircases built at the backside because of lack of space inside (N12)

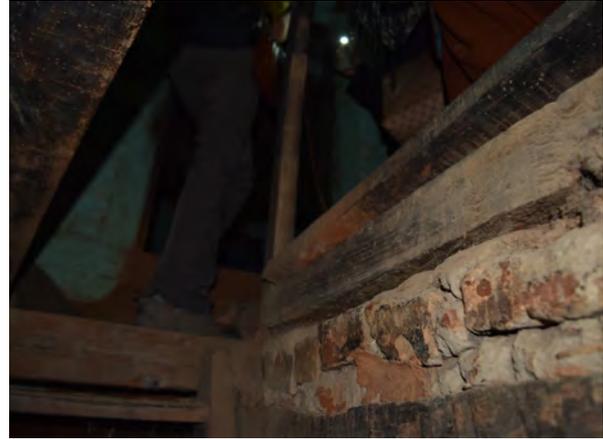
Fig. 3-4-12 Section of newly installed staircases (S12_b)

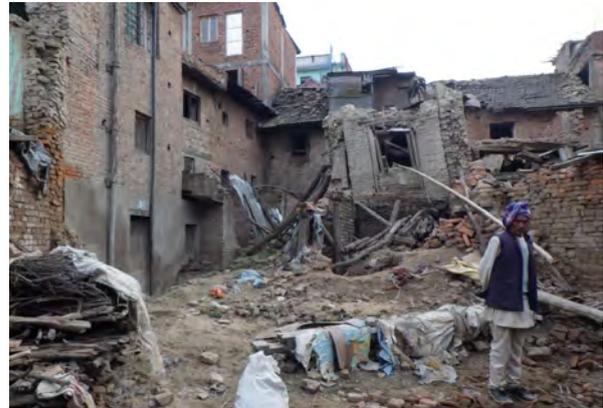
Fig. 3-4-14 Ruins of the collapsed house at the rear side of N04

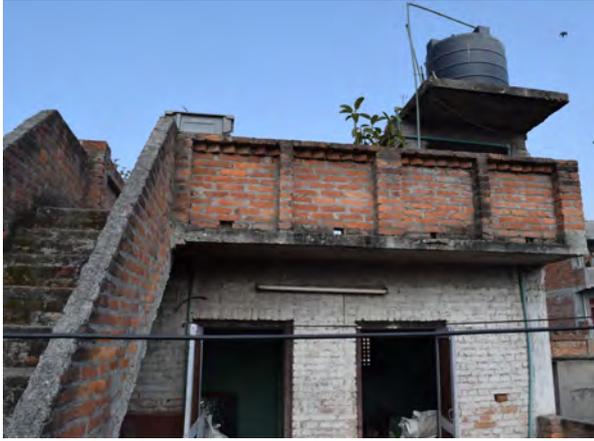
According to the interviewees, the fall of water storage tanks from the high-rise houses on to the traditional low-rise houses led to their damage. The considerable height differences of adjacent houses could be one of the causes of the heavy damage. For example, in one case, the water storage tank on the roof floor of a high-rise house of reinforced concrete (S17) fell onto the roof of the neighbouring traditional low-rise house (S18), causing the upper floor of the traditional house to mostly collapse (Fig 3-4-17, 18). It is considered this is just one example of many collapses caused by falling water storage tanks.

Fig. 3-4-15 Water storage tank placed on the roof top floor (N13)

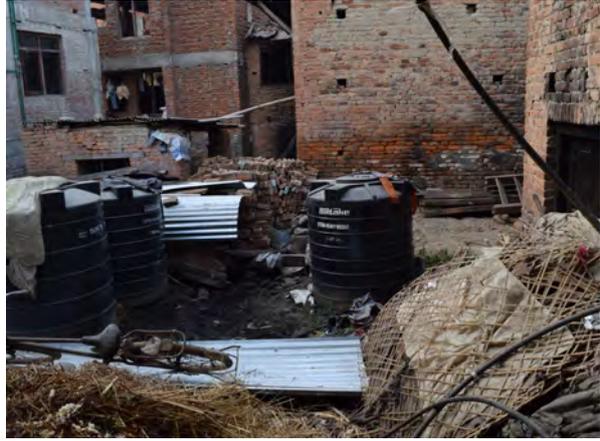
Fig. 3-4-16 Water storage tank placed on the ground after the disaster (S12-b)

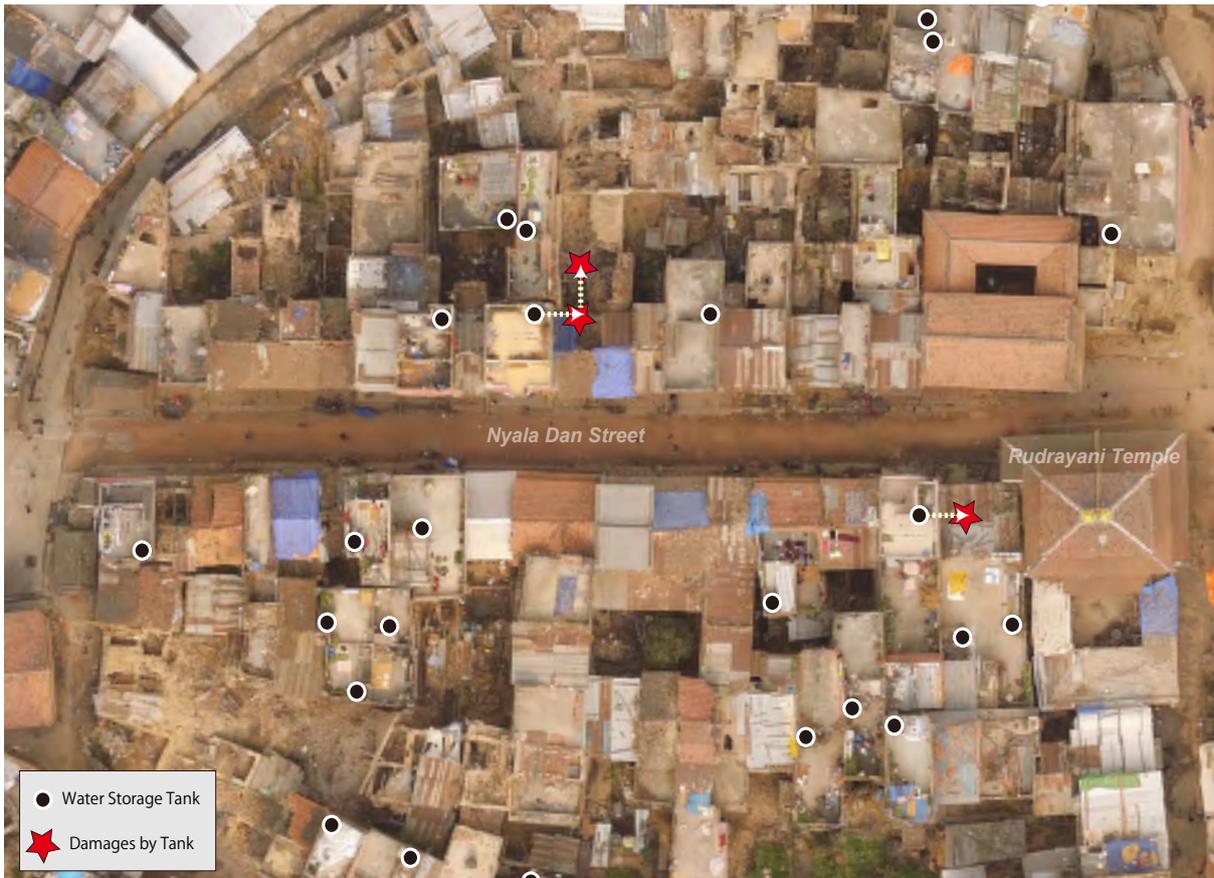
Fig. 3-4-21 Positions of water storage tanks according to the visual survey of photographs and that of actual damages according to the interview (Water storage tanks plotting on the photograph taken after disaster)

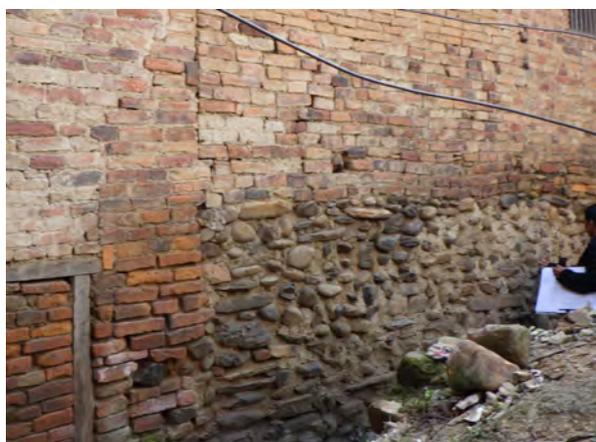
Every house but four completely collapsed in Khokana in the 1934 earthquake. The foundations of the ground floor of some houses built before 1934 are made of stones taken from the riverside and they remain in situ without cracks even after the 2015 earthquake. It is natural that the earthquake-resistant performance of houses built before 1934 is ineffective given that many of them collapsed in the 1934 earthquake. However, those houses would have some countermeasures and wisdom against the threat of earthquakes. Currently, the hard stones equivalent to those previously used as foundations are no longer used in the foundations of houses, and we cannot see that the replacement construction techniques have been successful. Among the four houses which did not collapse in the 1934 earthquake, S11 and S12 (which were SRU05 at that time, before it was divided in two) have remained on the street. The earliest documents we were able to find date back to 1969 and there is no way to investigate the forms and spaces of the houses before 1934. However, we consider it likely that they were, on the whole, mostly the same as the current houses.

Fig. 3-4-22 Foundation of masonry constructed by before by stone the earthquake of 1934 (S14)

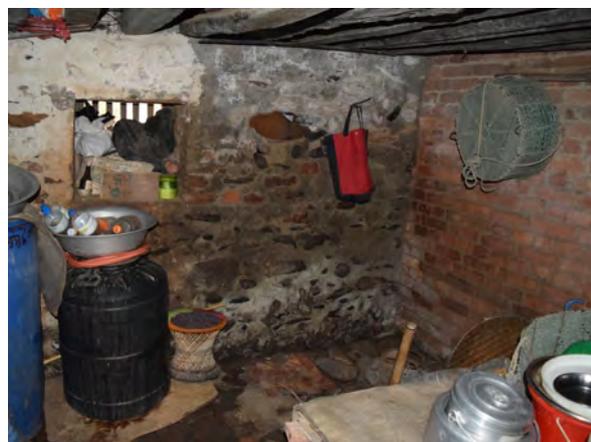
Fig. 3-4-23 Wall of masonry observed from the inside of the house (S10-b2)

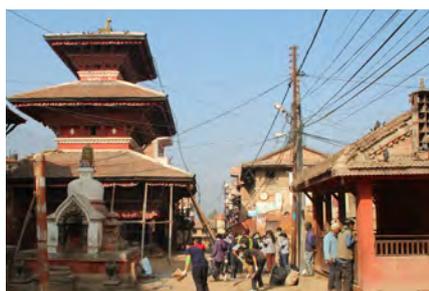
Fig. 4-10 Poles disturbing the townscape

Electric poles and overhead wires should be installed without spoiling the townscape. The pavement of the streets should be appropriate for the preservation district. Also, the drainage and its improvement system should be established.
