VERNACULAR HOUSES **in Bhutan**

Western Central Area
Thimphu, Punakha, Paro, Haa

Royal Government of Bhutan
Ministry of Home and Cultural Affairs
Department of Culture

Published in February 2022

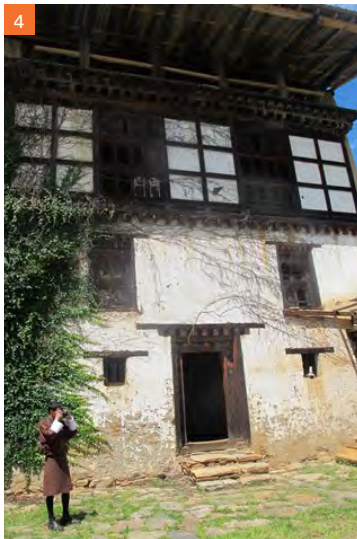
- 4 Details of the front side
- 5 Details of the north rammed earth wall
- 6 Short lintel of the doorway on the back side of the first floor
- 7 Long lintel of the original doorway

In the earlier renovations, many windows and doors were constructed or replaced. The newly constructed windows and doors have shorter lintel than usual and the gap in between is filled with stones and mud mortar. As a consequence, the newly constructed openings are not well connected with the walls. In few areas, there was no lintel at all. So due to shorter lintel, the cracks have developed along the new openings. Windows were replaced or newly constructed at the left and right walls, and consequently, the cracks formed. However, a door was newly constructed at the back wall. The window at the side has been closed with stone masonry wall. Since the old strong wall has been disturbed by making huge opening, thereby making the wall weaker, and as a result vertical cracks are formed at the back. The *choesum* - decorated space/room of the second floor which is immersed into the wall has also weakened the wall at the crack developed area.

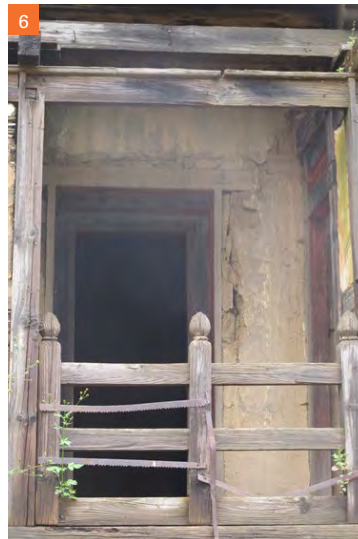
Vertical cracks are also observed on the left wall, at the intersection of transverse wall and left wall.

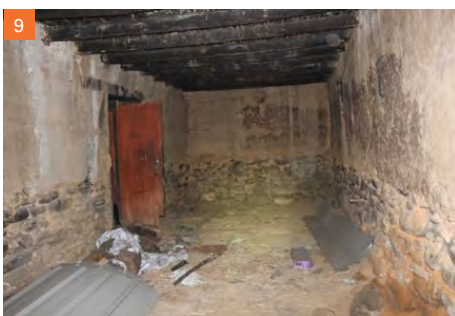
8 East room on the ground floor
 9 West room (Nagtshang) on the ground floor
 10 Temporary partition at the first floor
 11 Choesum at the second floor

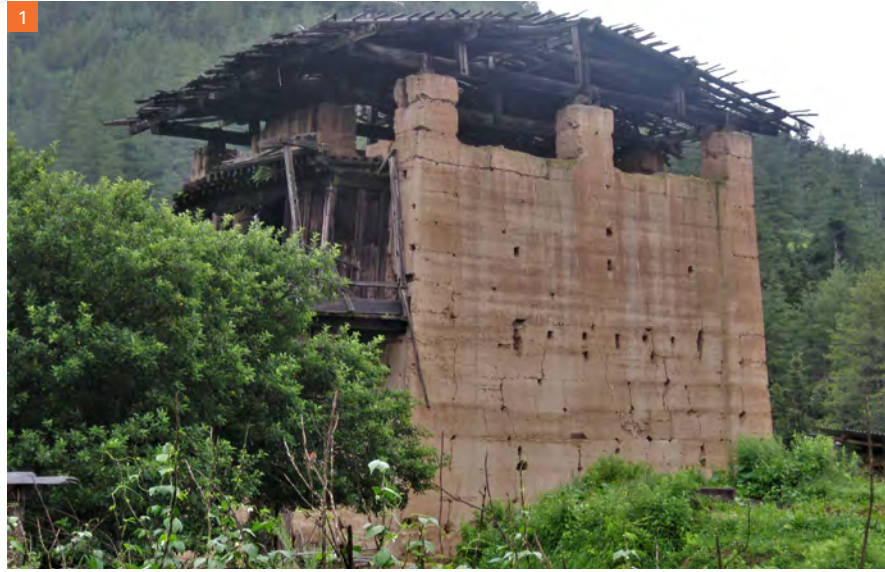
1 Front side view (from southwest)
2 Details of the front façade
3 Details of the bottom part of the balcony

The building has been unoccupied since 2008, and at the time of the investigation in 2013, the roof, the floor, and other wooden parts such as the balcony were showing significant decay. The building finally collapsed in 2017, leaving the outer rammed earth walls intact. From 2018 to 2019, all of the remaining materials were collected and sorted, and work began to identify the original location of each member, and to consider methods of reinforcement. The installation of the temporary roof to protect the rammed earth wall was completed in 2020 by the Department of Culture, and preparations are now underway for restoration work.

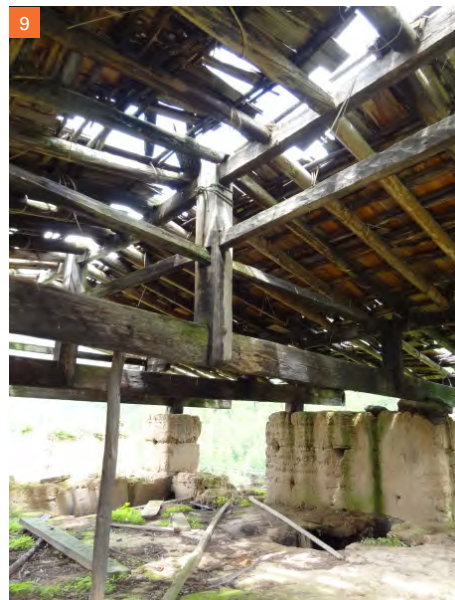
- 6 Partition on the second floor
- 7 Details of the central pillar on the second floor
- 8 Details of the upper part of the balcony
- 9 Attic space

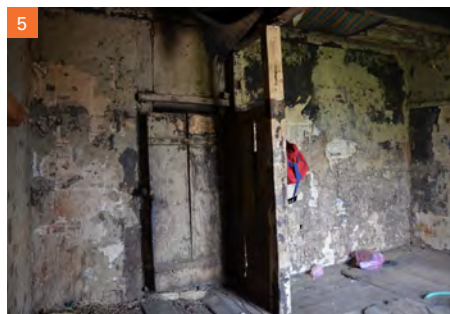
- 4 Earthen floor room on the south side of the ground floor
- 5 Traces of the doorway on the floorboard on the north side of the second floor

ings and the method of raising and lowering. A major modification is the addition of an exterior staircase at the front that has entrances to each floor but based on the traces from when it was built, we can assume that the first and second floors were originally connected by an interior staircase. Also, at some point in time, the south window on the second floor was used as the entrance and exit, and there was a veranda on the south side of the second floor. The doorway is thought to have been converted to a larger window. Traces indicate that the north window was enlarged, and other modifications were made to the building.

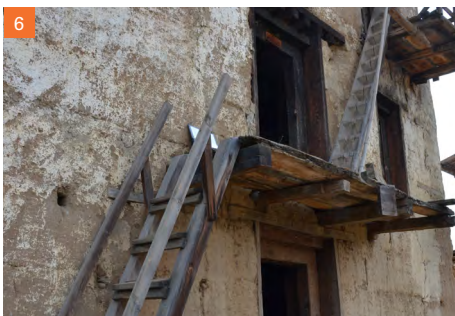
- 6 Entrances and the stairway on the outside of the front at present
- 7 Doorway on the first floor to the storage on the north side of the ground floor
- 8 Room on the south side of the second floor
- 9 Attic space

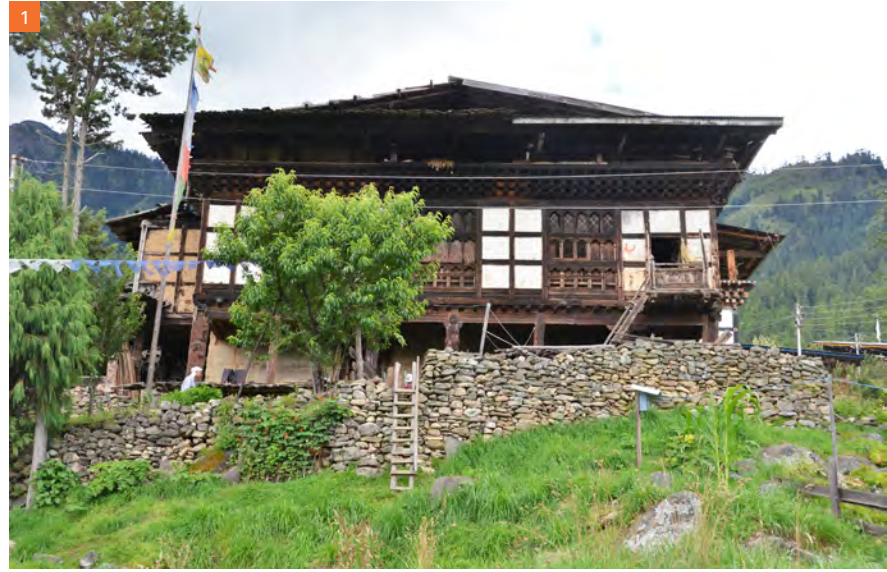
1 Front view (from southeast)
 2 Side view (from southwest)
 3 South exterior of the ground floor

This building was uninhabited at the time of the survey and in an advanced state of dilapidation, with a portion of the rammed earth wall collapsing and the loss of most of the eastern half of the first floor structure. By the time of our return visit in 2019, it had been demolished and replaced with a new building. This building was a valuable example of the unique process of extension. In that regard, its loss is regrettable.

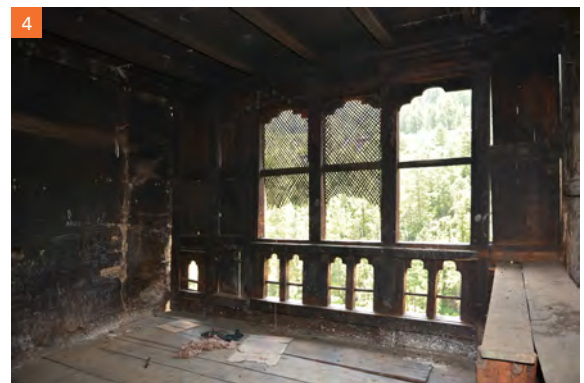
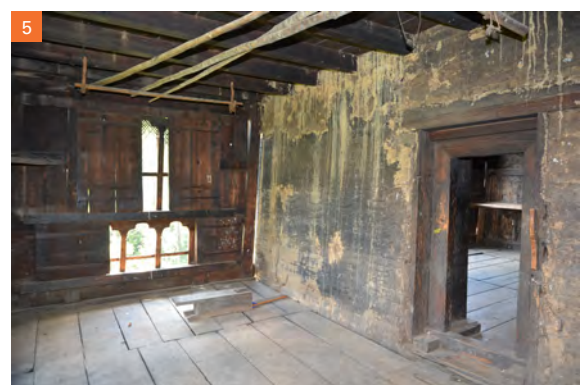
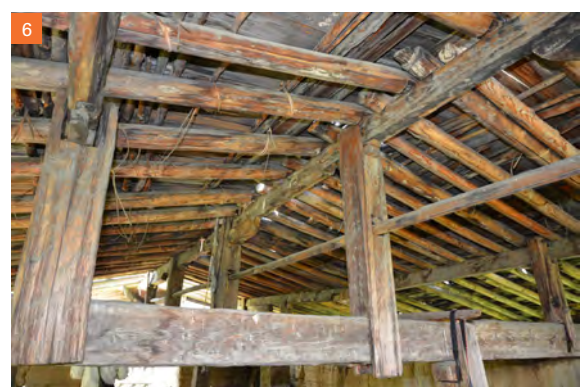
4 *Rabsel* window of the room on the south side of the first floor
 5 Room on the north side of the first floor
 6 Roof structure

The building is a small-scale house that was constructed using ruins, and the front of the two side walls have *rabseis* laid flush, rather than bay windows. This point is significant as it may indicate an older form in the Haa region. On the other hand, the breakage of the *rabseis* and the roof panel are remarkable, and the spandrel wall of the interior partition wall has exposed lathing, which indicates that the structure has been poorly preserved and requires urgent conservation measures.

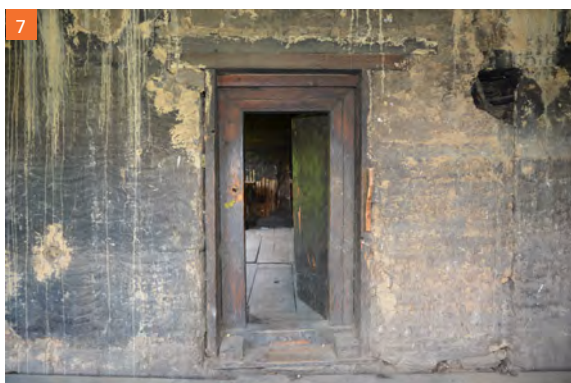
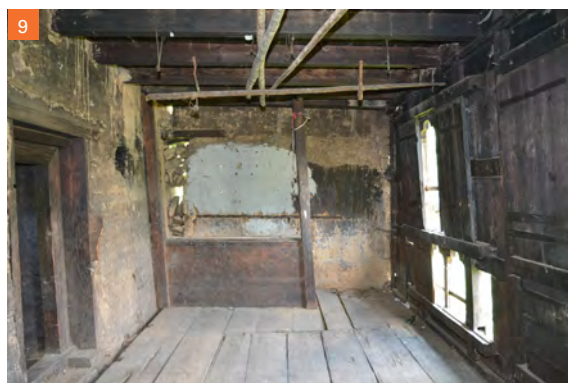
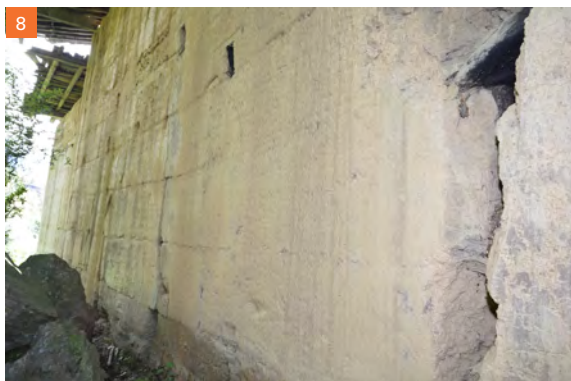
We can infer the modifications made from the traces found in the rammed earth wall and the wooden part. The rammed earth wall on the southwest of the ground floor is old, and new rammed earth has been piled on top of it, indicating that the building was constructed using an abandoned rammed earth wall.

7 Modification of the entrance on the first floor
8 Details of the back side elevation
9 Grain chest of the room on the north side of the first floor

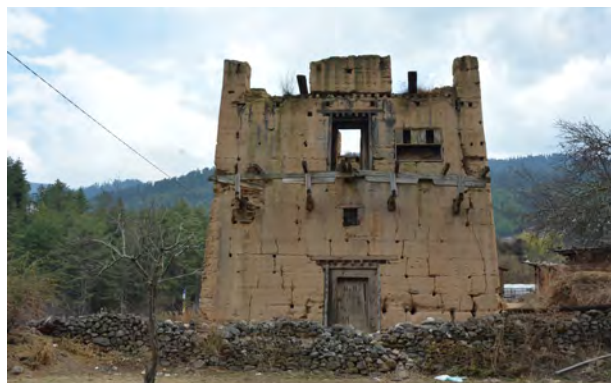
collapse of the roof had caused rapid deterioration of the inside structure of the building. A two-storey high rammed earth wall running in the north-south direction that divided the ground and first floors roughly in half had partially collapsed, the central section having completely fallen down (photos, next page). The wooden beams, joists and floorboards of each floor had also almost entirely collapsed inside the house, with the exception of the northeast sector of the first floor and a few isolated joists of the first and second floors. A wooden partition wall and a built-in wooden cupboard originally located on the second floor had also fallen down. The outside rammed earth walls, on the other hand, remained in relatively sound condition.

Lham Pelzom House, outside view from the west in March 2018

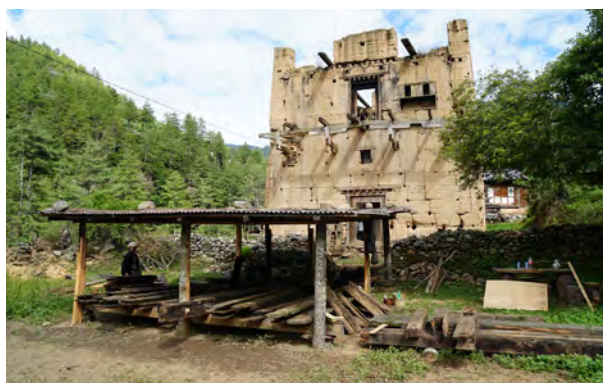
Temporary shelter for the storage of salvaged wooden members built in front of the house

On the other hand, the shelter where the wooden members are currently stored is only a temporary structure, and it is not intended for their conservation in the long term. Therefore, it is necessary to devise a comprehensive strategy for the salvaged wooden members, the standing building and the site that ensures their conservation in a permanent and sustainable way.

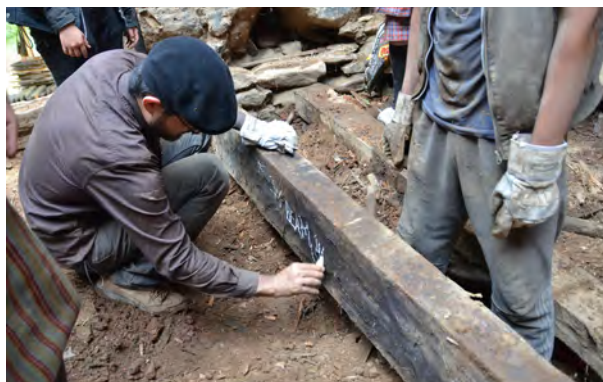
Temporary marking collapsed wooden members with chalk

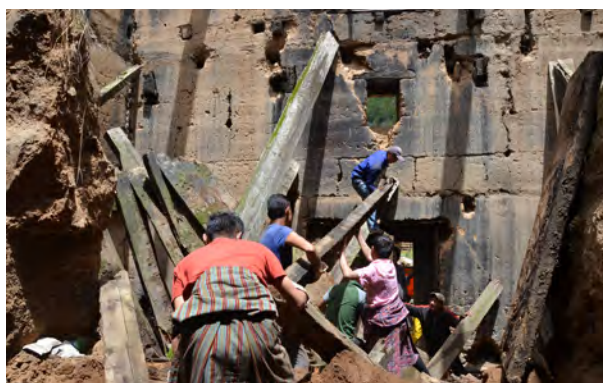
Removing collapsed wooden members from the building

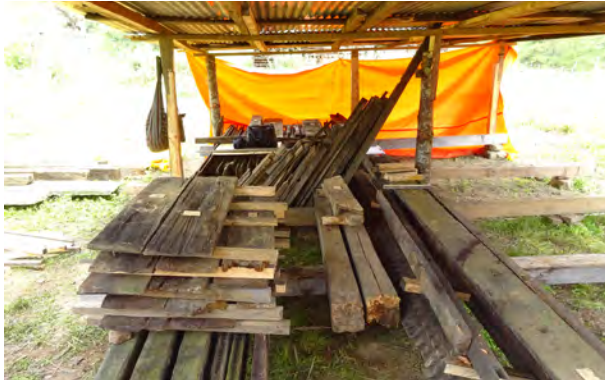
Salvaged members stored inside the temporary shelter

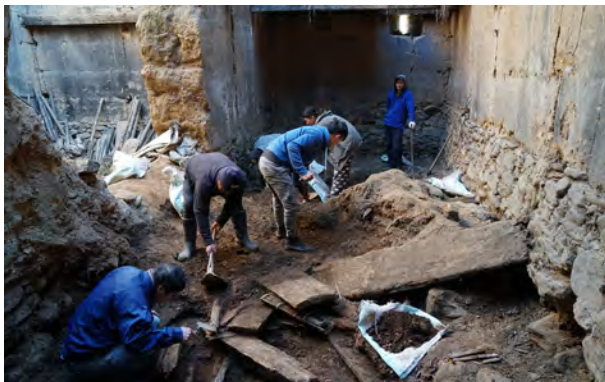
Removing the earth to salvage buried members in the east side of the building

In January 2019, the earth from the collapsed partition wall and the attic floor was removed to salvage the wooden members buried below (next page middle above). Several floorboards and joists were recovered (next page middle below). After documenting their as-found position, they were recorded, sorted and stored following the same methodology.

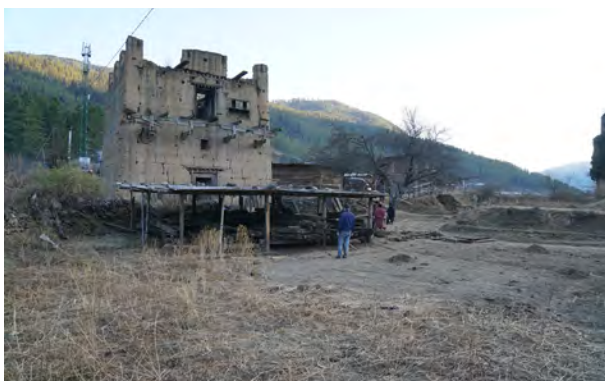
Lham Pelzom House in January 2019 after salvaging, sorting and storing all collapsed wooden members in the temporary shelter

As a result of these emergency conservation measures, it would be possible to reuse a large proportion of the original wooden members in their original location if it is decided to repair the collapsed parts of the building in the future.

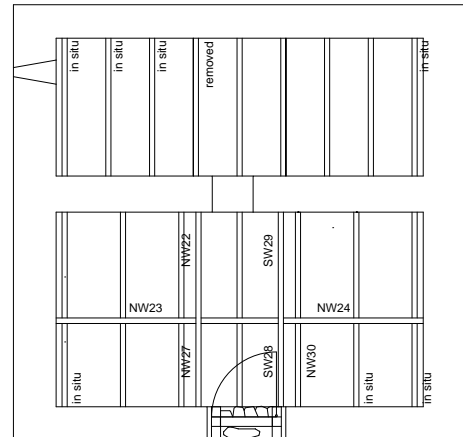
Lham Pelzom House, ground floor plan showing ceiling structure (numbered members were identified during the salvaging process)

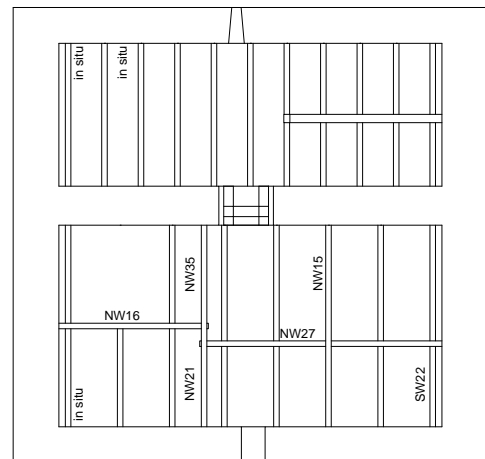
Lham Pelzom House, first floor plan showing ceiling structure (numbered members were identified during the salvaging process)

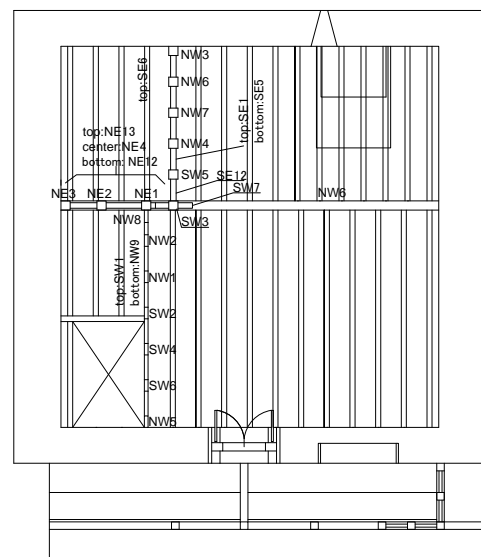
Lham Pelzom House, second floor plan showing ceiling structure (numbered members were identified during the salvaging process)
