Conservation and Restoration of Concrete Structures

Foreword

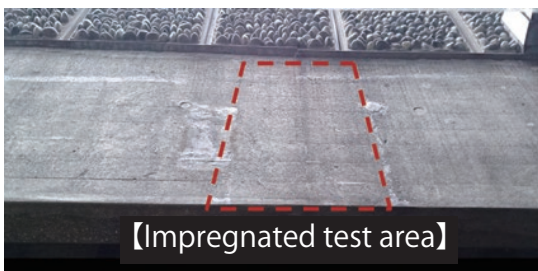
photo 10 Impregnation test

that was selected was the most capable of suppressing the infiltration of water effectively without affecting the appearance of the building. After performing an impregnation test of the agent (figure 21, photo 10), it was finally applied during the restoration of the NMWA's Main Building.

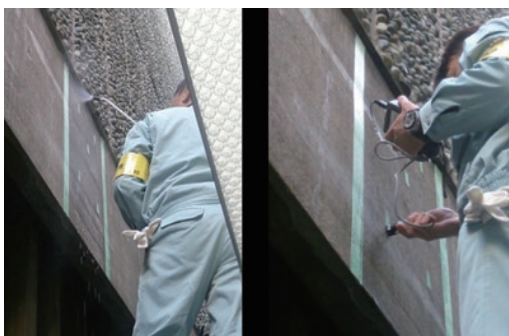
photo 11 Water repellency test on the concrete surface

Figure 22 and photo 11 show the water repellence of a concrete surface repaired using a surface impregnation agent. The water repellence of the concrete surfaces was evaluated using a non-destructive electrical method, as shown in photo 11.

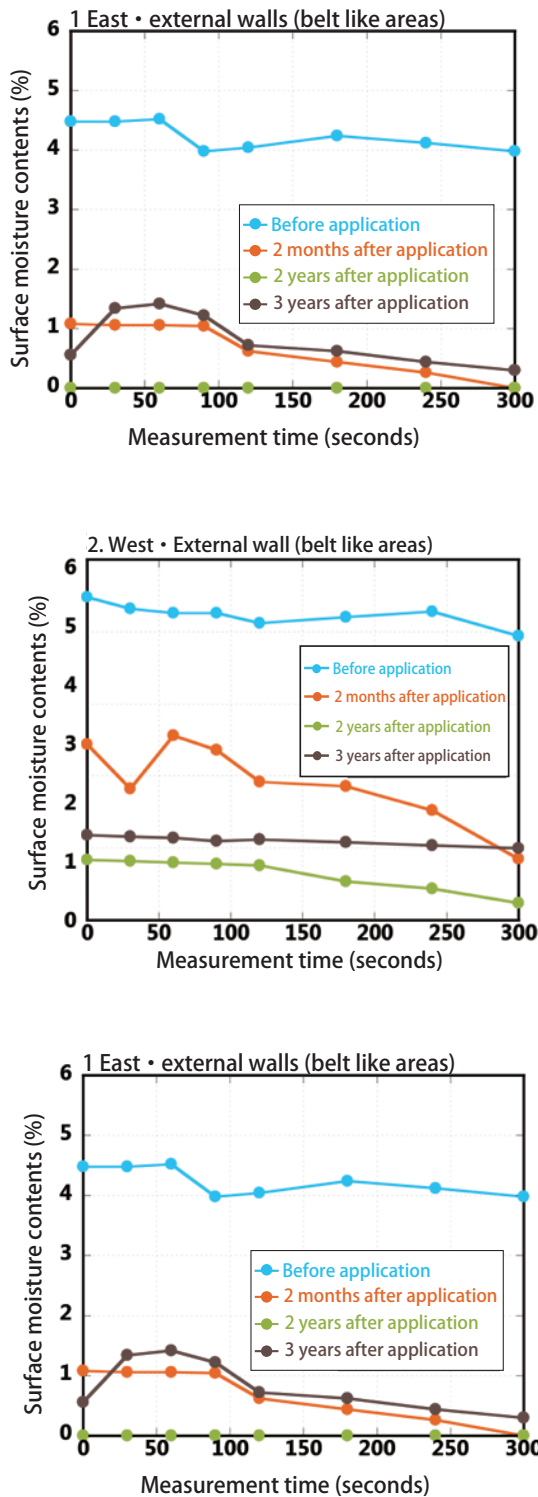
figure 23 Changes in surface water content⁹

Figure 23 shows changes in the water content of the concrete surface versus the length of time after the application of the surface impregnation agent. The values on the graph are the averages of from three to five measurement points examined. After the application of the surface impregnation agent, the concrete surfaces of the external walls on the four sides of the building had lower water content than before being treated with the agent. In addition, a certain level of water repellent effect continued for three years after the surface impregnation agent was applied. The external walls (belt-like areas) on the east and west sides also had lower surface water content after being treated with the surface impregnation agent. Of particular note, they underwent a large change in surface water content between the beginning of measurement and the end of measurement, indicating that those concrete surfaces

retained a high level of water repellence. In contrast, after two months had passed, the concrete surfaces of the external walls (belt-like areas) on the south side, although they retained a certain level of water repellence, did not have as much of it after being treated with the surface impregnation agent as was retained on the surfaces on the east and west sides. It was thought that this was because the silane treatment layer for some reason disappeared from those concrete surfaces.

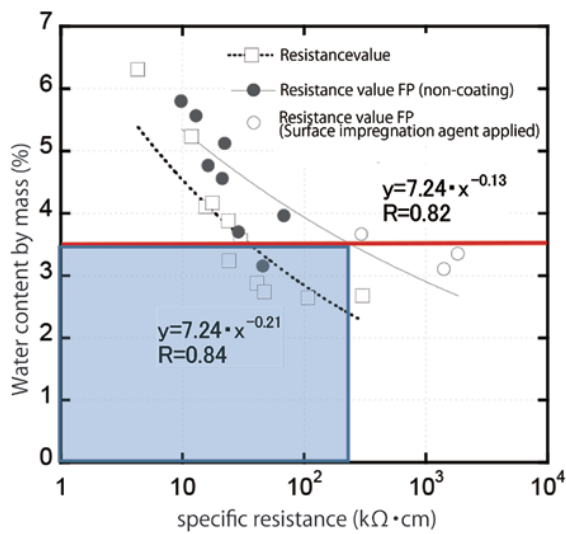
figure 25 Relationship between specific resistance and water content by mass⁹

Figure 25 also shows the specific resistance value P, which was obtained from previously performed research¹⁰. As shown in **figure 25**, it was found that there is a correlation between the specific resistance of concrete and its water content by mass. Therefore, we obtained an approximation formula taking into account the difference between the test units by which specific resistance values for P and FP had been obtained.

Our experiment also showed that there was a tendency for the specific resistance to increase in correlation with the effect of the surface impregnation agent. For these reasons, we concluded that the use of the 4-probe method made it possible to evaluate the water content of the concrete covering the rebar while avoiding the effect on the measurements of the disappearance of the surface impregnation agent from the concrete surface.

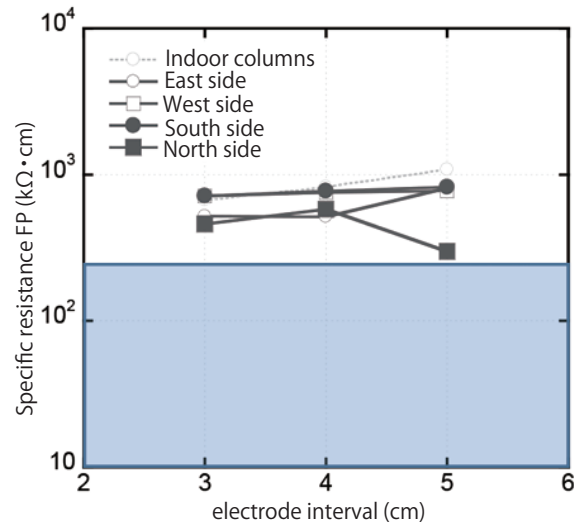
figure 26 Results of specific resistance measurements of the NMWA's Main Building⁹

In the previous investigations, the ability of the surface impregnation agent to suppress the infiltration of water into the concrete could not be sufficiently identified on the concrete of the south side of the Main Building. However, using the 4-probe method, regardless of the amount of space left between the probes, it was found that the concrete on the external walls on the south side had the highest specific resistance of the concrete of all the external walls

(those belt-like areas), indicating that the water content on that side was indeed low. When we examined the specific resistance values shown in **figure 26** against the relationship between the specific resistance and the water content by mass shown in **figure 25**, it was also found that all the measurement points had higher specific resistance values than the specific resistance value at which the water content by mass would be less than 3.5%¹¹, a value at which rebar is unlikely to corrode. Therefore, we concluded that the surface impregnation agent had effectively treated all four sides of the external walls (belt-like areas) and had sufficiently suppressed the infiltration of water into the concrete.

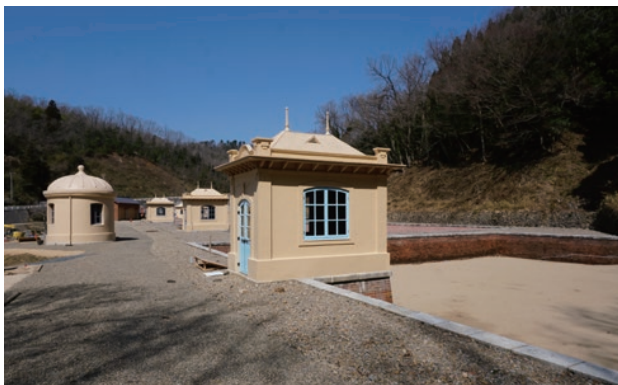
photo 1 Water control shed No. 5 (rectangular plan, in center) on the edge of filtration pond (right). Wells No. 4 and No. 3 can be seen toward the back. On left is the shed of Junction Well (circular plan) after restoration.

Although the water control sheds No. 1 to 4 were completed at the same time under the same conditions, differences were found in the extent of deterioration due to continued use over the years. No. 2 was the most damaged (**photo 2**). Also in the flood of 1918, No. 1 was toppled over by water current, which can be seen in a historic photograph. On the building placed back in its original position, traces of restoration, including deformation of the steel frame and additional lath inserted for reinforcement, can be found.

Each of the structures was more or less damaged with corrosion expansion seen in steel frames and metal lath, resulting in detachment and pop offs of the mortar and concrete surfaces. Nevertheless, the sound areas were confirmed to retain sufficient strength and therefore, the damaged portions were repaired and preventive methods for corrosion and water infiltration were taken. This was

These repairs followed contemporary conventional methods for recovering sectional dimensions in reinforced concrete structures. First, the sizes of detached areas and deformation were inspected in the walls to be repaired. Then, the areas to be removed were decided. After partially removing these damaged areas, the extent of corrosion on the rebars was visually inspected for carefully re-examining and finalizing the areas to be removed. If there was fear of further losing the original materials, the restoration method was to be reviewed.

For repairing smaller damage of cracks and detached areas, cement slurry was injected for filling small pockets inside the walls. Repairs on sectional dimensions were executed by filling the cracks with polymer cement using a trowel. The roof surface was then waterproofed.

The roofs of structures No. 1 through 4 were constructed without waterproofing as with the walls. The roof of structure No. 5 was covered with asphalt roofing and mortared, inducing damage due to mortar detachment. Repairs on all five structures were done in the same way as the walls, by entirely applying anti-corrosion paste then finishing with waterproofing paint.

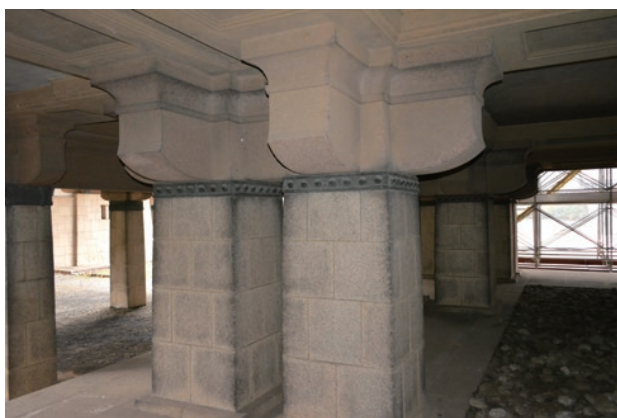
In the seismic analysis of Meiji Jingu Homotsuden Treasure Museum Middle Storehouse (Shibuya Ward, Tokyo Prefecture/ Important Cultural Property) built in 1921, evaluation of the stone clad columns of the first floor was found to be problematic (photo 3). The thick reinforced concrete columns with sectional dimensions of 580 mm by 580 mm with 120 mm thick stone veneering on all four sides were actually constructed by using the stone slabs as formwork, placing steel reinforcement inside, and then pouring concrete. They were judged to be structurally weak, when only the reinforced concrete portion of the columns was tested. As the stone material was found to be sufficiently integrated with concrete through core testing, this was together analyzed and the first floor area was found to meet the required performance in seismic resistance.

photo 3 Meiji Jingu Homotsuden Treasure Museum Middle Storehouse, first floor column

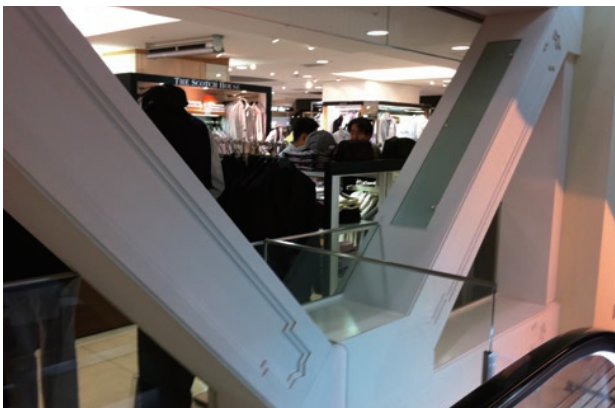
photo 7 Takashimaya Tokyo Department Store, reinforcement with bracing decorated to match the store interiors

Takashimaya Tokyo Department Store (Chuo Ward, Tokyo Prefecture/ Important Cultural Property) was reinforced in the least number of places, by employing steel bracing of extremely low yielding point designed to give in before shear fractures appeared in the extant concrete walls. The exposed steel bracing was covered and decorated with molding to match the store's interiors (**photo 7**).

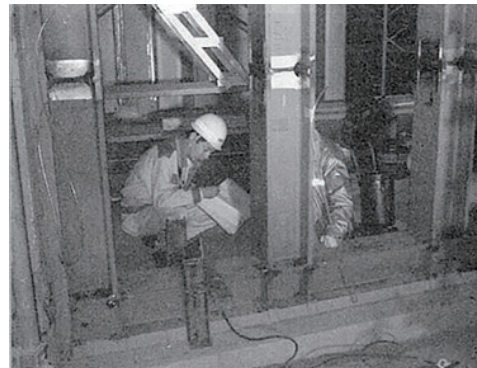
photo 9 Vertically latticed steel frames (reprinted from 『早稲田大学大隈記念講堂保存再生工事報告書』(早稲田大学、平成 20 年 (2008) 3 月) P.209)

Waseda University Okuma Memorial Hall (Shinjuku Ward, Tokyo Prefecture/ Important Cultural Property) (**photo 8**) was reinforced using steel frame bracing together with reinforced concrete anti-seismic walls. Specially designed vertically-latticed steel frames were installed between the columns in the basement small hall, so that the magnificent interior design would be least affected. They were installed by attaching with synthetic resin adhesive instead of directly

anchoring onto the structural frame (figure 2 and photo 9).

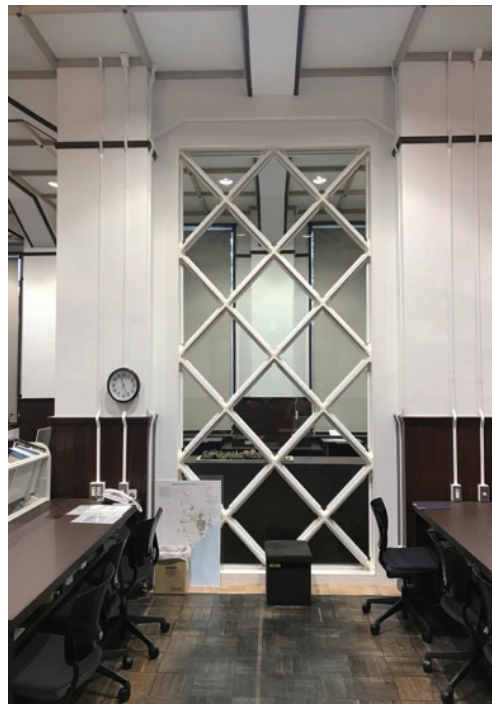
photo 10 Visible reinforcement at Former Institute of Public Health (Minato City Local History Museum)

Lastly, at the Minato City Local History Museum (Minato Ward, Tokyo Prefecture) housed in the newly restored Former Institute of Public Health, visible reinforcement was carefully designed and reinforcement adopting transparent materials such as glass was adopted (photo 10).

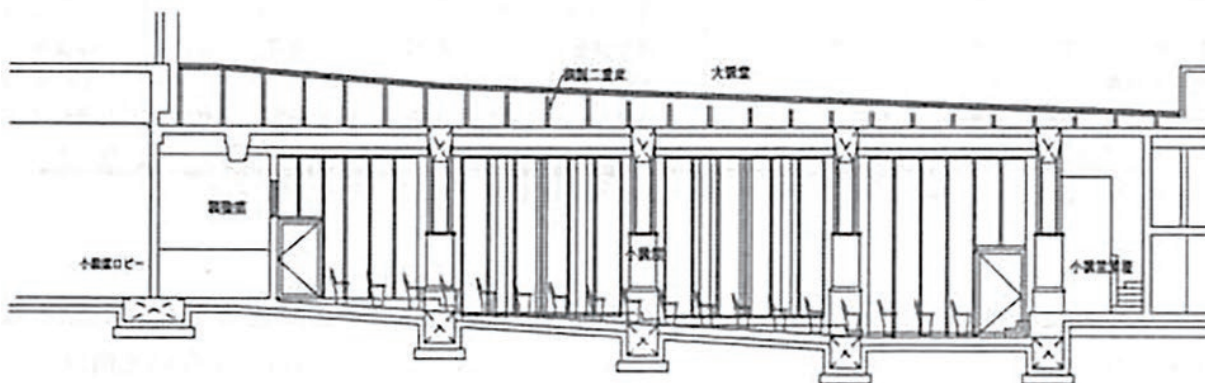
figure 2 Small assembly hall, reinforcement between columns with vertical lattice bracing (Reprinted from 『早稲田大学大隈記念講堂保存再生工事報告書』(早稲田大学、平成20年(2008)3月) p.116)

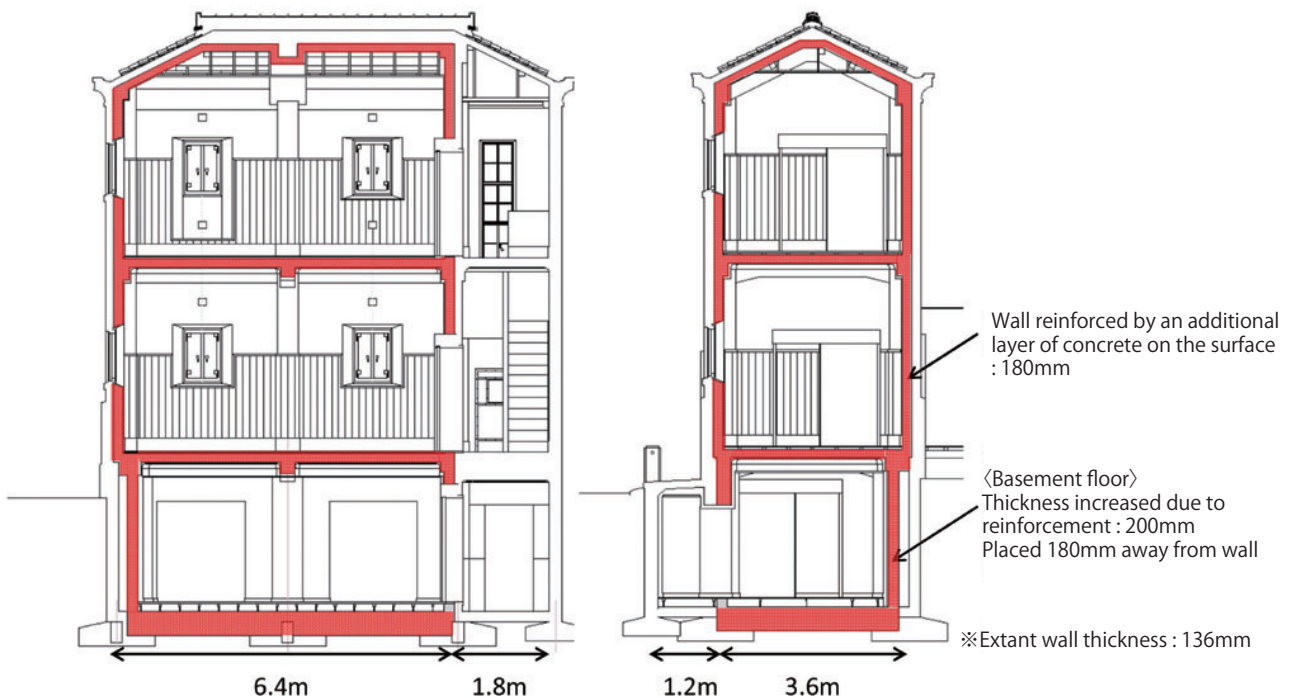
figure 3 Aishu Kindergarten storehouse, thickness of wall and roof slabs was increased, Diagram of locations where slabs were replaced

In the storehouse of Aishu Kindergarten (Osaka City, Osaka Prefecture) (photo 11) built in 1927, defective construction was found in numerous places. Although grout injection and re-alkalization were attempted, it was judged that the aimed strength could not be expected and thus, after having been permitted alteration of the present state, a reinforcing concrete layer was added onto the inner side of the walls and roof, with the floor slab being completely

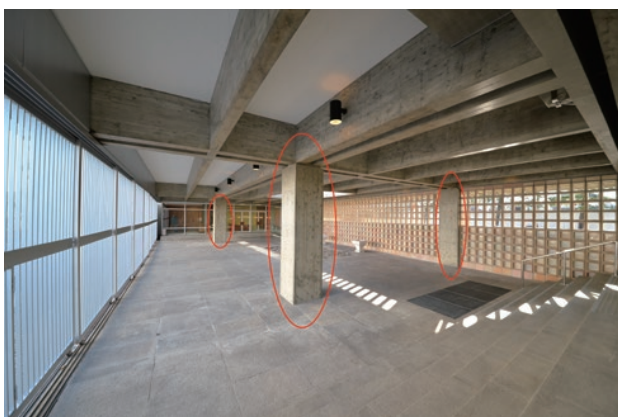
photo 13 Reinforced concrete column
The sectional dimension of those shown circled in red were enlarged by reinforcement

Regarding nationally Registered Cultural Properties, there is a case in which a part of the structure was carefully reconstructed considering effects on design, as can be seen in the restoration of Sumi Kaikan (Ichinomiya City, Aichi Prefecture) (photo 12). It is a reinforced concrete office building designed by Kenzo Tange completed in 1957. In reinforcing the area around the piloti, steel frame bracing was first considered, but it was decided to prioritize preservation of the open interior design. Surfaces of the extant concrete columns were carved off and reinforced by slightly enlarging the sectional dimensions with the addition of reinforcement bars (photo 13).

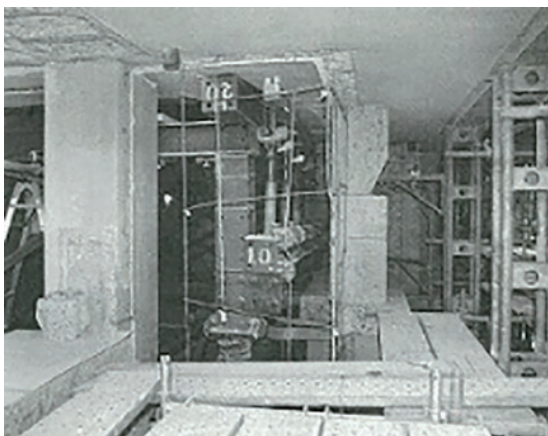
photo 15 Reconstruction of concrete wall. Southeastern area of second floor being dismantled (reprinted from 『重要文化財旧山邑家住宅（淀川製鋼迎賓館）保存修理災害復旧工事報告書』（株式会社淀川製鋼所、平成10年（1998）3月）

Reconstruction of the concrete structure was undertaken in areas including the south wing balcony and around the main staircase (photo 15). The original reinforcement bars of round sectional dimensions and smooth surfaces were left intact while inserting additional reinforcement of anti-corrosive deformed bars in the reconstruction. Concrete used

in reconstruction was specified for a compressive strength of more than 210 kg/sqcm four weeks after pouring, while core testing of the extant structure had resulted in an average of than 210 kg/cm².

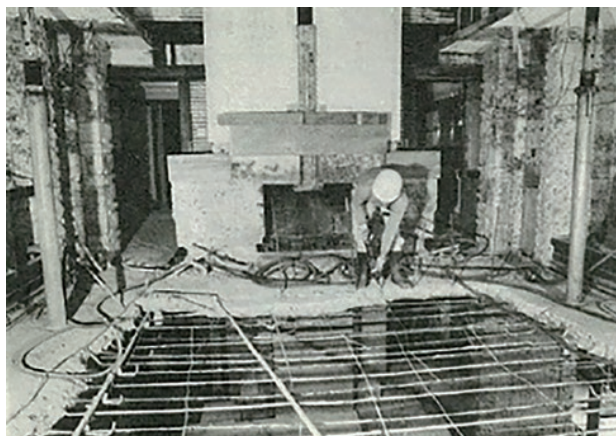
photo 17 Reconstruction of second floor slab. Dismantlement of extant slab (reprinted from 『重要文化財旧山邑家住宅（淀川製鋼迎賓館）保存修理工事報告書』（株式会社淀川製鋼所、平成元年（1989）2月）

bars of smooth surfaces were left intact, while bars of the same type were additionally inserted for reinforcement (**photo 17**). In the restoration from 2016 to 2018, steel frame supports were introduced under the sagged eaves on the south side and a temporary floor was installed, so as not to burden the fourth floor balcony slab. How these reinforcements are to be treated are issues to be dealt with in the future.

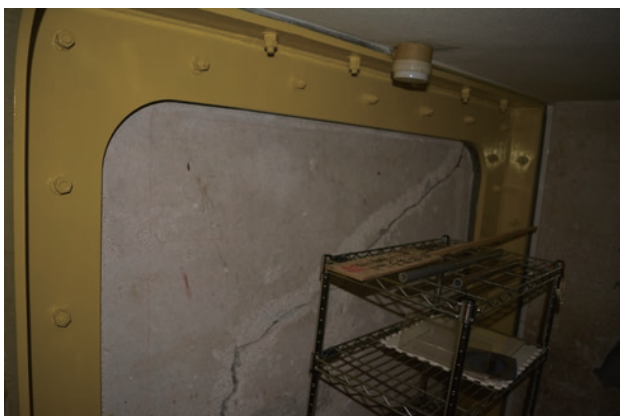
photo 16 Reinforcement with gate-shaped steel framework (in an area not open to the public)

On the other hand, the first floor walls of the storehouse were reinforced with gate-style steel framework for burdening earthquake forces, so that future earthquake damage could be visually inspected (**photo 16**). Other reinforcements included attachment of carbon fiber sheets on some areas of the floor slab and parapet.

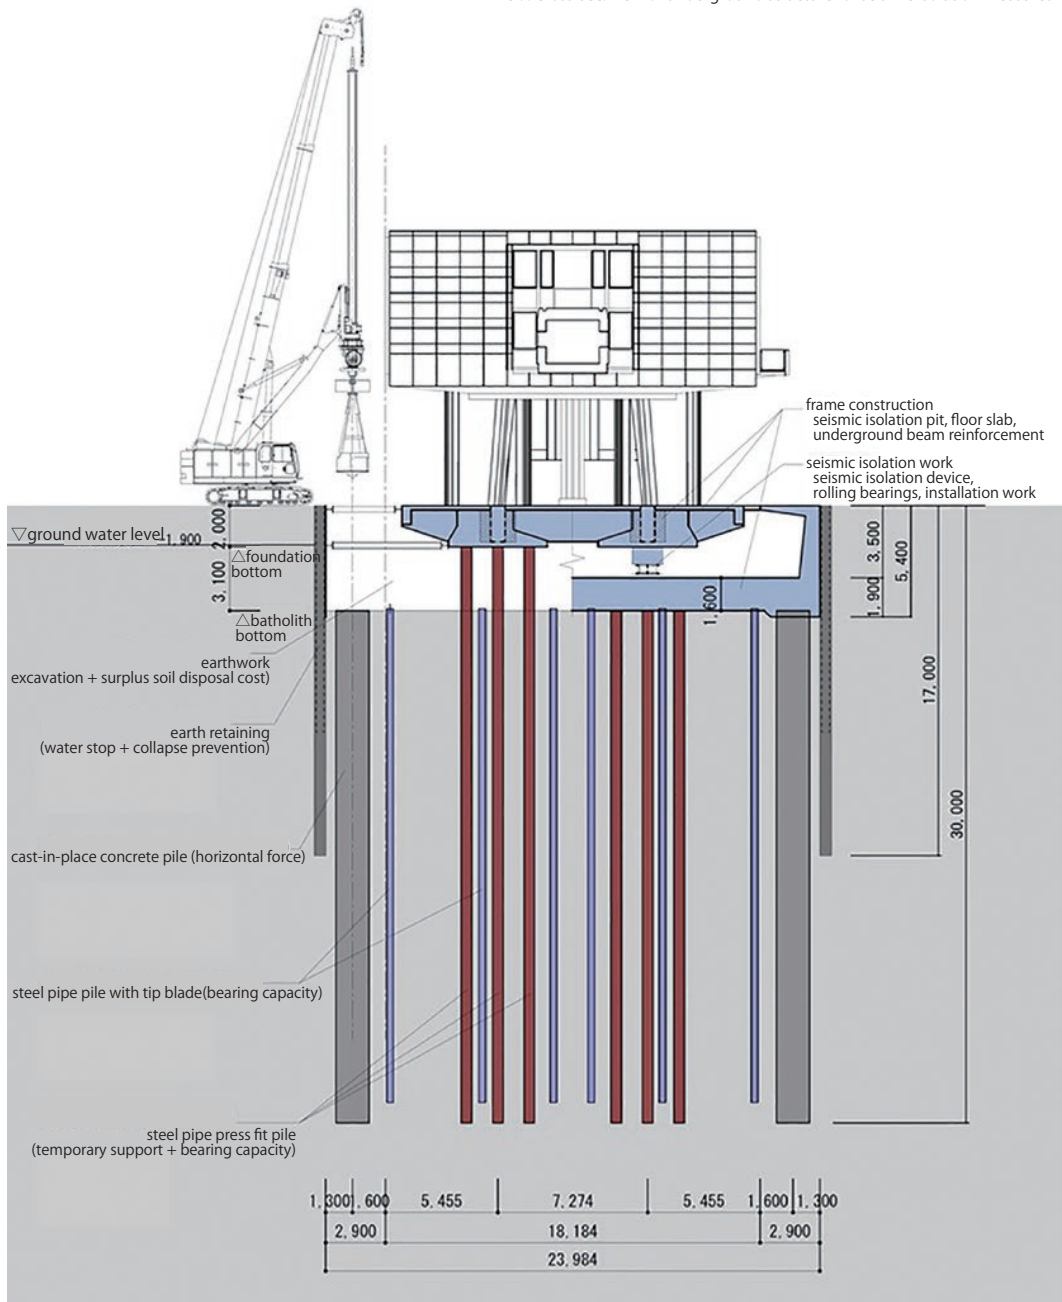
figure 4 Diagram of seismic isolation system

seismic control system on the first floor while adding anti-seismic walls on the second floor, (2) carving off concrete from columns and major beams and making changes in placement of reinforcement bars for partial structural reconstruction, and (3) underground installation of a seismic isolation system. The seismic reinforcement plan (1) was considered to have large influences on the exterior design and the landscape, and although partial reconstruction of the structure (2) would retain the visual design, it was judged to have too large an impact on the structure itself and would not be appropriate. Therefore, the seismic isolation plan (3) was adopted for having the least influences on design and landscape as well as on the structure (**figure 4**).

In the process of seismic isolation, a new underground beam system was added onto the extant system to be unified by steel bars for pre-stressed concrete for placing the structure on the seismic isolation system. Below the stairs were independent foundations that would interfere with the stairs when placed on the new underground beam system. Therefore, permission for alteration of the present state was obtained for their removal and records were made for those partially removed. Major members were removed in large pieces avoiding complete dismantlement (**photo 19**). Also, because the Hiroshima Peace Memorial Park is a nationally designated Place of Scenic Beauty, permission for alteration of the present state was necessary, and archeological surveys were undertaken on a large area of the premises before start of construction that involved excavation. Where non-designated corridors attach onto the east and west ends of the second floor, installation of expansion joints became necessary, which were made in forms that least affected the exterior design.

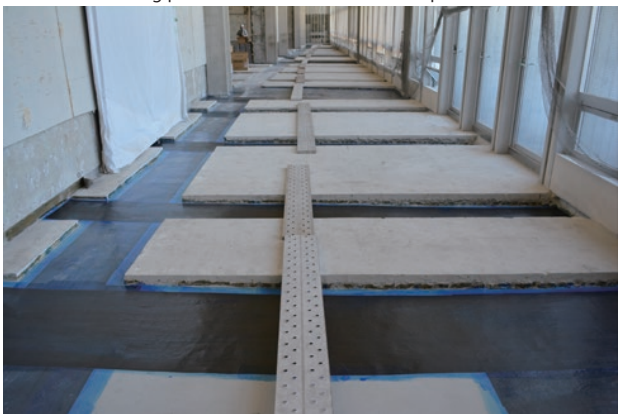
photo 20 Reinforcement of second floor upper surfaces with carbon fiber

Also, the cantilevered floor beams of the second floor supporting the floor slabs were reinforced on the upper side with carbon fiber sheets (**photo 20**).

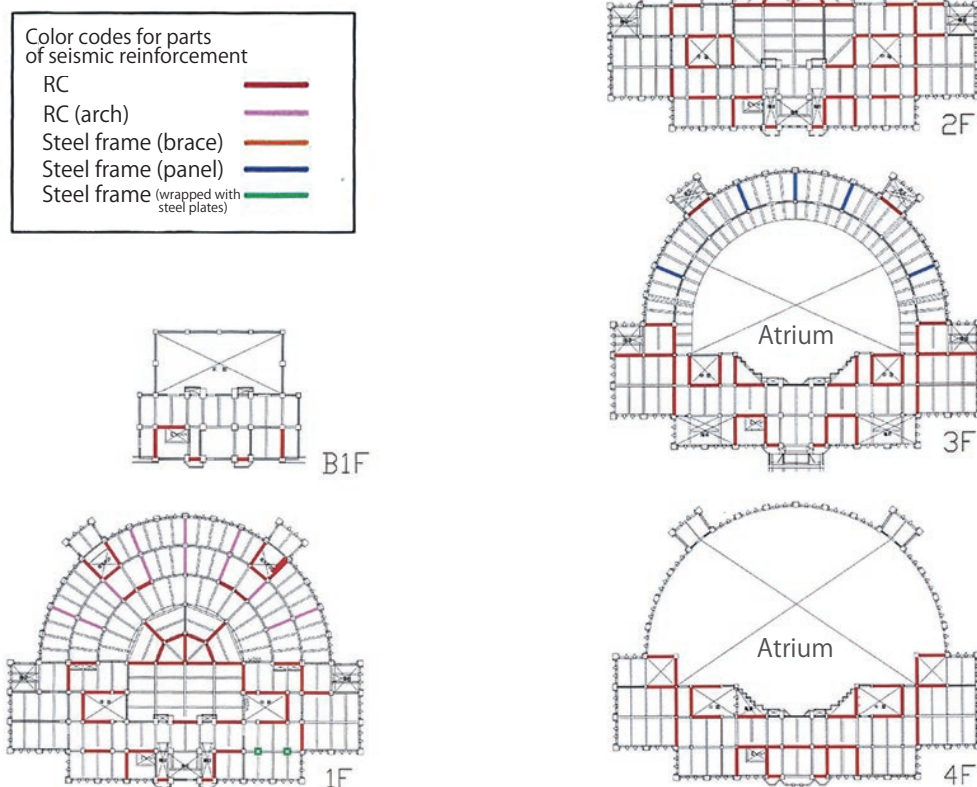
Seismic analysis was executed following second analysis method for extant reinforced concrete structures, by dividing the structure into the semi-circular auditorium and all other areas. The aimed I_s was set at 0.7 which was a little higher than that generally adopted for university facilities. Although the structure is comparatively uniform, there were columns with main reinforcement lacking and thin extant walls with 9mm diameter reinforcement bars placed at 300mm intervals, from which sufficient strength could not be expected in many areas. As a result, all areas other than the fourth floor did not meet the required level of I_s 0.7. On the lower levels of the tower, it was found to be smaller than 0.3 requiring reinforcement (figure 5).

figure 5 Diagrammatic plan of seismic reinforcement (reprinted from『東京大学大講堂(安田講堂)改修工事報告書』(東京大学 平成 28 年(2016) 3 月), images were edited)

The concept of restoration was to maintain the appearance at the time of completion and to make the building available for use by many students and the faculty. At the same time, seismic safety would have to be met while improving interior conditions and providing barrier-free access. Seismic reinforcement was realized through installation of additional reinforced concrete seismic walls on each floor (photos 23 and 24) and creating anti-seismic slits in some of the walls to prevent extremely short columns with low shear strength from cracking (figure 6). On the first floor, some columns were wrapped with steel plates (photo 25). In the corridor around the auditorium, steel frame panel walls were installed

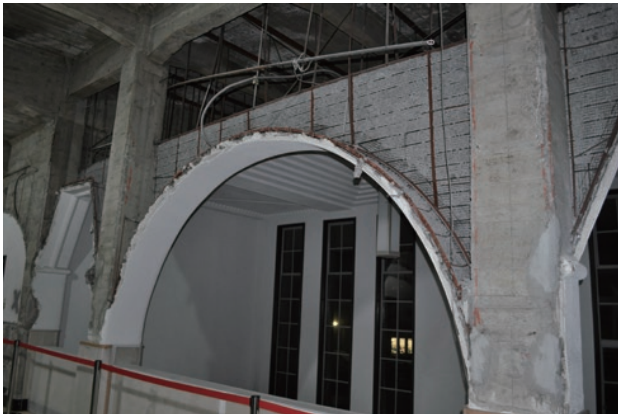
photo 23 Before installation of reinforced concrete anti-seismic wall. Removal of decorative mortared arch of lath substrate

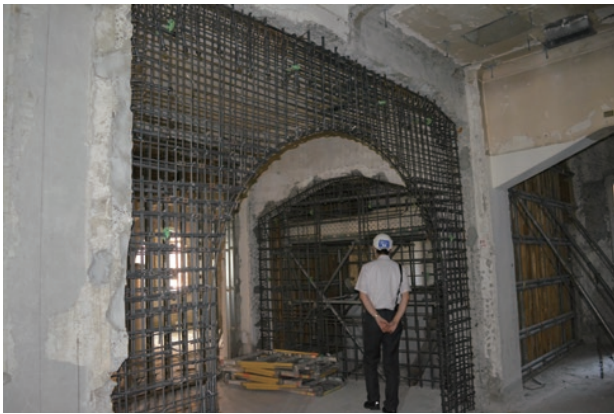
photo 24 Reinforced concrete anti-seismic wall, placement of reinforcement bars

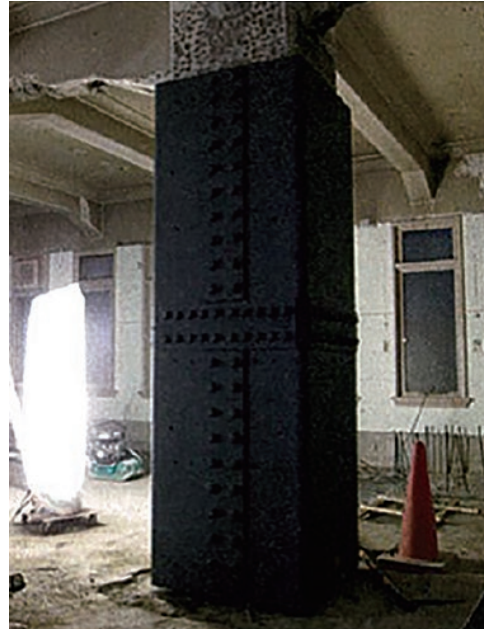
photo 25 Reinforcement of first floor columns by wrapping with steel plates reprinted from 『東京大学大講堂（安田講堂）改修工事報告書』（東京大学 平成28年（2016）3月）

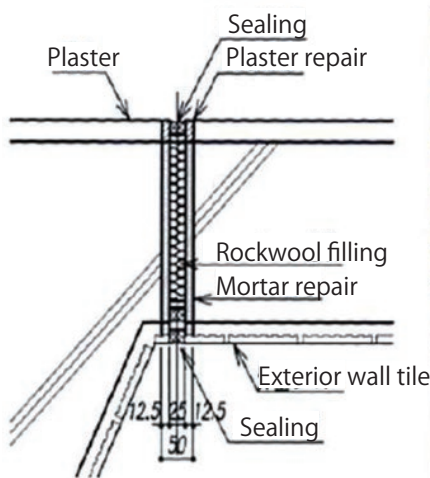
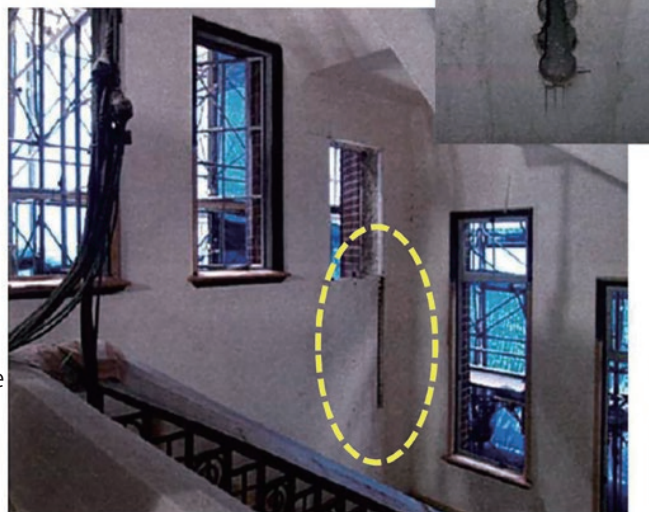
figure 6 anti-seismic slits (reprinted from 『東京大学大講堂（安田講堂）改修工事報告書』（東京大学 平成28年（2016）3月）, images were edited)

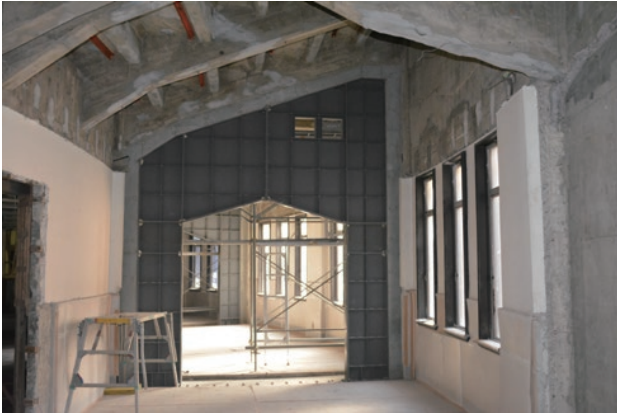
photo 26 Steel frame panel walls, corridor around auditorium

(photos 26 and 27). Also, the front porch was once cut off from the main structure to create an expansion joint.

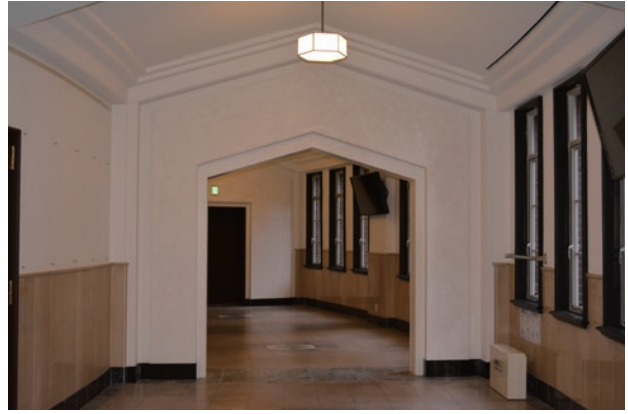
photo 27 Completed assembly hall corridor reinforcement wall. The opening was made with a pointed top to match the interior design

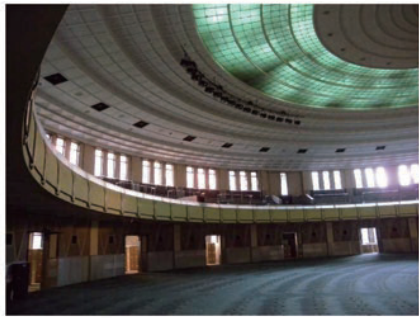
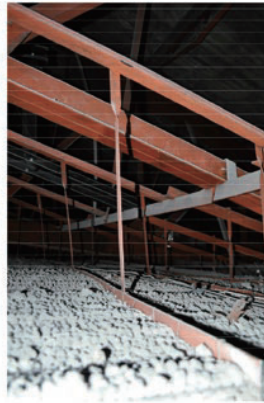
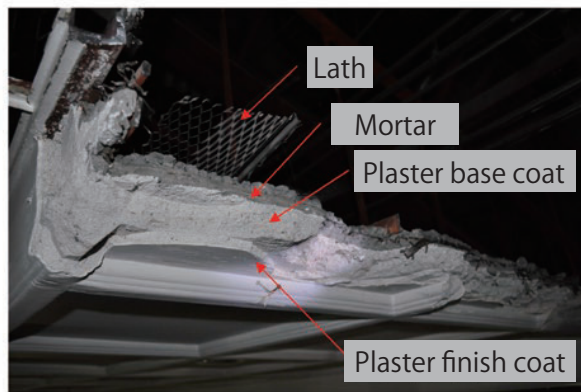
figure 7 Assembly hall, ceiling before restoration

The extant ceiling of the auditorium suspended from the roof truss, composed of a steel framework substrate covered with thick layers of mortar and plaster on a lath substrate, was extremely heavy and was in danger of collapse (figure 7). Therefore, it was decided to remove the entire roof structure including the steel framework substrate to recreate the ceiling structure entirely and replace with glass fiber reinforced gypsum (GFRG) panels designed to match the original ceiling (photo 28). Other areas worked on included the main circulation spaces of the lobby and corridors, in which the extant ceiling was removed as with the auditorium for restoration as semi-structure. On the staircase ceiling where the original plaster finish was retained, netting hardly visible to the eye was installed for safety in case the finish should fall (photo 29).

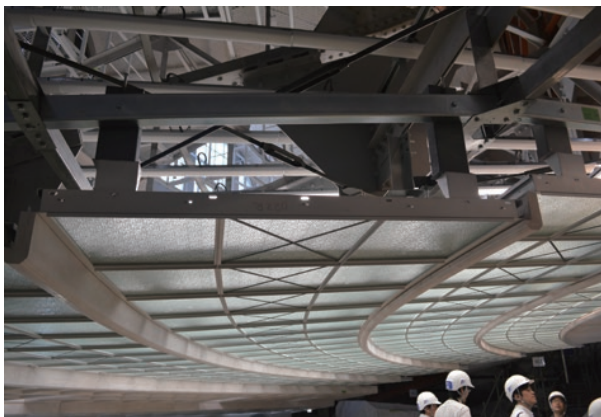
photo 28 Newly installed ceiling of glass fiber reinforced gypsum (GRG) panels

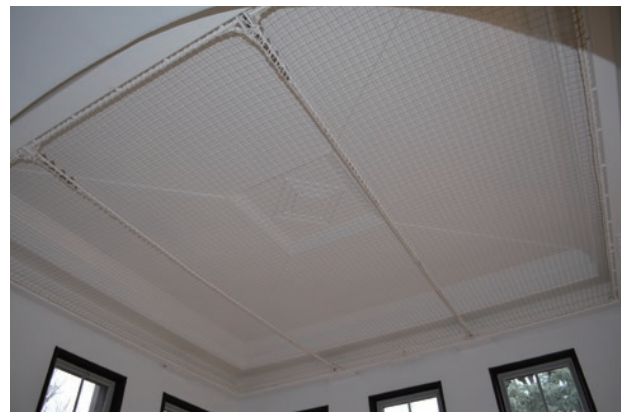
photo 29 Staircase, safety netting for ceiling plaster finish collapse

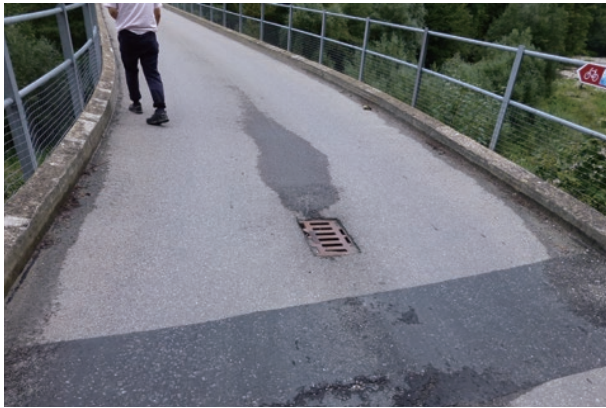
photo 3 Water drainage system on the bridge surface (a catch-basin was provided at the center of the road at each end of the bridge) and newly installed steel railings

The Rossgraben Bridge refurbishment project was performed during the period from March to September of 2005. Bridge refurbishment included improving the bridge's water drainage system (Photos 3, 4 and Figure 2), waterproofing the floor slab, renewing the roadway pavement, repairing areas that had concrete spalling and/or reinforcement bar corrosion, and impregnating exposed concrete surfaces with a water repellent (to a depth of 10 mm) for preventing water infiltration into concrete (Figure 3 and Photo 5). In particular, due caution was taken to faithfully replicate the original surface pattern left by the timber formwork on the concrete surfaces. When this concrete bridge was constructed, concrete was poured into wide plank forms. The pattern made by the wood grains

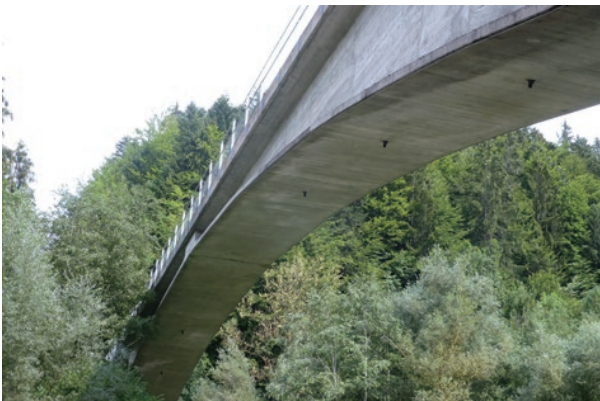
photo 4 Three drainpipes were provided at the bottom center of the arch.

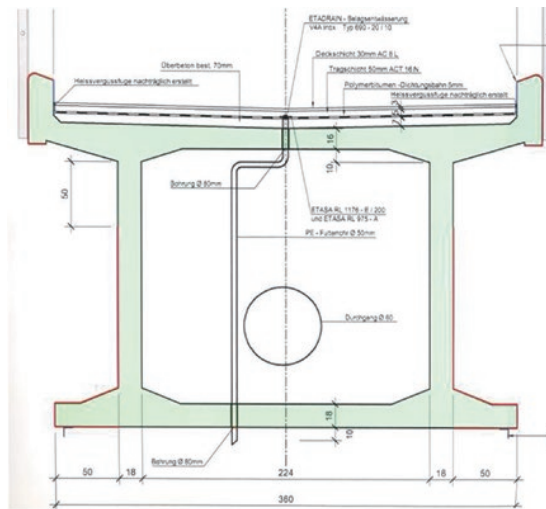
figure 2 Drainage system: Rainwater is run through the drainpipe from the catch-basin on the bridge surface to flow away underneath the arch.(photo provided by Prof. Eugen Brühwiler, Swiss Federal Institute of Technology in Lausanne)

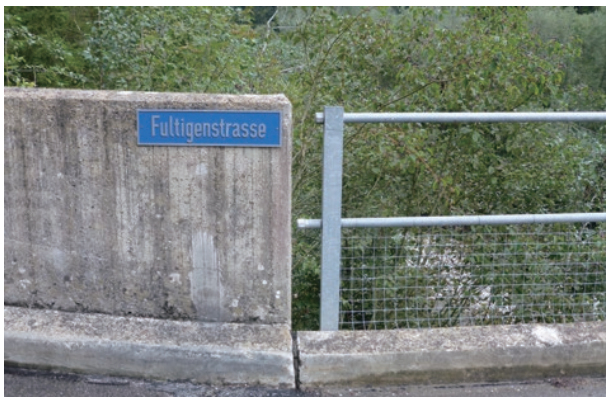
photo 5 A water repellent was applied to the surfaces of the concrete balustrade and wheel guard.

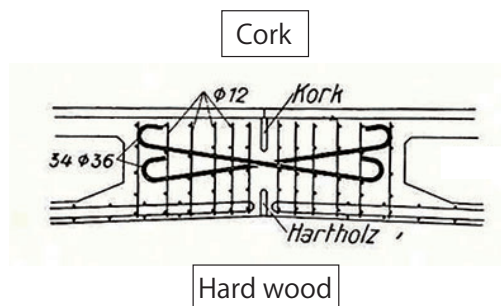
figure 4 Details of the original center hinge section (photo provided by: Prof. Eugen Brühwiler)

piece of hard wood at the bottom of the mid-point. 74 years have passed since the construction of this bridge and these components as well as the concrete have come to show deterioration. They were thus replaced during the refurbishment project. The two hinges at the ends of the arch ring were also repaired at the same time.

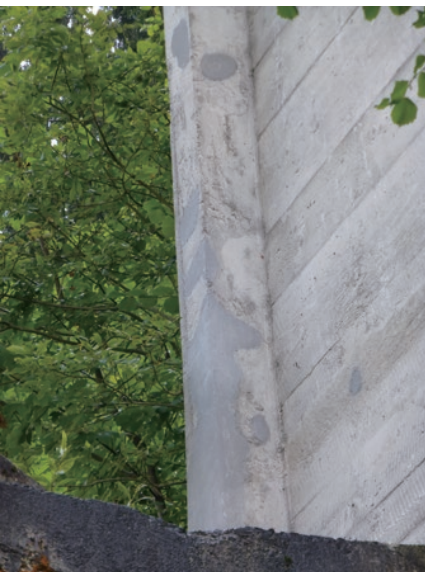
It seemed to me that the concrete covering the rebar was not very thick. Although I did not get to study the drawing of the Rossgraben Bridge's rebar arrangement myself, the thickness of the concrete covering the Rossgraben Bridge steel was estimated to be about 25 mm, a figure derived from those given for the Schwandbach Bridge and the Salginatobel Bridge. Specifications for Highway Bridges in Japan (published in 2017) require a minimum of 30 mm of concrete over road bridge steel. Perhaps in Robert Maillart's time the emphasis on the importance of the thickness of the concrete covering rebar was not as great as it is today. Therefore, it does seem that the corrosion of the steel reinforcement and spalling of the concrete that were found in many areas was due to this thin concrete cover. The result was that, during the conservation and refurbishment project, focus had to be placed on the repair of corroded steel bars and the spalling of concrete (photos 6 and 7).

photo 7 Repaired spandrel wall (There is not much difference in color between the concrete used for the repair and the original structure.)

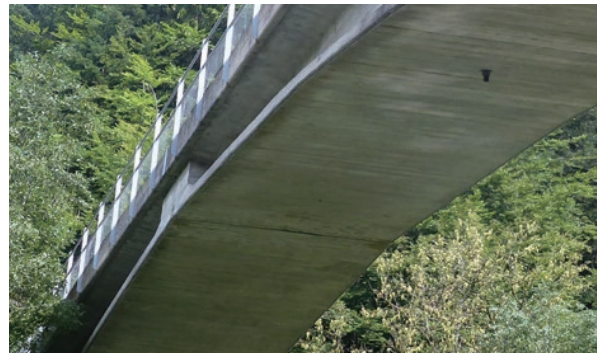
About 80 years have passed since construction. All around the Rossgraben Bridge, many trees have taken root and flourished. In areas near the base of the arch ribs, plants are growing so thickly that the arch rib is constantly in contact with moisture, blackening the concrete that makes up these parts (photos 8, 9 and 10).

photo 9 Repaired hinge section

The vegetation growing thickly around the bridge will tend to accelerate the deterioration of the concrete. It is necessary to prune back the plants around the bridge at regular intervals.

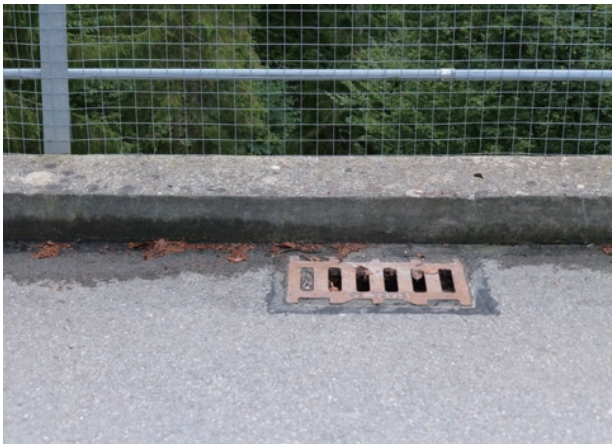
it is located on the edge of the inner curved side near the center of the bridge (**photo 13**).

photo 13 Catch-basin of the Schwandbach Bridge (at the edge of the inner curved side near the center of the bridge)

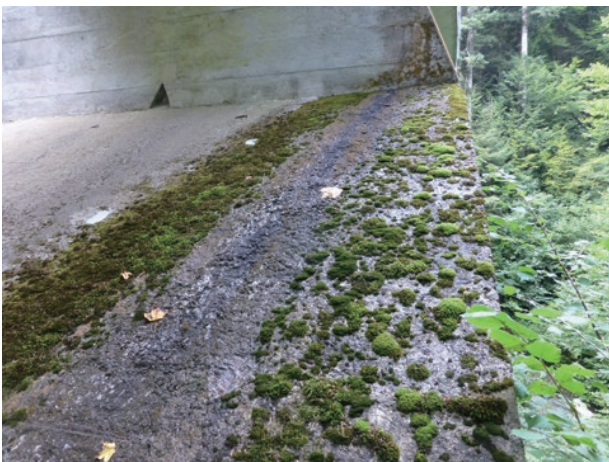
In the same manner as for other areas of the Schwandbach Bridge's arch ring, rainwater runs down through a triangular hole provided at the bottom edge of the wall along the arch ring (**photo 14**). However, as with the Rossgraben Bridge, plants proliferated near the bridge and moss was found growing on the outer surfaces of the concrete arch (**photo 14**). If a bridge is affected by its natural environment in such a manner, it is necessary to prune the plants to reduce the impact of vegetation as much as possible. In the conservation and refurbishment project for the Schwandbach Bridge, focus was placed on the repair of its spandrel walls (**photo 15**). A close look at the previously repaired areas will reveal that the color of the concrete used for repair appears slightly brighter than the color of the original structure. However, when seen from a distance, there should be little or no distinguishable difference in color between the newer and older parts. It is supposed that those areas had also been repaired because of rebar corrosion and spalled concrete.

photo 14 Drainage system running from the arch rib

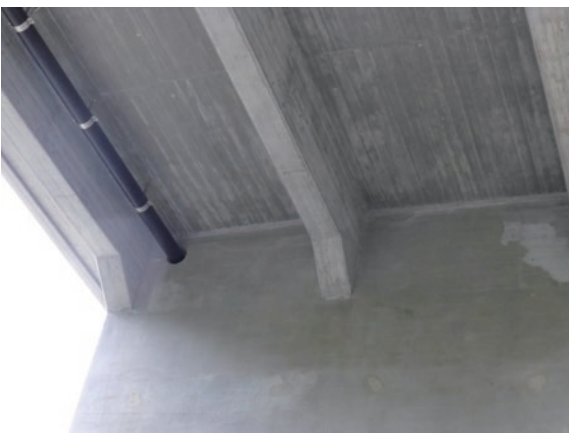
It is supposed, from noting that the bridge's drainage systems were retrofitted at later times, that not so much emphasis was placed on how to drain rainwater at the time when Maillart's bridges were designed (photos 21 and 22).

photo 21 Retrofitted drainpipe (1)

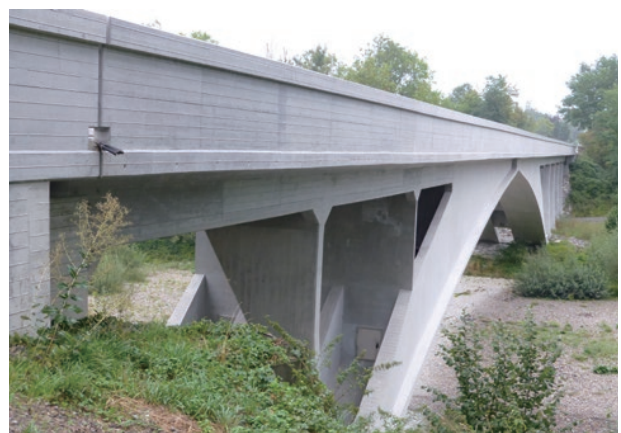
At present, a drainpipe protrudes from the wall balustrade to drain rainwater that accumulates on the floor slab (photo 23). This is the sole drainage system for carrying water away from the bridge's surface.

photo 23 Drainpipe protruding from wall balustrade

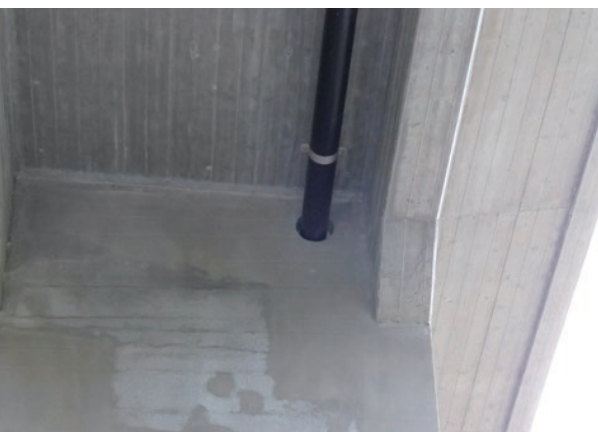
photo 22 Retrofitted drainpipe (2)

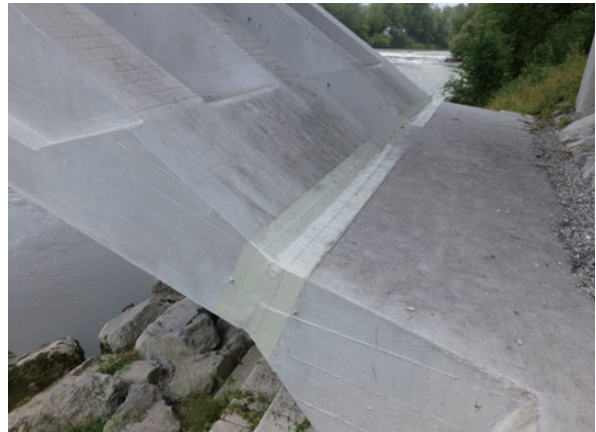
The hinges at the ends of the arch are sealed to prevent the entry of rainwater (photo 24).

photo 24 Repaired hinge

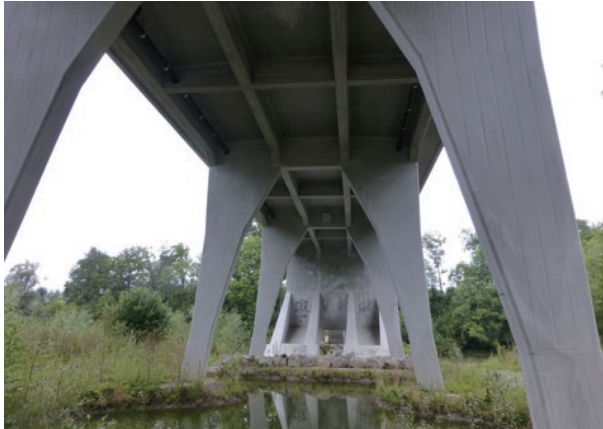
observed on the piers (**photo 25**) and concrete balustrades (**photo 26**). However, it seems that the color of the concrete in these areas is too light for concrete that is 80 years old.

photo 25 Replication of the original surface pattern left by timber formwork on pier concrete surfaces

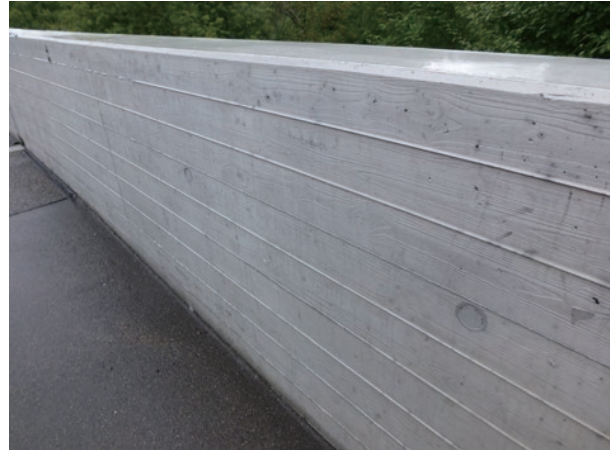
photo 26 Replication of the original surface pattern left by timber formwork on balustrade concrete surfaces

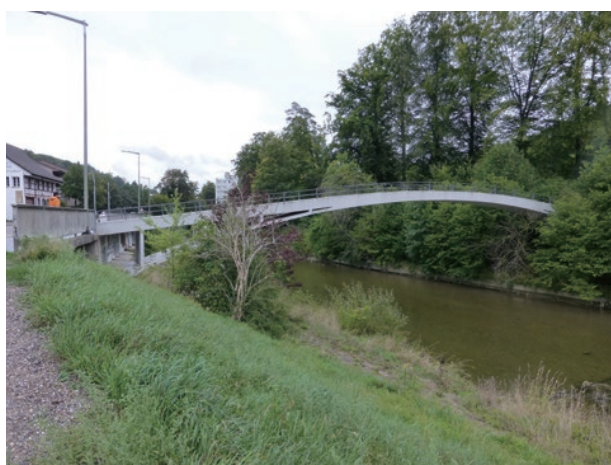
ring is 14 cm thick and the floor slab is 9 cm thick. The arch and the floor slab are joined in the center, making the total thickness there 23 cm (**figure 7**). The arch-to-rise ratio of this pedestrian bridge is 1:10.34, making it the flattest arch among the bridges designed by Maillart. It is unknown when the Töss footbridge was repaired last, but it seems that the color of the concrete is too light for its age (**photos 27** and **28**).

photo 27 Overall view of the Töss Footbridge

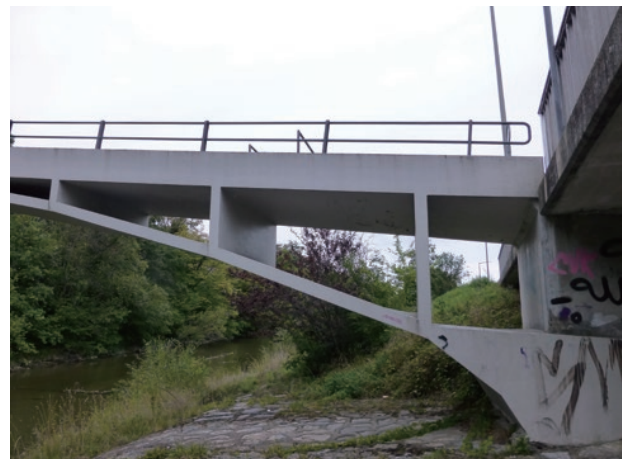
photo 28 Springing

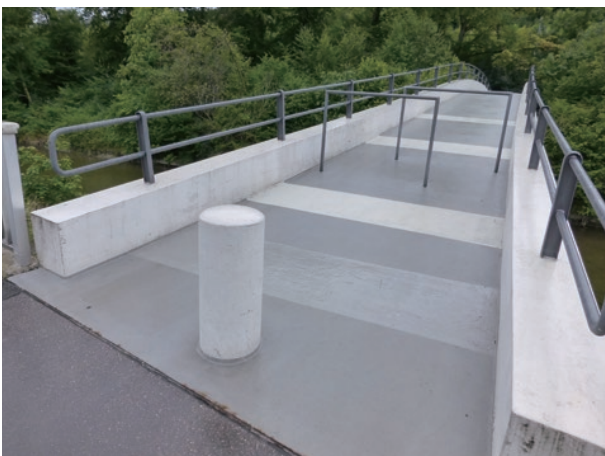
The floor system of the Töss footbridge is shown in **photos 29** and **30**. Deteriorating reinforced concrete was repaired

photo 30 General view of the floor slab

and the railings were replaced with new ones. New concrete was sprayed on, but it would have been better to reproduce the color of the old concrete (in this case, 80 years old) to the extent possible.
