Conservation and Restoration of Concrete Structures

Foreword

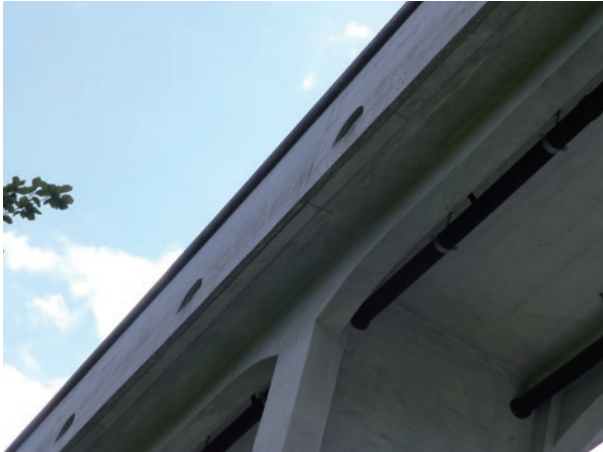
Figure 8 shows a general structural diagram for the Salginatobel Bridge. The original design for this bridge included a plan to drain rainwater that accumulated on the floor slab outside the arch through semicircular holes made in the lower area of the wall balustrade (**photo 33**). However, rainwater that flowed out through these semicircular holes splashed over the spandrel walls and arch ring concrete, causing the concrete to deteriorate. At that time, it does not seem to have occurred to Maillart that rainwater that accumulated on the floor slab could be drained away from the bridge efficiently by installing gutters or something similar in the lower areas of the concrete wall balustrades.

the rainwater that accumulates on the floor slab. All the semicircular holes have been closed to prevent the rainwater that accumulates on the floor slab from flowing out through them. (photo 33: drain holes viewed from outside the bridge and photo 34: Catch-basin.)

photo 33 Drainage holes viewed from off the bridge

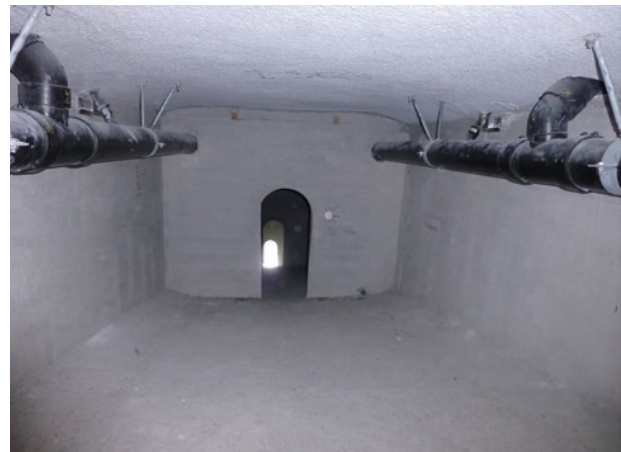
Photo 35 shows how the drain pipes are arranged in the bridge girders. The inside of the arch ring has openings through the spandrel walls to allow the passage of personnel and to drain rainwater (photo 36). One of the characteristics of Maillart's design is its design strength. The strength of a cubic specimen of reinforced concrete is 333 kg/cm^2 . In

photo 35 Arrangement of drainpipes inside the girder

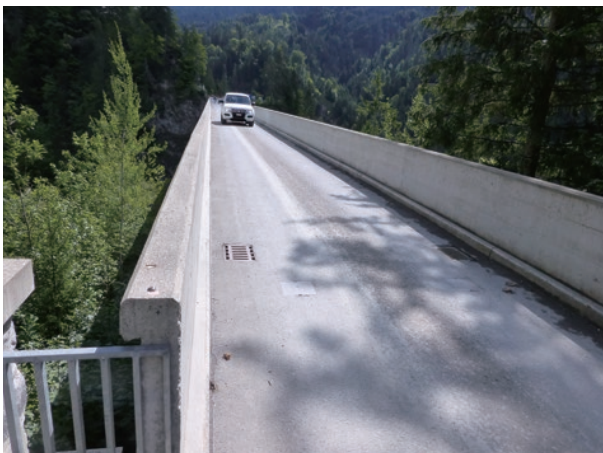
photo 34 Drainage system on the bridge surface (provision of catch-basins)

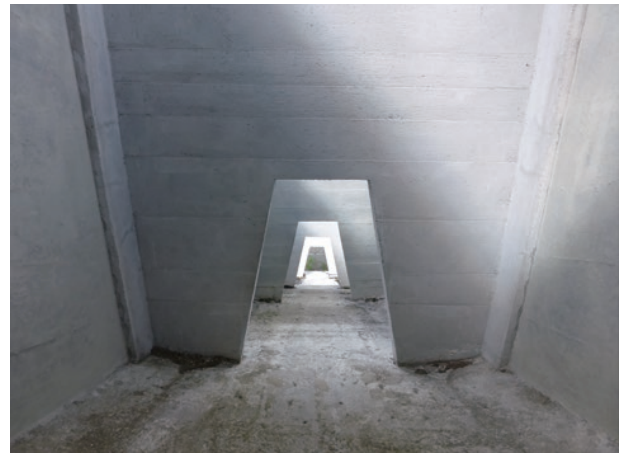
photo 36 Drainage system inside the arch ring

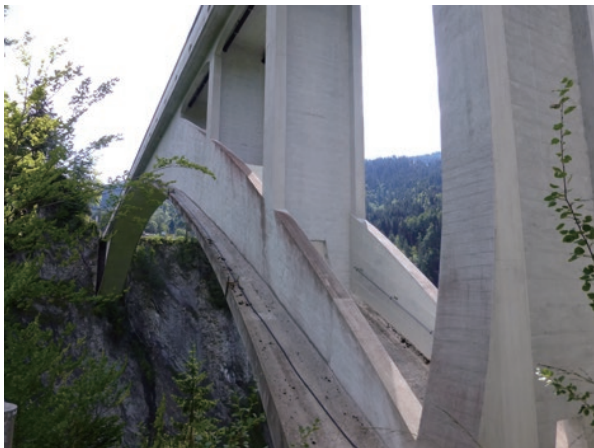
Photo 37 shows the difference between the arch ring on the north side of the bridge and the one on the south side. The arch ring on the south side is always exposed to daylight. Consequently, moisture evaporates from it swiftly and the concrete has retained its light tone, whereas the arch ring on the north side often retains moisture, so the concrete has darkened (**photo 38**). **Photo 39** also shows the appearance of the arch ring concrete on the south side. **Photo 40** shows a piece of the timber formwork that was actually used to hold the concrete when the bridge was originally constructed. Annual tree rings can be clearly seen, left on the formwork by the imprint of the planking. It is understood that in Switzerland when conserving historic concrete structures, they place emphasis on the replication of the original surface pattern left by the formwork timbers.

photo 37 Arch rings on the north and south sides

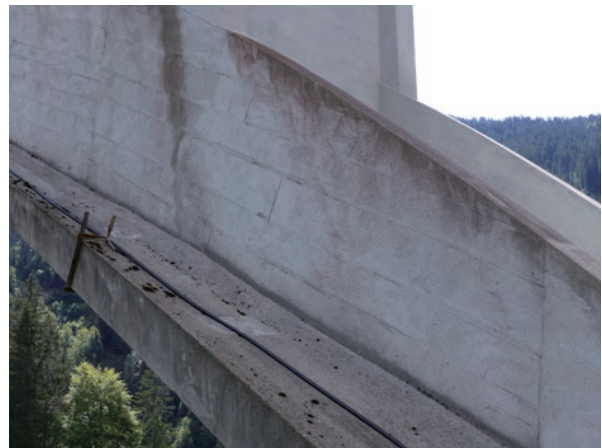
photo 38 Discoloration of the north-side arch ring's concrete

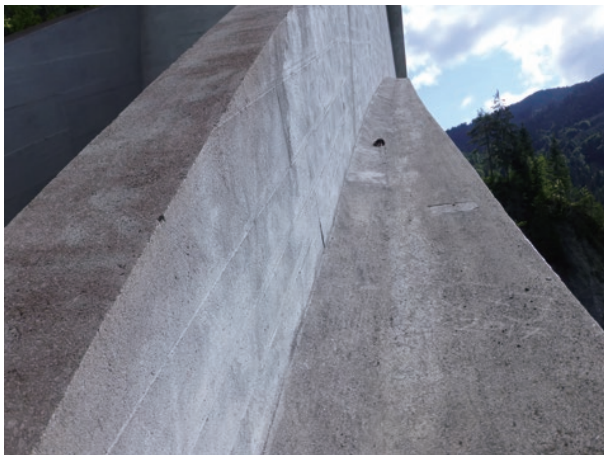
photo 39 South-side arch ring concrete

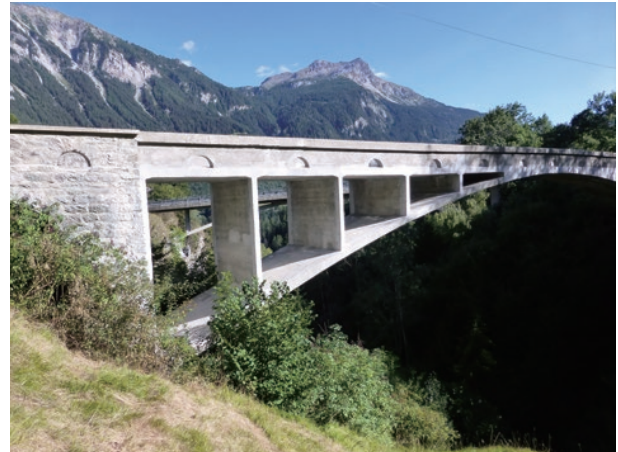
photo 42 Valtschiel Bridge (close view) (cited from a photograph of a signboard installed on site)

Photo 42 shows the state of the deterioration of the Valterschiel Bridge's concrete at that time. The refurbishment

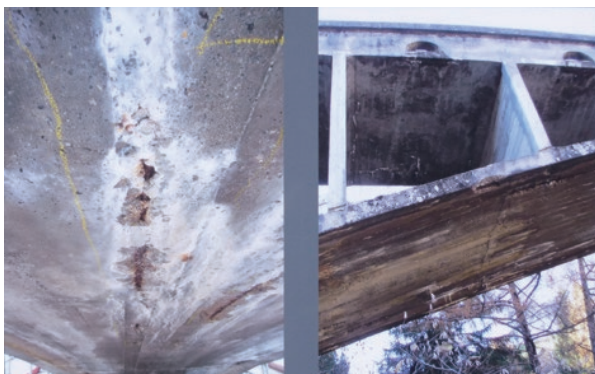
photo 43 Deteriorated Valterschiel Bridge before restoration (cited from a photograph of a signboard installed on site)

project for the Valterschiel Bridge was started in 2013, based on the results of the inspection of the bridge in 2009. The refurbishment history of the bridge is shown in **Table 6**. Three major refurbishments were carried out during this project. First, two layers of ultra-high-performance concrete (UHPRFC) were placed on the deck to improve its waterproofness (**photo 43** and **figure 10**). Second, the bottoms of the semicircular holes were elevated by filling in

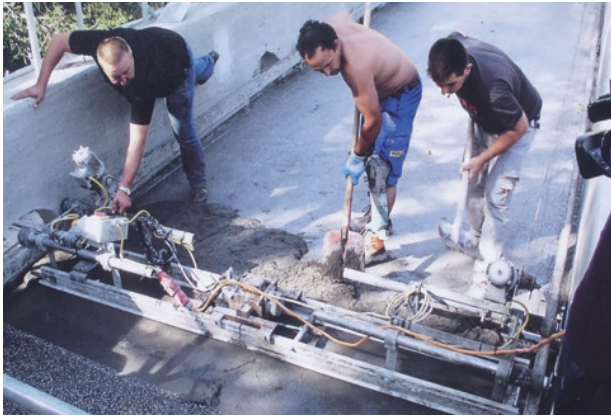
photo 44 Waterproofing using 2 layers of UHPRFC (cited from a photograph of a signboard installed on site)

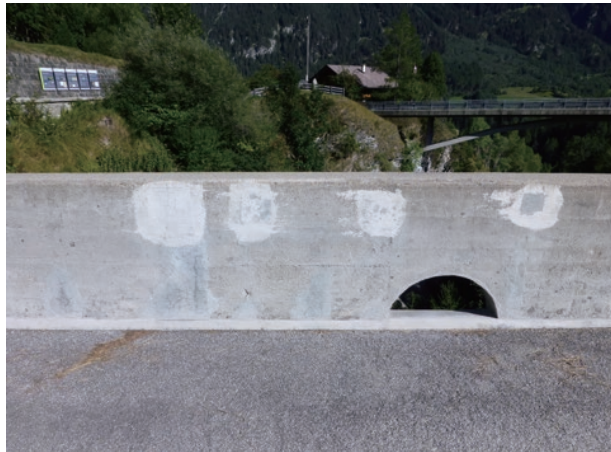
photo 45 Preventing rainwater from splashing over the outside of the bridge

the lower section with concrete. This kept rainwater away from the openings in the balustrade and prevented it from splashing over the concrete arches. In addition, drainage channels, running along the centerline of the bridge, were placed under the new level of the semicircular holes (photos 44 and 45). Third, deteriorated concrete was removed by spraying water under pressure on those areas and repairs were made using sprayed concrete. The concrete in the repaired areas is conspicuously lighter in color than the

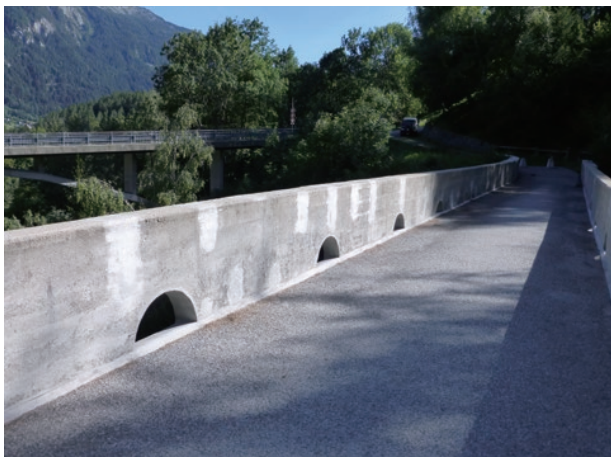
photo 46 Preventing rainwater that accumulates on the bridge surface from flowing out of the bridge

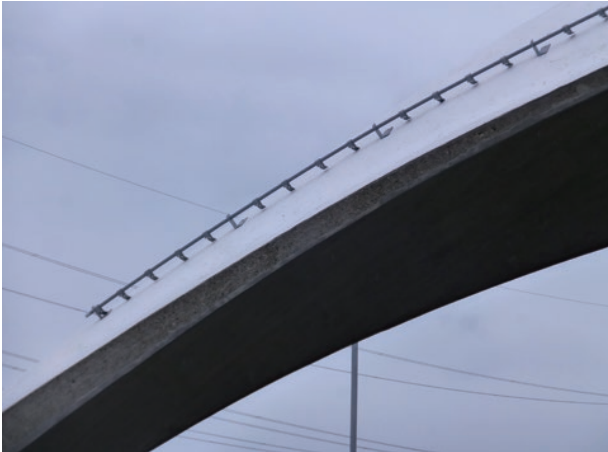
photo 57 Installed snow guards

During refurbishment, snow guards were installed on the roofs as a new feature, to prevent masses of snow from sliding down onto the ground when snow accumulates on the roofs (photos 57, 58 and 59). This shell roof structure, consisting of two triangles, was designed on the basis of the Mövenpick logo. Heinz Isler created concrete shell structures in a variety of shapes to suit the purposes and intentions of their owners. His engineering sense is spectacular.

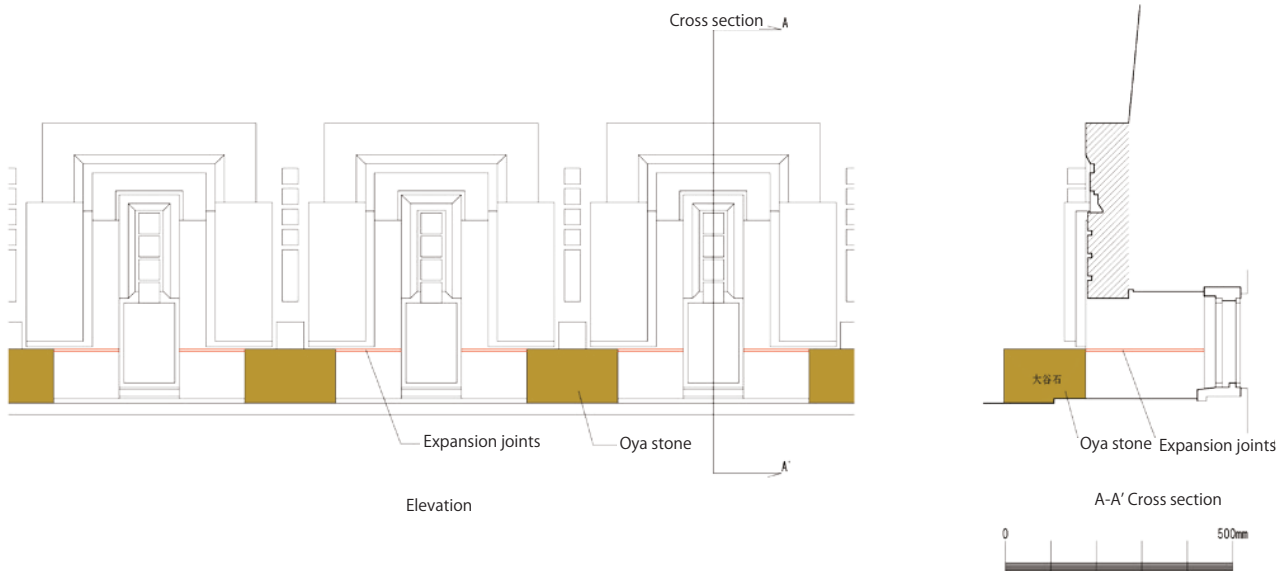
figure 1-3 : Provision of joints between ornaments and their base stones (type A) (red parts were joints of provision) (figure provided by : Architectural Research Association)

Measure ③ : Considering the design of the building, it was anticipated that the waterproofing layers would need repeated repairs in the future. Therefore, expansion joints were made between the artificial-stone ornaments and the Oya stone base stones, because the ornaments would need to be removed to repair the waterproofing layers in subsequent refurbishment projects (figure 1-3).

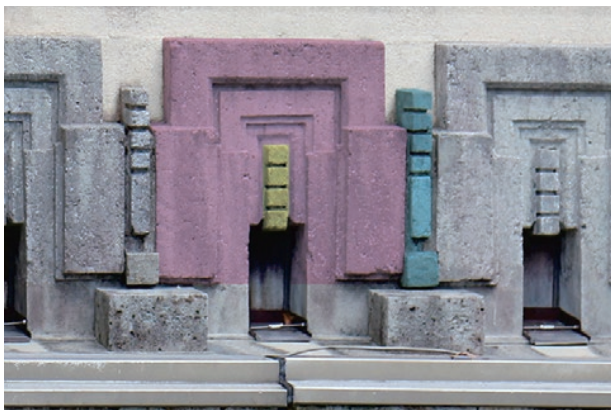
photo 1-2: Type A artificial-stone ornaments (with three parts reassembled) (red parts were newly placed in-situ) (photo provided by : Yodogawa Steel Works, Ltd.)

It was found from examining relevant literature that in relatively many cases the type A artificial-stone ornaments tended to retain their original integrity. It was also found from a preliminary investigation that these were constructed using hard mortar to fill the center of the mold as a core, and then the outer part was covered with relatively soft artificial mortar. A piece of type A artificial-stone ornament was broken apart for examination. After examination, the ornament was restored by treating it as three parts. One part was repaired with in-situ concrete and two parts with precast concrete, and then the three parts were reassembled (**photo 1-2**).

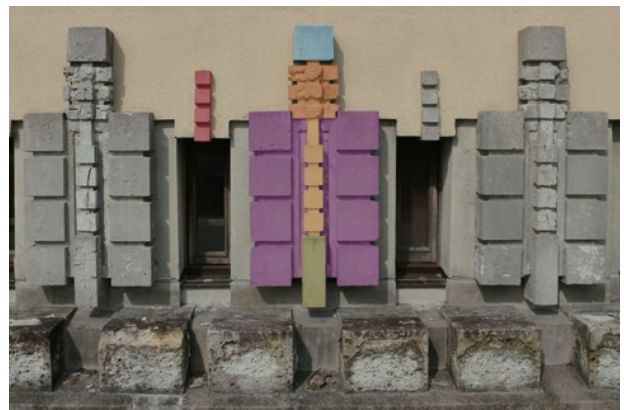
photo 1-4 : All five separate parts of a type B artificial-stone ornament were reassembled (They are color-coded) (photo provided by : Architectural Research Association)

On the other hand, not even one element of the type B artificial-stone ornaments was found remaining on the building in an investigation performed in 1983 preceding the earlier restoration. It was therefore not clear what the original specifications of the type B artificial-stone ornaments had been. New type B artificial-stone ornaments were fabricated by dividing the design into five separate parts and installing the replacements during the conservation and restoration project performed between 1985 and 1988 (**photo 1-4**).

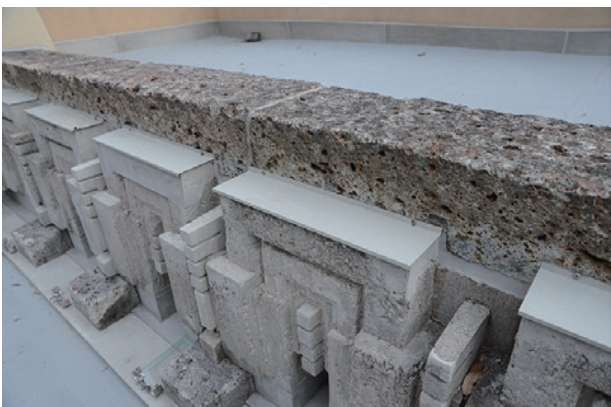
The state of conservation of the artificial-stone ornaments depended on the extent to which they were exposed to rainfall. The type A ornaments, which retained relatively large amounts of the original materials, were refurbished by installing a Galvlume steel sheet on top of each ornament to serve as a form of eaves (**photo 1-3**).

photo 1-3: Galvalume steel sheets on top of ornaments to serve as a form of eaves.

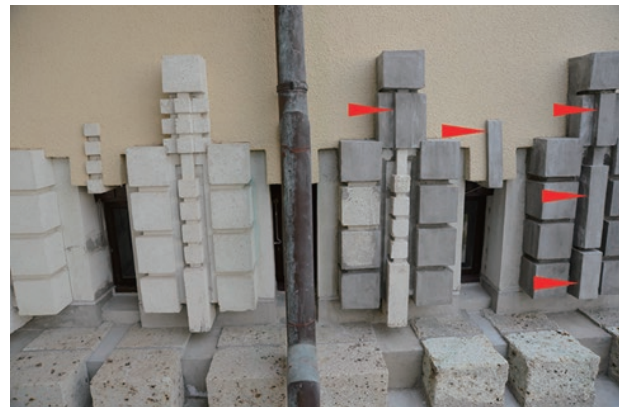
In addition, to prevent the ornaments from breaking, no rebar was used inside them. The type B ones were more severely deteriorated than the type A ones, but the cause of deterioration was not clearly identified. Finally, restoration of the detailed design of this type was temporarily abandoned (photo 1-5). Complete restoration of the type B artificial-stone ornaments will be performed after durable repair materials to be used for the project are identified.

photo 1-5: Type B artificial-stone ornament whose restoration of detailed design was abandoned (indicated by red arrows)

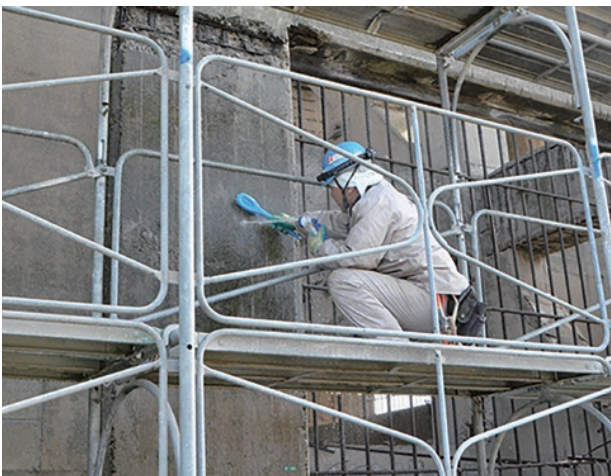
photo 2-2: Cleaning of the concrete surfaces (photo provided by : The Japanese Association for Conservation of Architectural Monuments)

After scaffolding had been installed to facilitate this conservation and restoration project, the structure's entire concrete surface was cleaned with high-pressure steam (**photo 2-2**) to remove contaminants. Then the textures and colors of the concrete surfaces revealed after cleaning were examined carefully. This pre-repair cleaning process was carried out by utilizing the experience of the conservation and repair project performed on the Hiroshima Memorial Cathedral for World Peace.

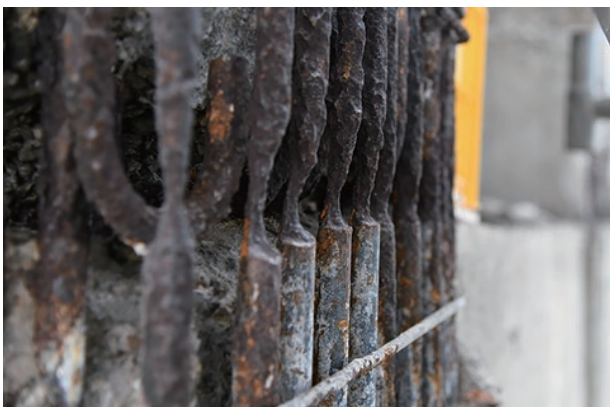
photo 2-6: Corroded rebar

be replaced on the basis of the state of corrosion of all the steel bars embedded inside a given pole or beam, not the corrosion level of each piece of steel bar. That is, it was decided that main rebar should be replaced or repaired appropriately if the combined reduction of cross-sectional area of all the steel bars embedded inside a column or beam had been lowered by more than 20% (photo 2-6).

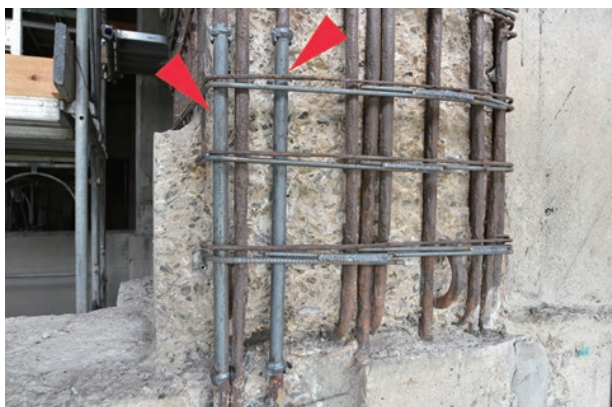
photo 2-8: A new piece of steel bar inserted using enclosed arc welding (steel bars indicated by red arrows) (photo provided by : The Japanese Association for Conservation of Architectural Monuments)

This approach conforms to the afore-mentioned repair policy of: "maintaining the current structural integrity of the Shaft Tower as much as possible" as well as the principle of preserving original structural members to the extent possible. When splinting the corroded rebar with new rebar, position and length were determined in the same way as in the case when a splint is lap-spliced to the sound part of existing rebar. The lap length of each joint was set at $40d$ ($40 \times 25 = 1 \text{ m}$ if the main rebar inside the column base was 25 mm in diameter) according to the Standard Specifications for Construction Work (JASS5 Reinforced Concrete Projects) published by the Architectural Institute of Japan (AIJ). If it was difficult to add a new steel bar into the rebar system as a splint (for example, if there was no space for a new steel bar), the thinned part of the corroded steel bar was cut away and then a new piece of steel bar was inserted into the section of existing rebar where the old piece was cut away, using enclosed arc welding (photo 2-8).

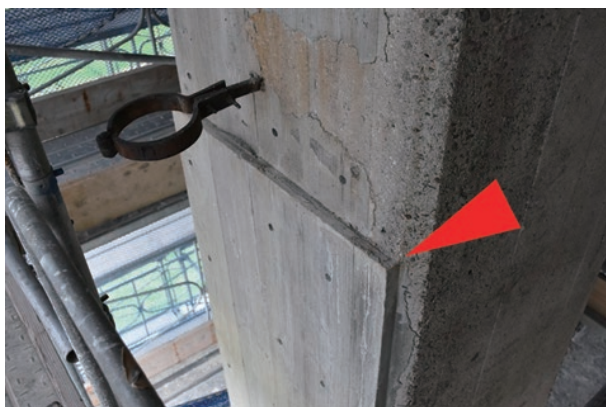
photo 2-9: New concrete was placed to areas whose thickness of covering concrete was insufficient (increased thickness indicated by a red arrow) (photo provided by : The Japanese Association for Conservation of Architectural Monuments)

of replacing the corroded and reduced rebar with a new one. Furthermore, the following conditions were also observed when patch repairing was performed on areas where the concrete covering the rebar was too thin. Generally during restoration, it is necessary to increase the covering concrete's thickness so as to slow down the progress of deterioration. However, in some repaired areas, if this project's covering concrete were to be increased to 40 mm, the value specified in JASS5, it would have created a big difference in thickness between repaired and non-repaired areas, significantly impairing the structure's appearance. Therefore, the plan discussed below was used to determine the thickness of the covering concrete in the areas to be repaired, to minimize the difference in appearance between repaired and non-repaired areas while assuring that the resistance of the repaired areas to carbonation was adequate. A guideline on the design of concrete constructions published by the AIJ states that the magnitude of concrete corrosion factors should be determined when carbonation reaches the depth of the rebar. Therefore, during this conservation and restoration project, it was assumed that rebar corrosion started when the difference between the thickness of the concrete covering the rebar and the depth of carbonation became equal. In the meantime, on the assumption that cultural properties need to be refurbished every 50 years, the thickness of the original covering of concrete that would allow a time span of 50 years until the carbonation depth reached the rebars was calculated from the rate of carbonation for each type of concrete material. On the basis of the results of these calculations, the restorers determined the minimum thicknesses of covering concrete necessary for the various areas to be repaired. Different thickness of covering concrete were established for the different areas to be repaired and the work methods to be used: 18 mm (with the injection method) or 14 mm (with the plastering method) for areas of repair exposed to rainfall; and 10 mm (injection) and 6 mm (plastering) for other areas (**photo 2-9**).

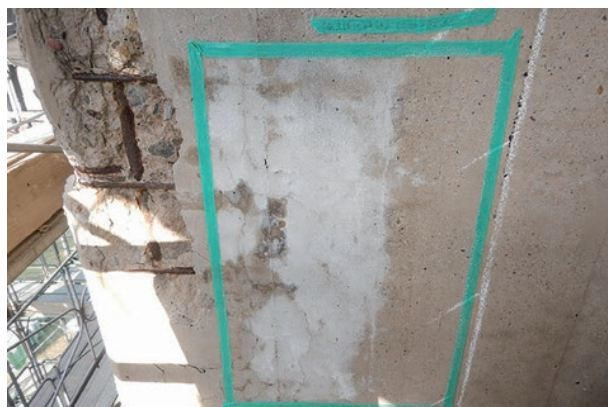
Test results: A slight amount of efflorescence occurred on the surface of concrete used as a repair material.

photo 2-10: Development of efflorescence: after the application of nitrite-based permeable rust-inhibitor+ silane-siloxane-based surface penetrant (photo provided by : The Japanese Association for Conservation of Architectural Monuments)

The three types of surface protection were tested according to plan. The water-based hydrophobic agent was selected on the basis of the test results, because it had a strong anti-efflorescent effect on the concrete repair material and was

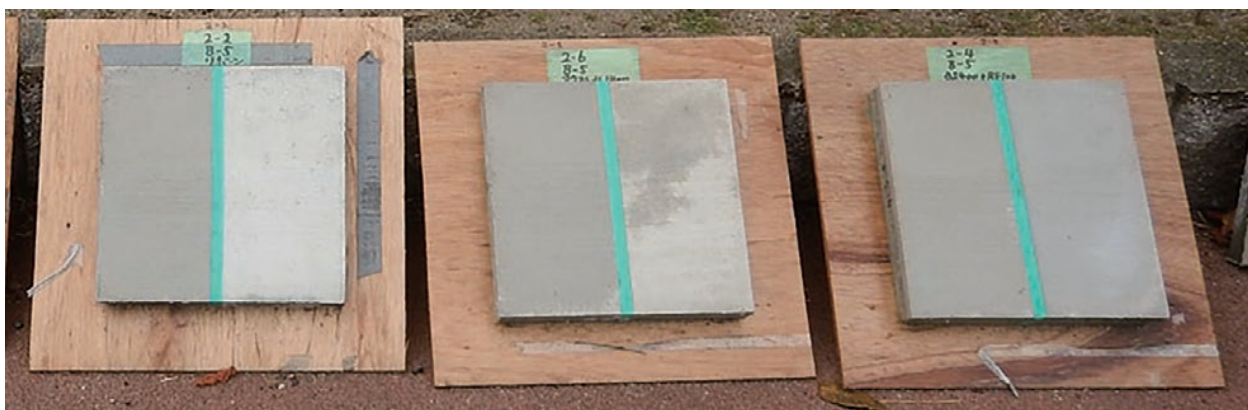
photo 2-11: Test specimens made of a repair material coated with three different types of surface protection agents (from left: liquid water-based hydrophobic agent, silane-siloxane-based surface penetrant + nitrite-based permeable rust-inhibitor and silicate-based surface penetrant + nitrite-based permeable rust-inhibitor) (photo provided by : The Japanese Association for Conservation of Architectural Monuments)

quite durable. There were no significant differences in terms of water permeability. It was also found that all three types of surface protection agent had some degree of reversibility, although there were differences in degree among them.

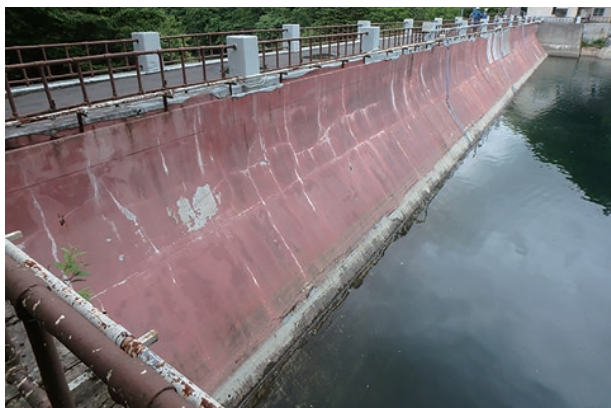
Marunuma Dam (**photo 3-1**) was repaired in 2001 by applying a protective coating (polyurethane resin) to the dam's upstream face (concrete core wall) in order to prevent deterioration of the concrete due to repeated cycles of freezing and thawing. However, rainwater made its way underneath the coating film, which led to about 460 m² of coating peeling away (**photo 3-2**).

The main causes of the peeling off of the protective coating applied to the upstream face were thought to have been: First, rainwater made inroads into the concrete through cracks at the crest of the dam. It then passed through cracks inside the upstream face and reached the boundary between the protective coating and that wall, thus weakening the bond of the coating to the concrete, and resulting in deterioration of the concrete. On the basis of these assumptions, it was planned to provide a new protective coating that would waterproof the crest of the upstream face and to fill the cracks on the upstream face using an appropriate material.

photo 3-2: The protective coating of the dam's upstream face peeling away (photo provided by : Tokyo Electric Power Company Holdings, Incorporated)

The upstream face itself was repaired in the following manner. First, the primer which had been used to repair the peeled-off protective film in the past was removed and the exposed surface of the concrete was cleaned. Then, a low-viscosity epoxy resin waterproofing agent was injected from the surface into the cracks (**photo 3-6**). Finally, the whole surface of the upstream face was coated with a silane-based surface protective agent (**photo 3-7**).

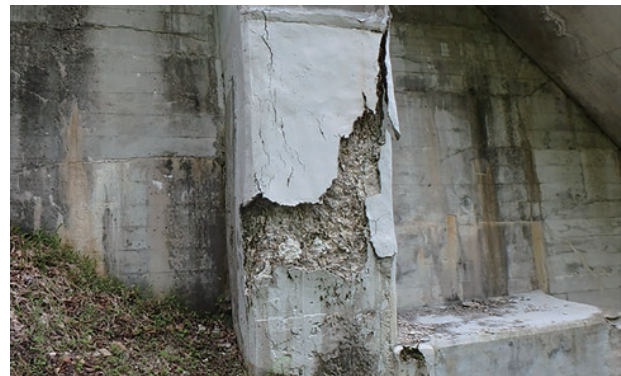
Two of the buttresses that had been repaired during the preceding repair project became severely deteriorated due

to freeze-thaw cycles that affected the upper rear part of the dam on the right bank side (**photo 3-3**).

photo 3-3: A buttress deteriorated due to freeze-thaw cycles (the surface coating provided in the past repair project peeled off) (photo provided by : Tokyo Electric Power Company Holdings, Incorporated)

The two severely deteriorated buttresses were repaired as follows: The layer of concrete that had deteriorated due to repeated cycles of freezing and thawing, 150 mm to 200 mm deep, was chipped off the surface of each buttress; the buttress's newly exposed concrete was cleaned (**photo 3-8**); and steel tie-bars were installed over the areas where deteriorated concrete had been chipped away (**photo 3-9**), followed by

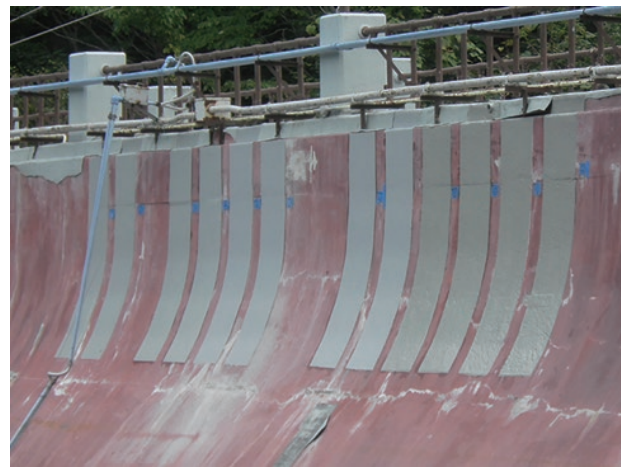
While studying what waterproofing to use on the crest of the upstream face, three types of elastic waterproofing coating (polyurethane resin, epoxy resin, and inorganic glass) were applied to the existing concrete surface at the site, on a trial basis (**Photo 3-4**). During the same period, these were also subjected to laboratory tests including an accelerated degrading test, to compare their bond strengths and durability. On the basis of the test results, as well as evaluations of workability and cost-effectiveness, it was decided to use the epoxy-resin to make repairs during this refurbishment project.

photo 3-4: Monitoring of the protective coating applied on a trial basis (photo provided by : Tokyo Electric Power Company Holdings, Incorporated)

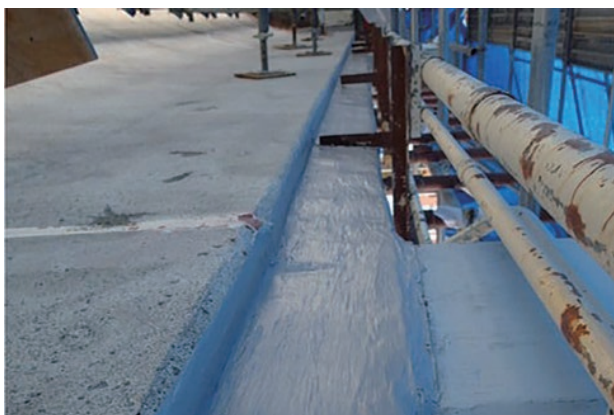
photo 3-5: Protective film applied over the whole concrete surface of the crest (photo provided by : Tokyo Electric Power Company Holdings, Incorporated)

The crest of the dam through which rainwater had made its way to the boundary between the upstream face concrete surface and the protective coating was repaired by: (1) removing all the protective film applied on the existing concrete of the crest surface; (2) coating deteriorated concrete surfaces with polymer cement mortar; then applying epoxy resin-based protective film over the whole concrete surface of the crest (**photo 3-5**).

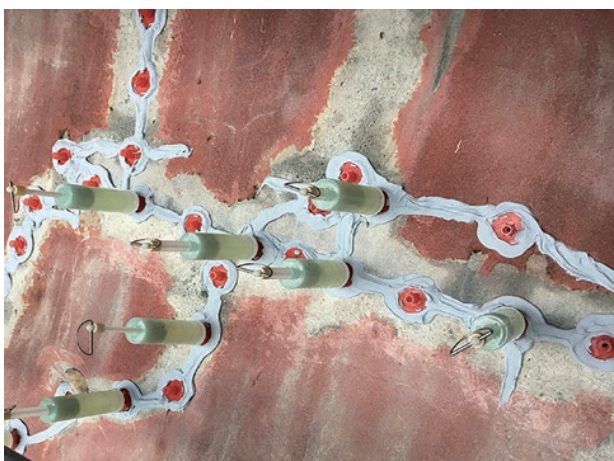
photo 3-6: Part of the protective film peeling off from the dam's upstream face (photo provided by : Tokyo Electric Power Company Holdings, Incorporated)

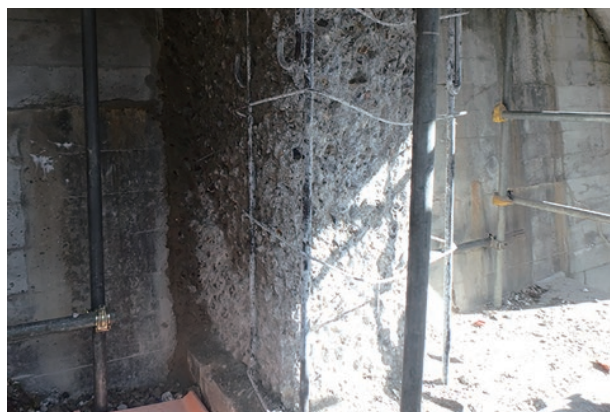
photo 3-8 : Deteriorated concrete chipped off and the exposed concrete surface cleaned (photo provided by : Tokyo Electric Power Company Holdings, Incorporated)

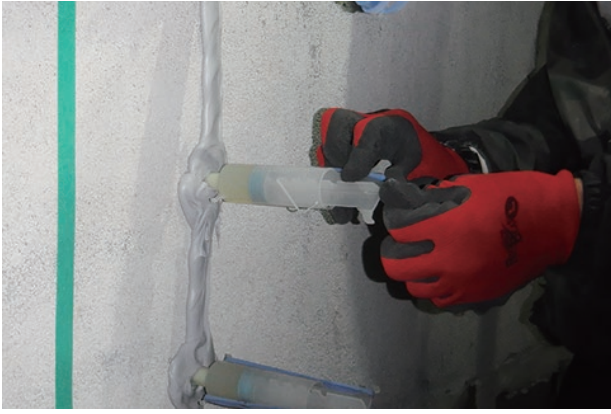
photo 5-3: Injecting epoxy resin under low pressure (Ceiling of the inner sanctum) (photo provided by : Shimizu Corporation Hiroshima Branch)

In this refurbishment project, the chief method used to repair cracks was the injection method, in which cement slurry is injected into cracks under low pressure. However, the repair methods and/or materials were changed according to the widths of the cracks, as stated in table 5-2. Cracks with a width of 1.0 mm or more were repaired by injecting epoxy resin, with a priority placed on securing strength. Those 0.2 mm or more and less than 1.0 mm wide were repaired by injecting polymer cement slurry.

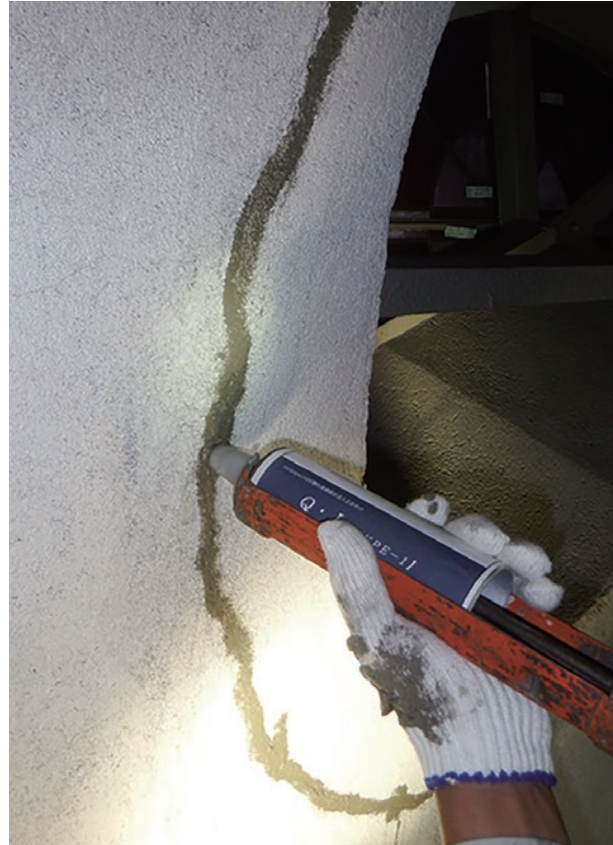
photo 5-4: Injecting ultra-fine polymer cement (photo provided by : Shimizu Corporation Hiroshima Branch)

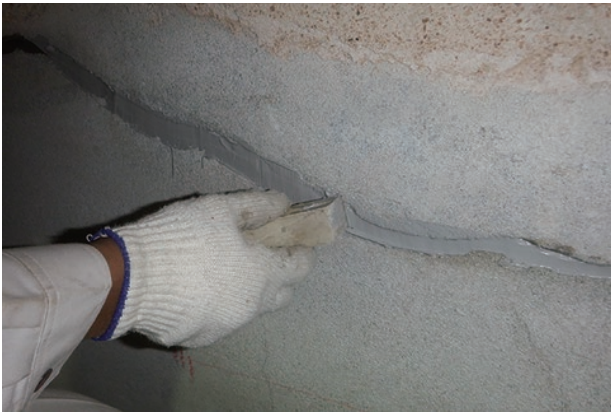
photo 5-5: Routing and sealing (photo provided by : Shimizu Corporation Hiroshima Branch)

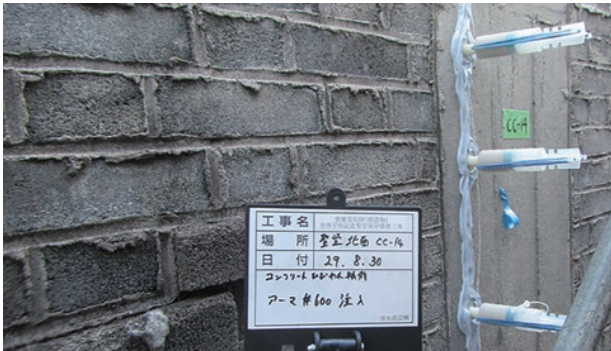
photo 5-6: Injecting cement slurry under low pressure (External wall) (photo provided by : Shimizu Corporation Hiroshima Branch)

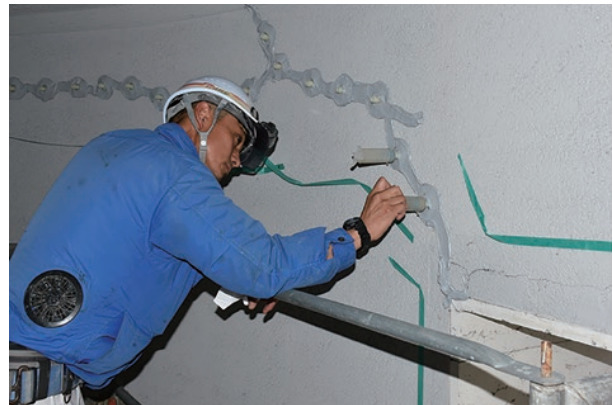
photo 5-7: Injecting cement slurry under low pressure (Internal wall) (photo provided by : The Japanese Association for Conservation of Architectural Monuments)

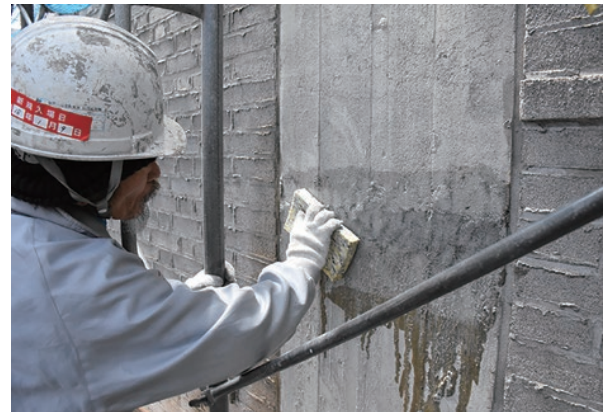
photo 5-8: Decorative coat being applied to a repaired area of the concrete (photo provided by : The Japanese Association for Conservation of Architectural Monuments)

The existing concrete surfaces of the Cathedral in some areas had a strong yellowish color. These variations in the color of the concrete surface were color matched to the surrounding areas using either of the following two methods: admixing a coloring agent into the repair materials or applying a concrete decorative agent onto the concrete surface after repairing the cracks (**photo 5-8**).

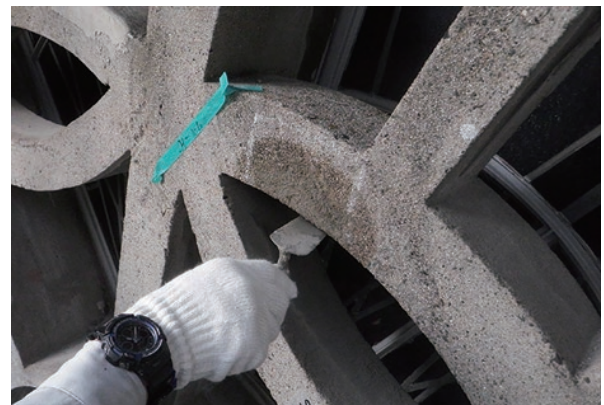
photo 5-9: Precast concrete area being repaired (photo provided by : The Japanese Association for Conservation of Architectural Monuments)

When repairing the Cathedral's precast concrete and cement mortar bricks, consideration was given to harmonizing the texture of the repaired areas with that of the original areas by adjusting the type, quantity and size of the aggregate (sand) to match the original (**photos 5-9 and 5-10**).

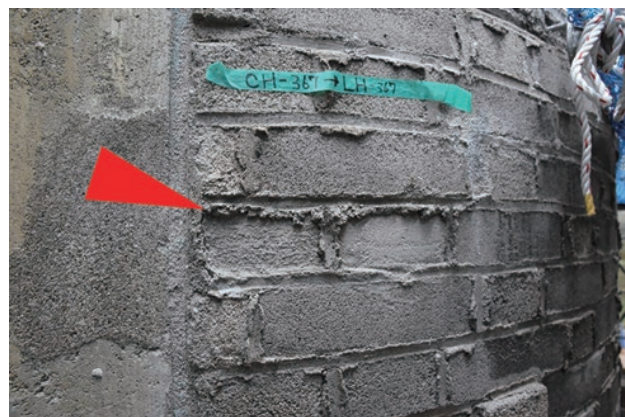
photo 5-10: Cement mortar bricks being repaired (photo provided by : The Japanese Association for Conservation of Architectural Monuments)

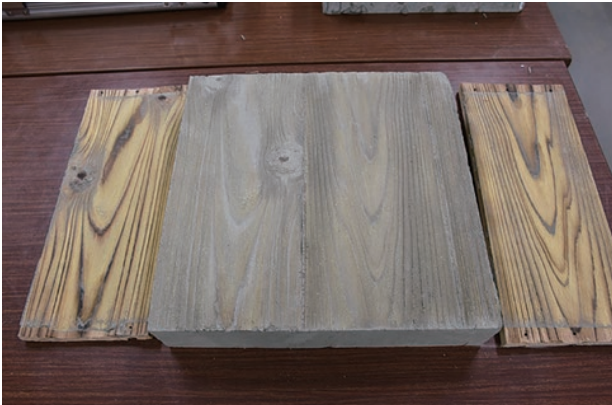
photo 5-11: Surface roughening (embossing) made on a trial basis (photo provided by : The Japanese Association for Conservation of Architectural Monuments)

In the injection method, the forms are installed with sheathing boards arranged to produce wood grain patterns resembling those left on the existing concrete. Cedar was selected to make the forms, because it would leave a clear wood grain imprint on the concrete surfaces in the repaired areas (photo 5-11). Separators or form ties were not used, in order to avoid leaving tie holes on the concrete surface. Forms were secured from outside, using only pipes or pipe supports to the extent possible, but reinforced using concrete screws when neces-

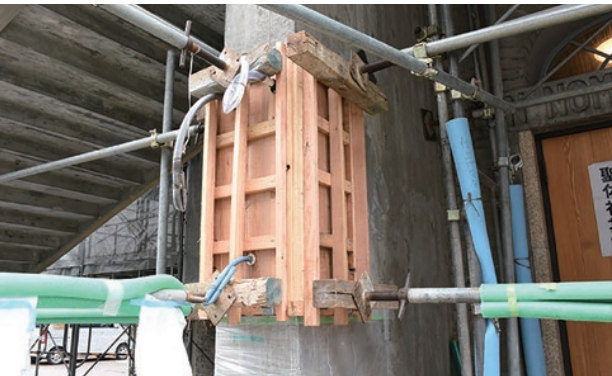
photo 5-12: Refurbishment using the injection method (photo provided by : The Japanese Association for Conservation of Architectural Monuments)

sary (photo 5-12).

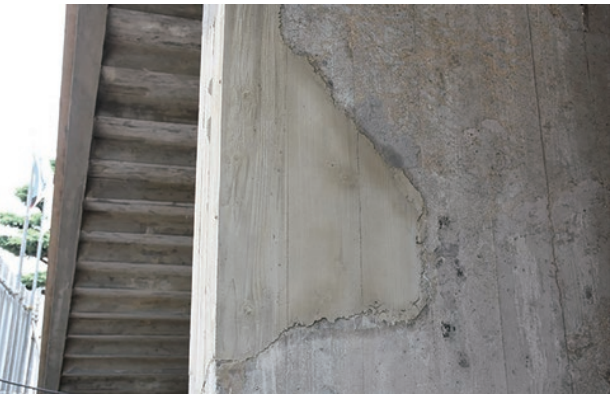
After refurbishment using the injection method, the following problems were reported (photo 5-13). (1) Leaking mortar: Irregularities on the existing concrete surface produced by small gaps between the formwork and the concrete surface sometimes caused leaks of the poured mortar; (2) Poor filling of mortar: In addition, maybe uneven between an area to be repaired and those surrounding it at the edges where deteriorated concrete has been chipped away. To prevent

mortar from leaking from gaps like that, created between the concrete surface and the formwork, at first non-shrink mortar was poured into the deteriorated areas, but the result was unsatisfactory and left some areas poorly filled; and (3) Traces of cement injection ports: The injection method also posed the problem that the traces of the cement injection port left in the repaired area needed to be removed after injection.

photo 5-13: A concrete surface from which the form has been removed after refurbishment using the injection method (photo provided by : The Japanese Association for Conservation of Architectural Monuments)

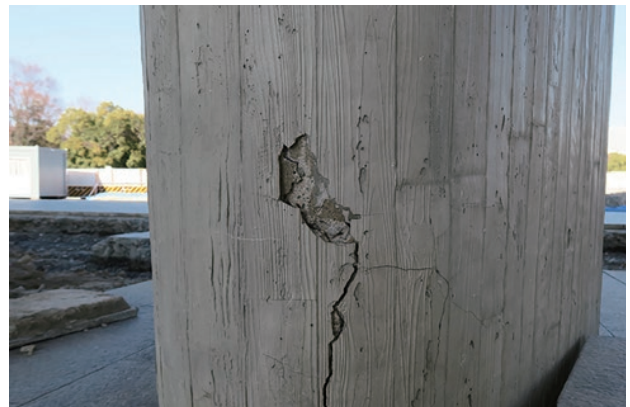
photo 6-3: Concrete pillar with a quasi-undressed finish, showing deterioration and damage

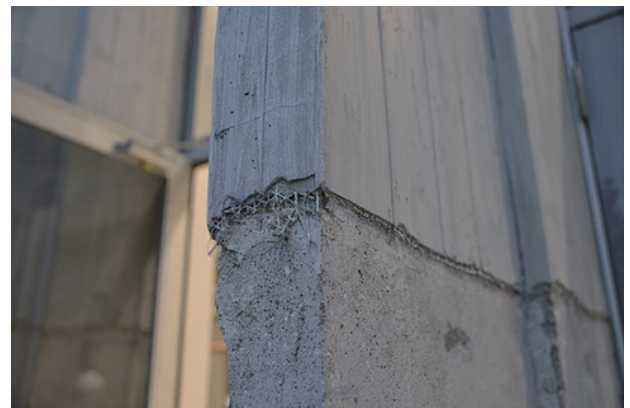
photo 6-4: Some of the finishing material was removed. (This view shows both the finishing material and the concrete underneath.)

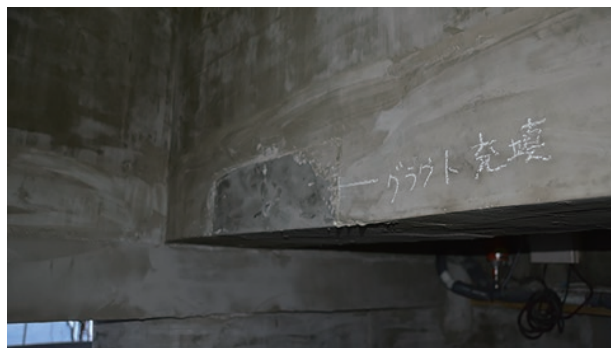
photo 6-6: Beam repaired by filling grout

Any deteriorated or damaged concrete within the areas to be finished using the quasi-undressed concrete technique were repaired by pouring concrete or filling with grout using a filling port (**photo 6-6**) if the deterioration or damage was extensive enough to warrant this, or by using the plastering method if the problem was not so extensive.

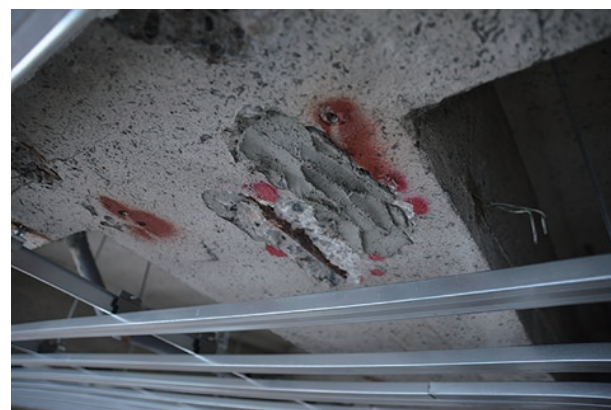
photo 6-7: Areas where repaired parts could be hidden using a finishing material were treated in such a way that the repaired area could be clearly identified

Some areas where the concrete was deteriorated and damaged to the extent that rebar was slightly exposed, and repaired portions that could be hidden later by the application of finishing material were repaired simply by applying a rust inhibitor (**photo 6-7**).

theless, some areas deemed to substantially affect the structural integrity of the building were repaired using a special rust inhibitor (DS-400: Taiheiyo Techno Corporation) designed for use with the Chipping Refrete system.

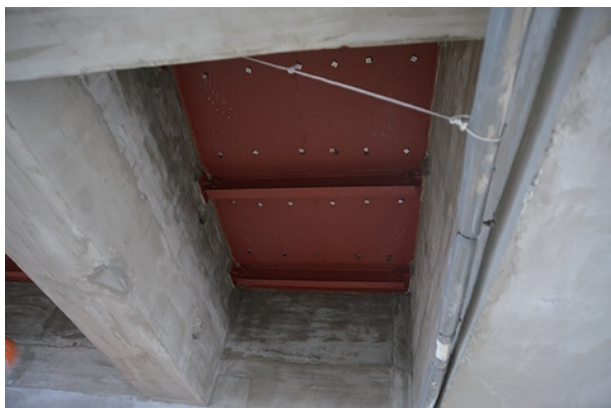
photo 6-8: The space between the steel plates and the existing concrete was filled with grout

The concrete in the lavatories was extensively deteriorated and damaged, and it also was not thick enough to assure structural integrity. These areas were repaired without the installation of new concrete, as follows: The original slab was left as is and was not removed; new steel plates were installed underneath that slab; and then grout was filled in the space between those steel plates and existing concrete (photo 6-8).

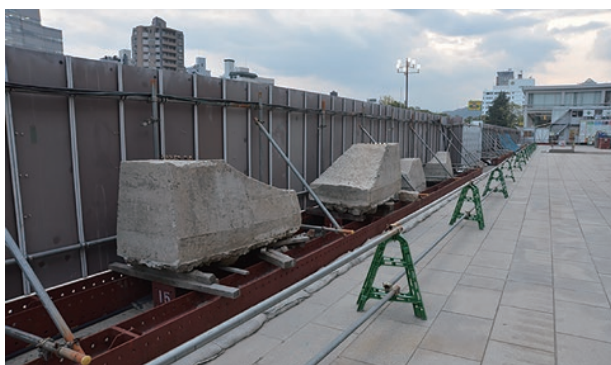
photo 6-9: The quadruple foundation elements were removed for underground preservation

It was originally planned that the quadruple foundation **photo 6-9** underneath the lower edge of the staircase would be removed and discarded following the installation of base-isolation devices. However, it was decided to conserve them by reburying them underground outside the base-isolation areas for safekeeping their technological and material value. **Table 6-4** shows the recording and preservation processes performed in dismantling the building's foundation.

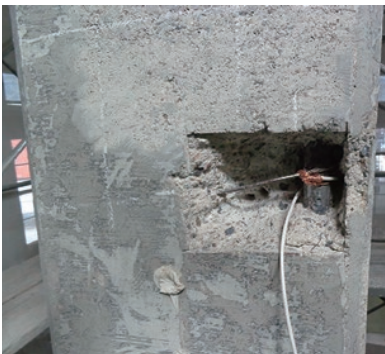
photo 7-1: Internal electrode set up inside the concrete (photo provided by : West Japan Railway Company)

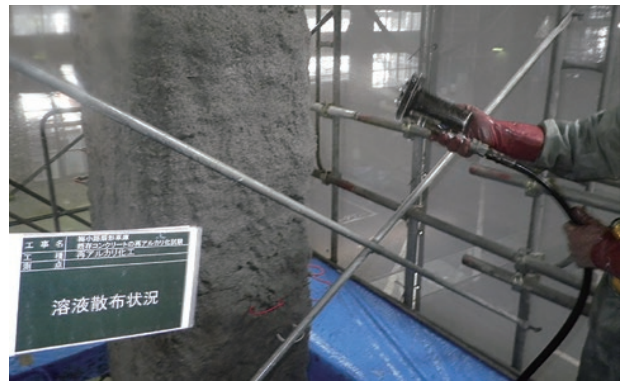
photo 7-4: Spraying on the electrolytic solution (photo provided by : West Japan Railway Company)

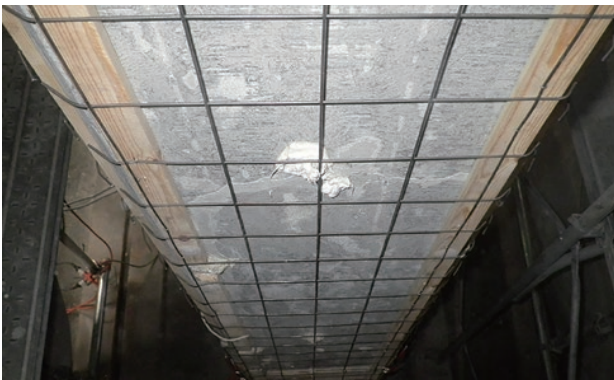
photo 7-2: Temporary anodes installed on the concrete surface (photo provided by : West Japan Railway Company)

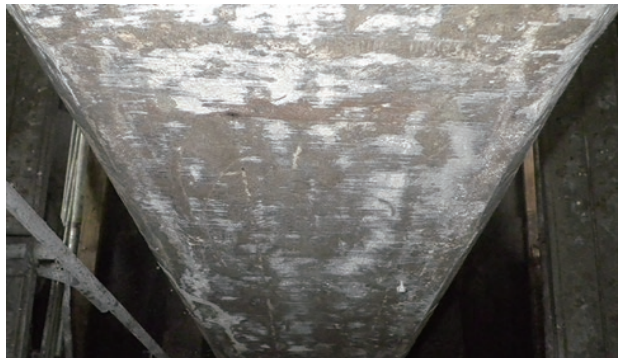
photo 7-5: Appearance after removal of the re-alkalization setup (photo provided by : West Japan Railway Company)

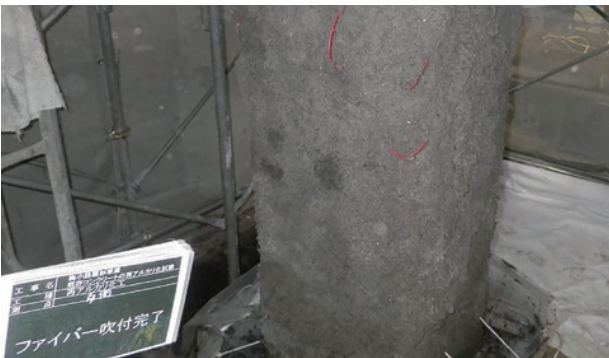
photo 7-3: Sprayed-on cellulose fibers (photo provided by : West Japan Railway Company)

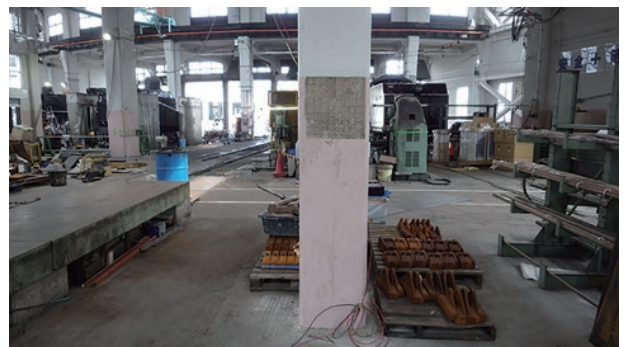
photo 7-6: Current appearance of a column undergoing re-alkalized in this project (photo provided by : West Japan Railway Company)

have been no big changes in average potential for some time, it can be concluded that the environment inside the concrete is being maintained in a non-corrosive state.

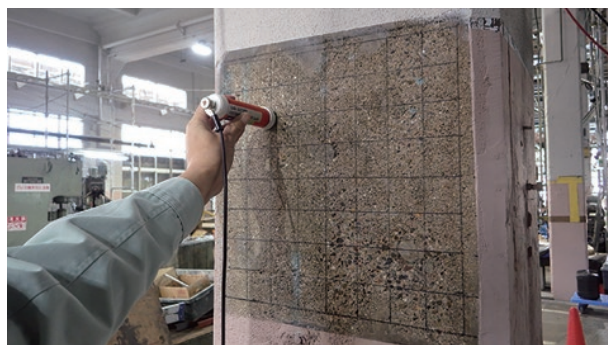
During the monitoring of the Umekoji Locomotive House project (**table 7-5**), the average potential values were -234 mV at 24 months after the end of re-alkalization and -239 mV at 36 months, meaning that the evaluation of rebar corrosion remained uncertain. The field restorer said that it is ideal for the average potential value to return to -200 mV or more positive; but, if the value levels off at around -230 mV, it is necessary to keep monitoring for changes in the corrosive environment in the concrete, using that value as the standard for comparison against later changes. It is now believed that, since there

photo 7-8: Spontaneous potential measurement (photo provided by : West Japan Railway Company)

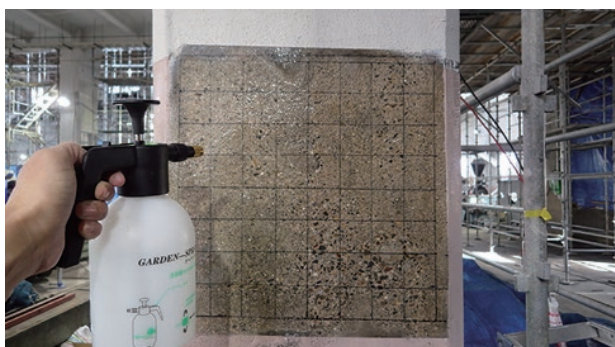
photo 7-7: Water being sprayed before monitoring (photo provided by : West Japan Railway Company)

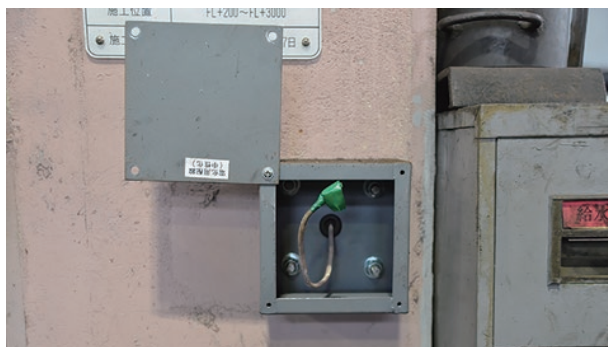
photo 7-9: Wiring for the internal electrodes left for monitoring purposes
