Conservation and Restoration of Internal Features

Tokyo National Research Institute for Cultural Properties
Center for Conservation Science, Restoration Techniques Section

Foreward	Saito Takamasa	3
Introduction	Nakayama Shunsuke	5
Chapter1 Conservation and restoration of internal features in the Bank of Iwate (Former Morioka Bank) Main Office Main Building	Tsumura Yasunori	9
Chapter2 Restoration lighting historic house	Fukuda Kazuya	33
Chapter3 Painting repair of graining in Meiji-mura - Case study of restoration of No.25, Nagasaki Foreign Settlement -	Matsushita Michio	75
Chapter4 Case study of conservation and restoration of internal features	Nakayama Shunsuke	89

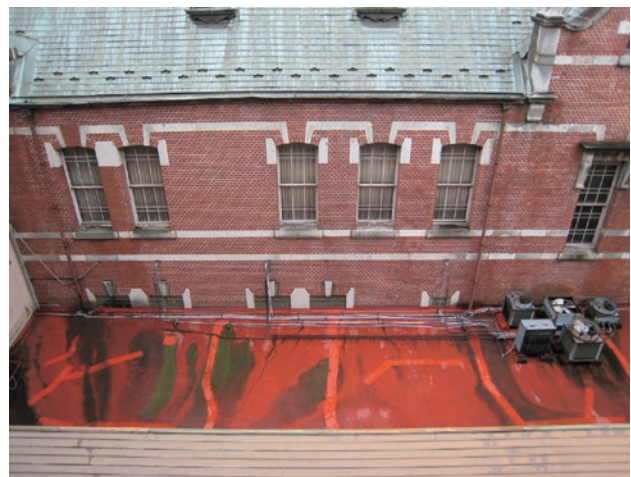
photo 5 North outer wall before conservation (photographed in 2008)

exterior wall finish (**photos 5 and 6**). In addition, the brick wall of the partition between the civic gallery on the first floor and the west side public space and the brick wall of the former general meeting room on the second floor, which was lost due to remodeling in later generations, were restored to their old states as structural reinforcement (**photo 7**).

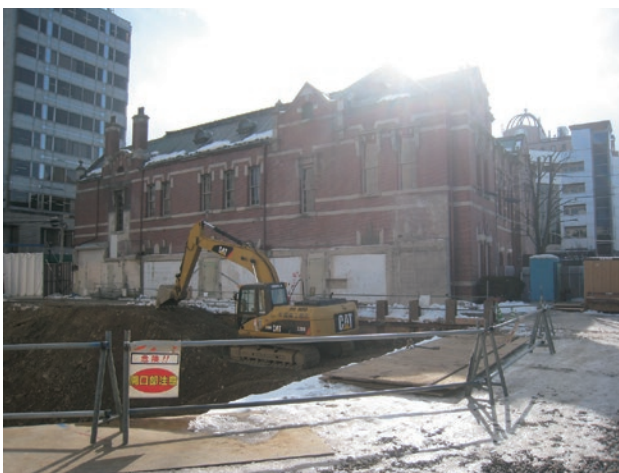
photo 6 North outer wall before conservation (photographed in 2012)

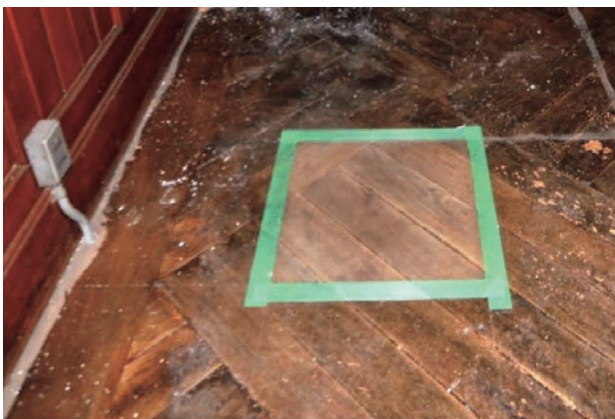
When the finished tile carpet of the branch manager's room (former second reception room) was peeled off, the zelkova parquet was exposed (**photo 12**). As there is no historical material and no trace of replacement when observed from below the floor, it was judged to be the original floorboard. Before the restoration, the adhesive on the tile carpet was removed, after which a disc sander was swept along the direction of the flooring, carefully roughened and polished; the nail holes were filled with wood repair putty. Subsequently, undercoating and intermediate coating were added with urethane resin

photo 12 Branch manager's room (former second reception room) parquet floor

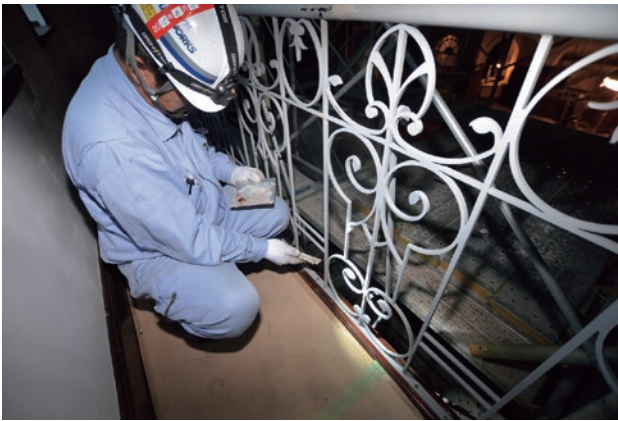
photo 31 Handrail installation

Both the southeast and east corridors were brought to the site after being painted in the factory to prevent rusting (**photos 30 and 31**). The support material for the eastern corridor handrail was installed in advance, and a 20 mm wire was inserted into the joint between the cross rails to penetrate the handrail and fix it. For the joint part of the handrail, a receiving round pipe, which is smaller than the round pipe of the handrail, was installed to fix both handrails. The support material and the gallery were carefully fixed with hexagonal nuts after inserting all the screws, and the joint part was puttied to complete the installation. Finally, synthetic oil paint was applied, with a Munsell value of 2.5G3/4,

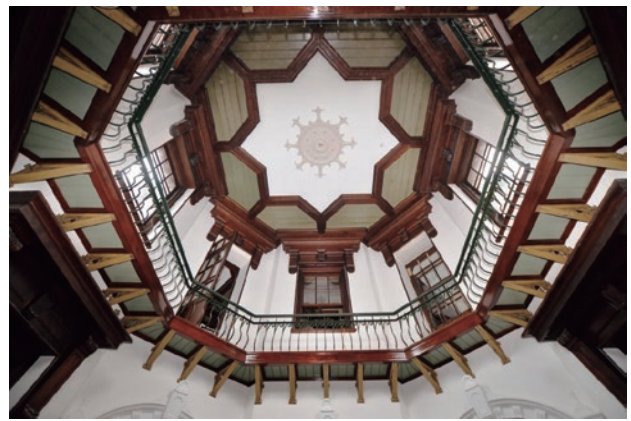
photo 32 Octagonal tower handrail completed

following the dark green color of the lowest layer of the remaining material (**photo 32**).

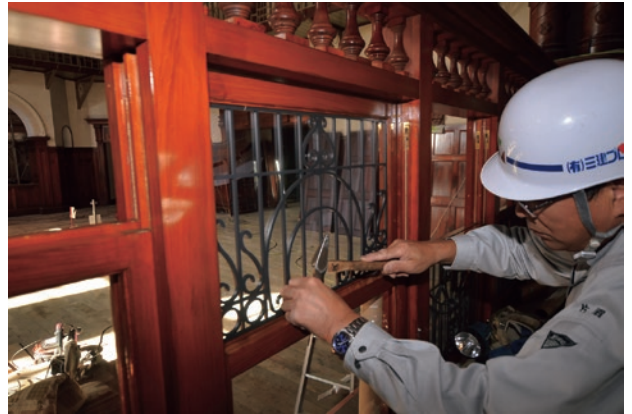
photo 36 Screen hardware factory inspection

photo 37 Screen hardware laser cutter processing

photo 38 Screen frame mounting

photo 39 Screen hardware installation

photo 40 Counter remaining parts

Both the wooden decorative sections and the screens that could be raised and lowered, which had been above the counters in the southeast and east public spaces and the southeast public space but had been lost, were restored (**photos 36-40**). After removing the buried wood on the top plate and the artificial stone polishing finish that were buried in the support position of the original support, the support was fixed to the top plate, the pulley was attached to the mullion, and the joinery frame was painted in advance. Subsequently, the fittings

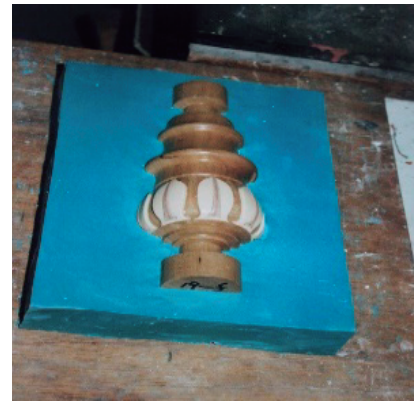
photo 53 Ornamental railing top at the bottom of the main body

photo 54 Central pipe dressing

photo 55 Central pipe dressing

As the prototype of the wooden pattern is accurately expressed as is, the wooden pattern was inspected individually (**photos 53–55**). Notably, the dimensions of the prototype and the finished casting will serve as shrinkage of the prototype by approximately 7/1000. The casting mold factory has a ruler such as a casting scale, which measures it. Depending on the shape of each part, there are those that process a plate-like object and make it into a drawing metal fitting, those that lathing and hammering to add texture, and those that use sand, bow, sandpaper, etc., to make the best use of the surface of the casting.

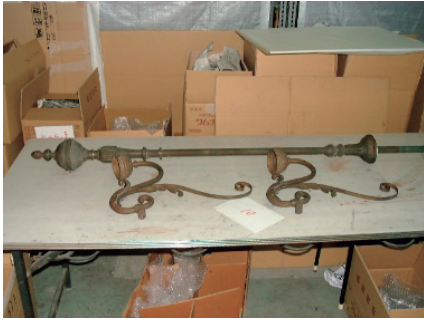
photo app.1-34 Checking for missing parts

Restorations and manufacturing were conducted for the uneven glass decorations, the replacement of all bead joints with copper pins, insufficient decorative glass, the production of missing octagonal diamond type parts, and glass globes. The cracked metal pipes, that act as the support of the instrument, were welded and repaired. During the era the original product was manufactured in, the flat plates were still made into

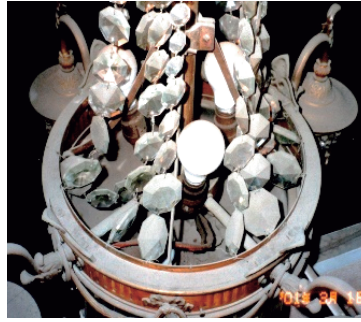
photo app.1-35 Glass condition

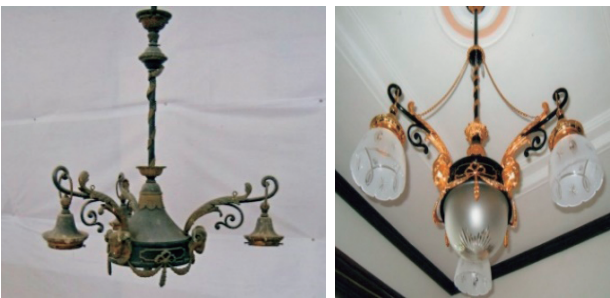
photo app.1-43 Reading room on the 2nd floor, before and after repair

Some of the fixtures had been removed, and some had missing parts, but they were not irreparable.

To return them to their original state, we removed and disassembled them, checked their parts, and removed all dirt and rust.

- * Metal coloring: A dyeing method in which the metal pattern is colored with chemicals on copper or its alloy
- * Electroplating method: Electroplating (pure gold plating)
- * Black coloring on the surface of pure gold-plated finish
- * Shade (glass globe) is made by imitating what remained of the original

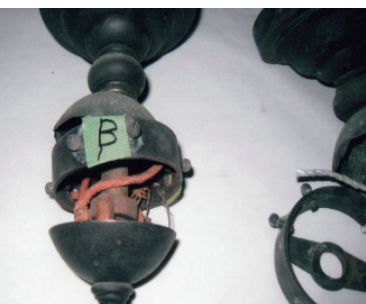
photo app.1-59 Corrosion

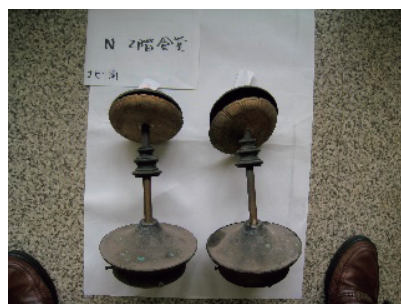
photo app.1-60 Corrosion

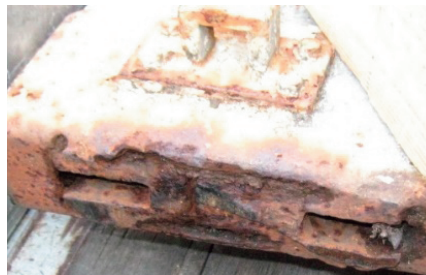
photo app.2-2 Corrosion of rail

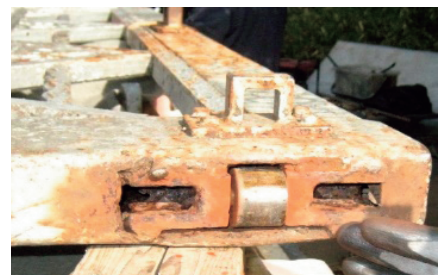
photo app.2-3 Corrosion of rail support

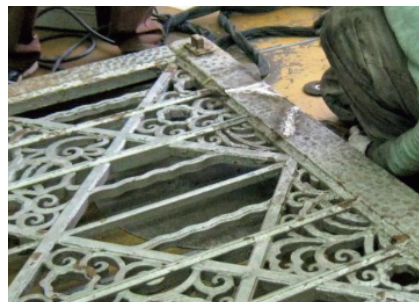
photo app.2-5 Cracks

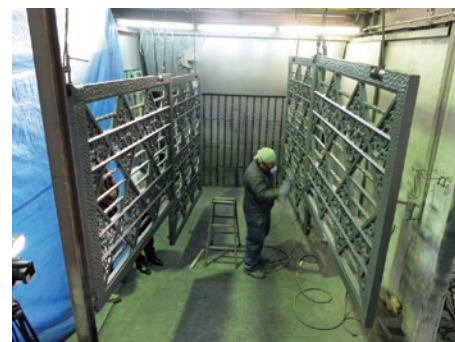
photo app.2-8 Repair work

be rusted when the gate was opened and closed. It was in a state where it could not serve as the sheaves. There was a crack in the pattern and support parts of the main body, so it was removed from the gate pillar and repaired. The cracked part was widened, and the mouth was closed with a stainless steel welding rod. The sheaves was restored in accordance with the design of the original one. A zinc metallikon finish was sprayed over it.

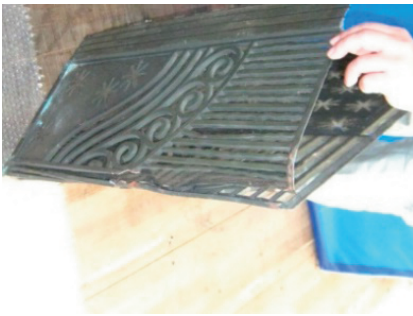
Repairs of the radiator cover, made by the copper electroforming method, were made. The cover was bent and was stored in the warehouse. It was folded in two, and the front surface was damaged. The frame and

photo app.2-9 Damaged front cover

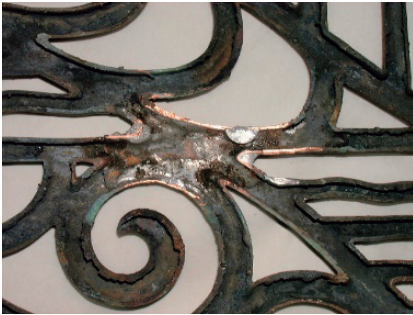
photo app.2-12 Damaged pattern

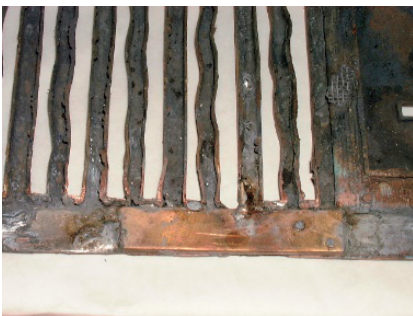
photo app.2-15 Back refill metal fitting welding

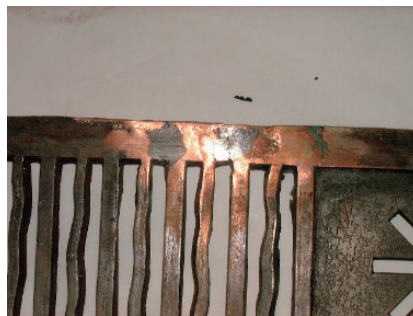
photo app.2-16 Damaged frame attachment

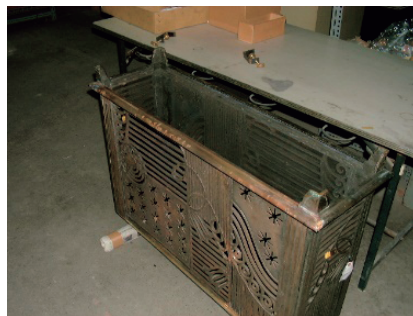
photo app.2-19 Frame welding completed

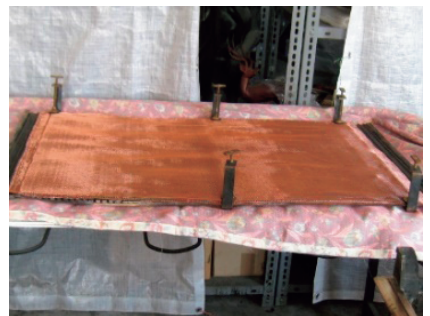
photo app.2-20 Wire mesh welding

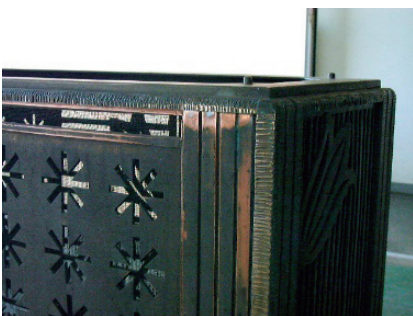
photo app.2-21 Damaged frame casting molding

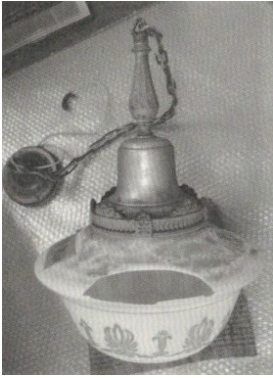
photo app.2-37 Pendant glass that was stored in the warehouse as a residual material while being damaged

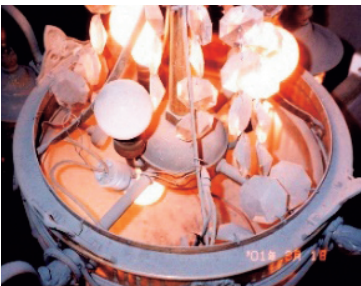
photo app.2-45 Defective beads

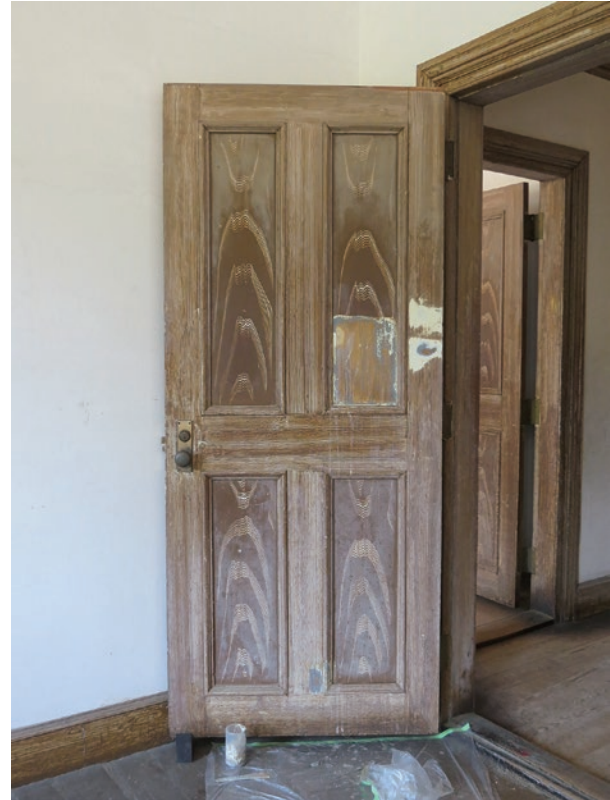
We conducted both a scraping survey and peeling survey on the doors, joinery frames, and baseboards inside and outside the building and confirmed the bottom graining coating film in various places. Various sandpapers were used for the coating film scraping investigation and Neorever, manufactured by Sansaikako Co., Ltd., was used for the chemical peeling investigation. We used both these together to peel off the existing coating film, layer by layer (**photo 3**). However, the investigation was extremely difficult because the coating film surface of each layer was uneven, and the ambient temperature and humidity subtly affected the impact of the release agent. Therefore, we obtained limited information, and the number of finishing layers remaining in various parts of the interior was not uniform. We also found it difficult to accurately calculate the number of times the paint has been repainted.

photo 3 Main building No. 4 room door peeling investigation status

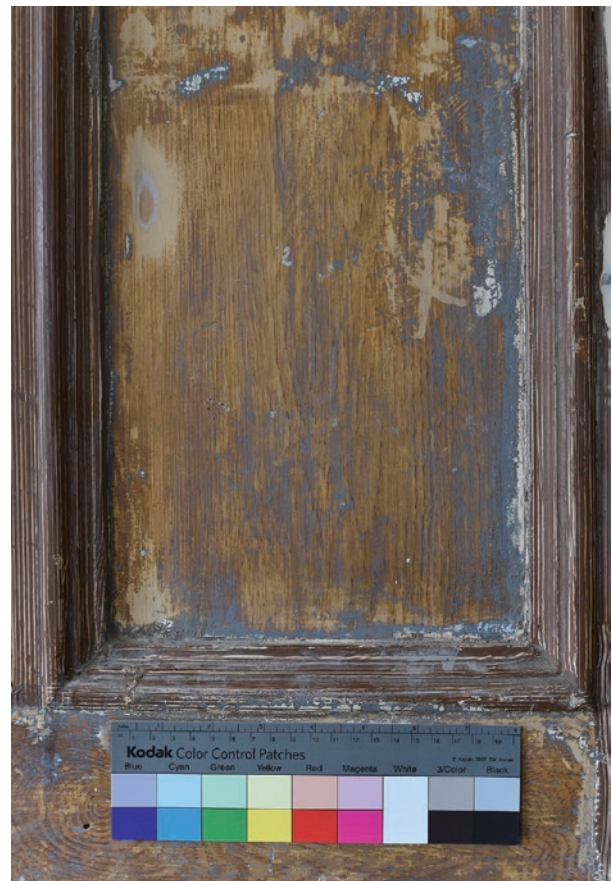
ed on the panel board of each door, and eyeball figured grain was used for the figured grain. We can also see the basic regularity of the door stiles, door and window frames, picture frames, skirts, etc., which are coated with fine grain (photos 5–7). However, as seen in the annex building, fine, straight lines similar to baseboards were drawn on the panel boards of the doors. Thus, there was a clear difference between the main building and the annex regarding the depiction and classification of the figured grain in the various parts of the doors.

photo 6 Bottom graining-bamboo figured grain (Main building No. 4 room door endplate)

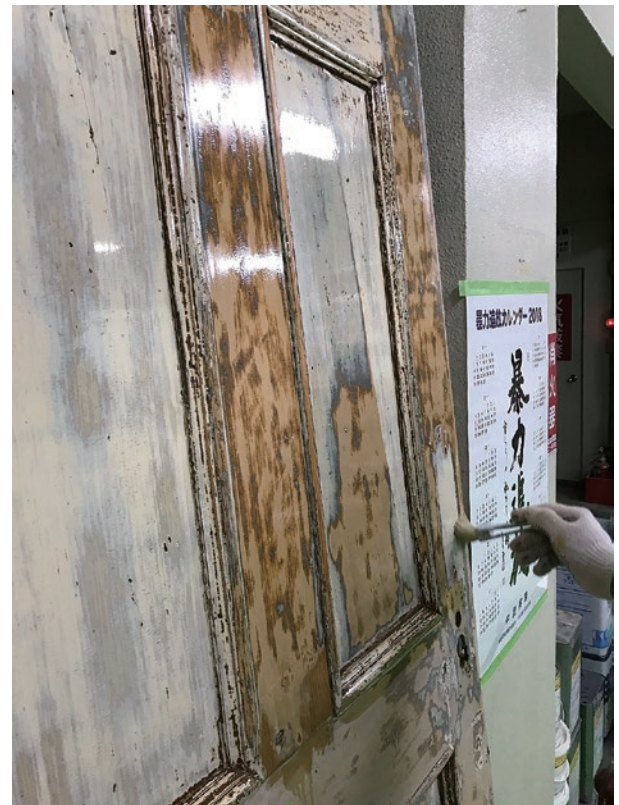
photo 15 Graining process ②③ sealer coating and undercoating

Taking the graining of the main building door where medium figured grain is painted on the panel board as an example, the main points of the painting process are summarized as follows (**photos 14–26**): (1) sander scraping; (2) base material adjustment by keeping put-

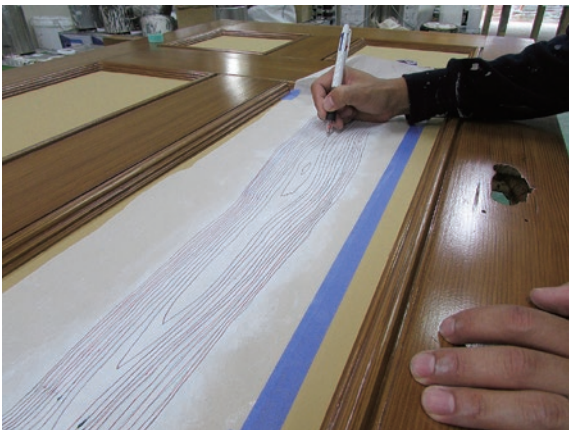
photo 18 Graining process (medium figured grain) ⑥ -1 panel board medium figured grain marking

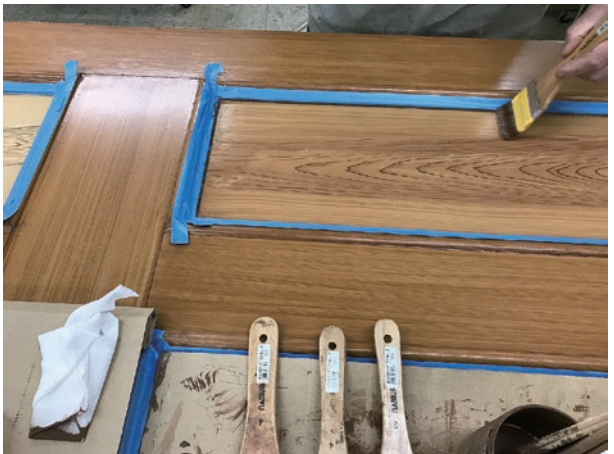
photo 22 Graining process (medium figured grain) ⑥ -5 panel board straight grain brush pulling

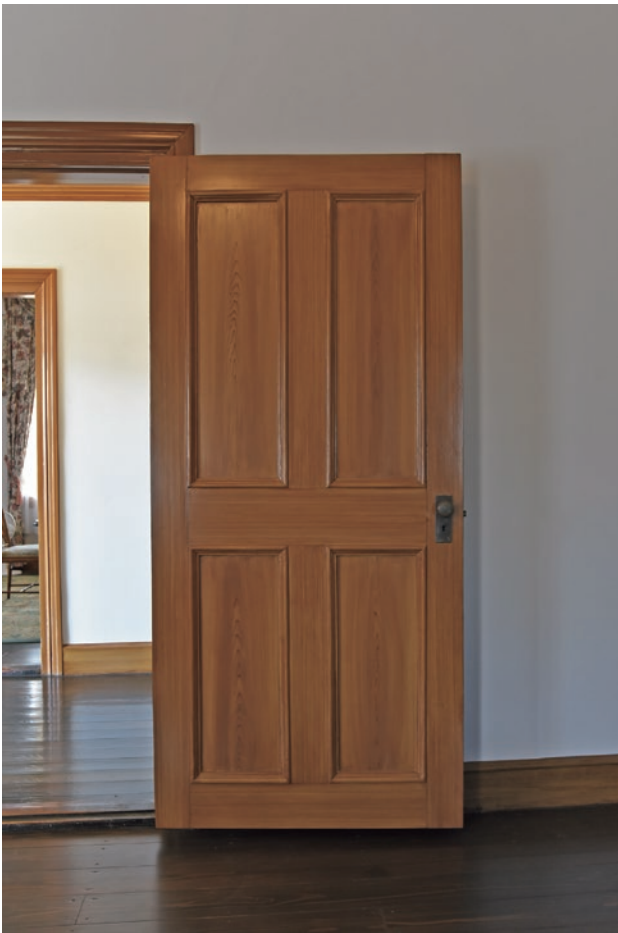
photo 30 Graining completed - door

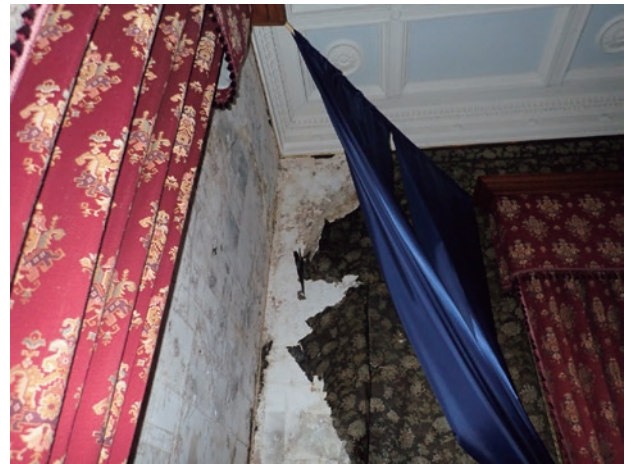
As a result of a survey conducted before the preservation and restoration work carried out from 1984 to 1987, about half of the wallpaper of the Honored Guest Room on the second floor had been replaced or repaired. As for the conference room, the east side was completely replaced. Regarding the wallpaper, it was confirmed that it was Gold-embossed wallpaper "Kinkara-kawashi" ^{*1} during the preliminary investigation work, and the manufacturing method is also being investigated. This time, we conducted a paint analysis and confirmed it during the production. Regarding the Honored Guest Room, we created woodblocks based on the current wallpaper, renewed the wallpaper, and partially restored it. In the situation where the water leakage did not stop after that, the deterioration of the wallpaper did not stop even after the previous repair, and the peeling was progressing newly.

photo Wallpaper that is currently peeling off

Regarding the conference room, the east side that had been replaced was once removed and then reattached.

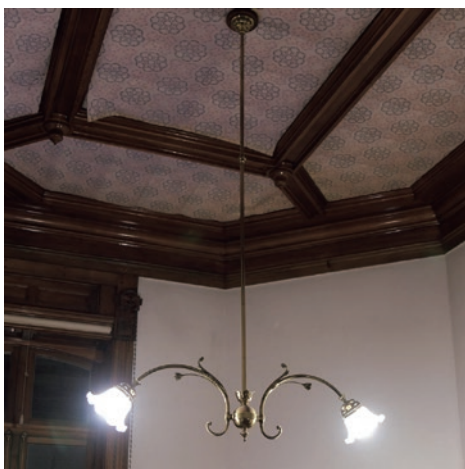
photo Lighting equipments in the branch manager's room (restored based on old photographs; the same applies to the first reception room)

The 2nd floor dining room, 1st floor branch manager's room, 1st reception room, salesroom, and other missing parts were estimated and maintained from photographs and traces of the site.

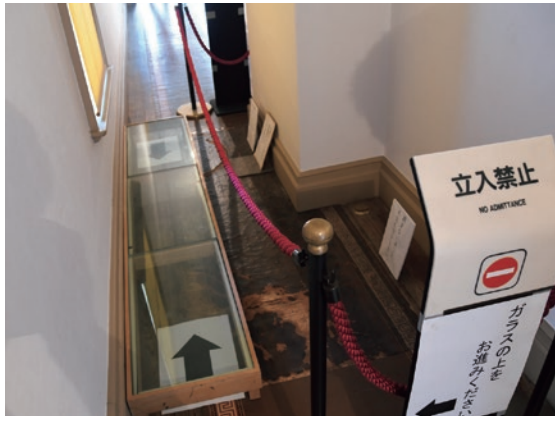
photo The original linoleum floor that remains in the corridor of the north wing of the chamber

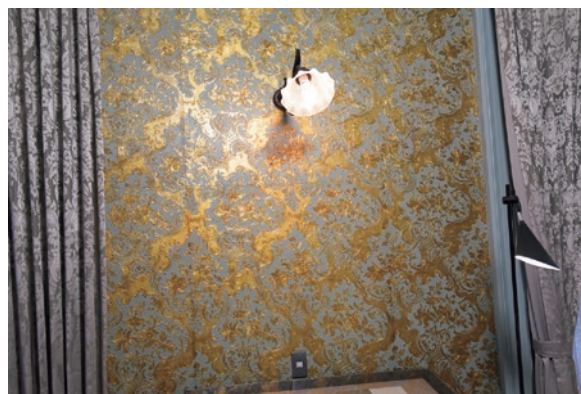
photo Restored wallpaper of the small guest room (southeast room) on the 2nd floor

Therefore, the confirmed woodblock roll is used for the restoration of Gold-embossed wallpaper "Kinkara-kawashi" *1. In the southeastern room, the woodblock rolls used for restoration are on display.

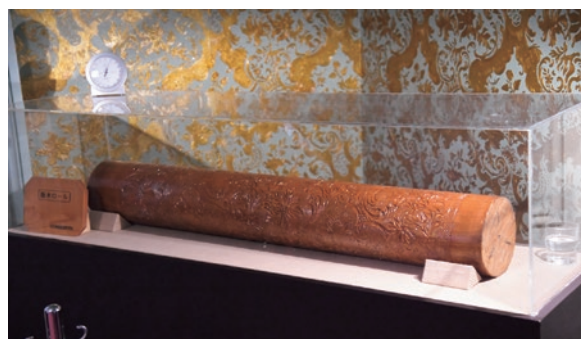
photo Woodblock rolls exhibited in the small guest room on the 2nd floor

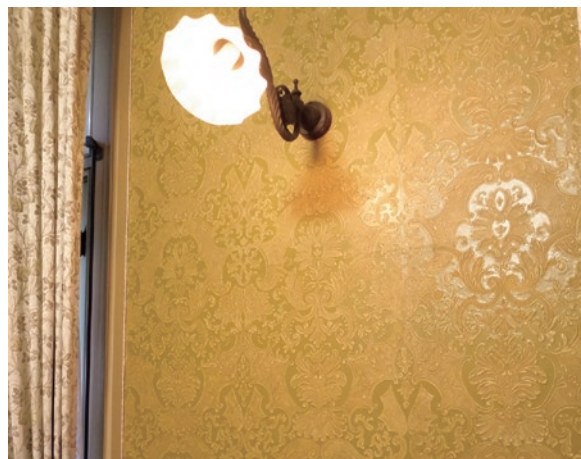
photo Restored Gold-embossed wallpaper "Kinkara-kawashi" *1 in bedroom 1 (northeast room) on the 2nd floor

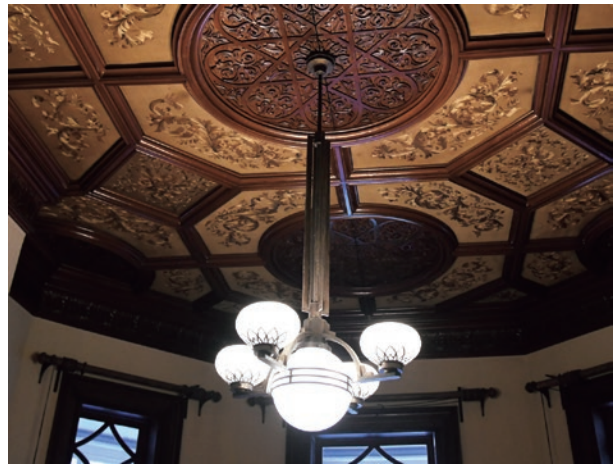
photo Original pendant light in the lady's guest room on the 1st floor

Many of the lighting equipment still exist, and they are removed, cleaned, repaired, and reused.

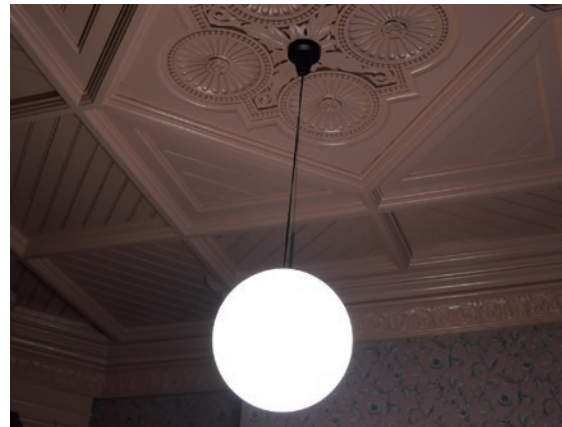
photo Commercial pendant light in the arge guest room on the 2nd floor

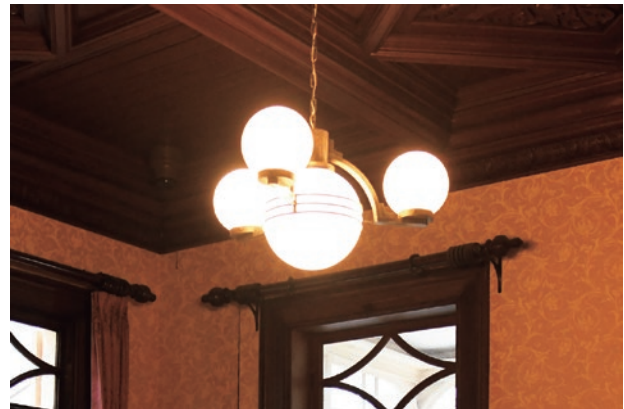
photo Original pendant light in the guest room on the 1st floor

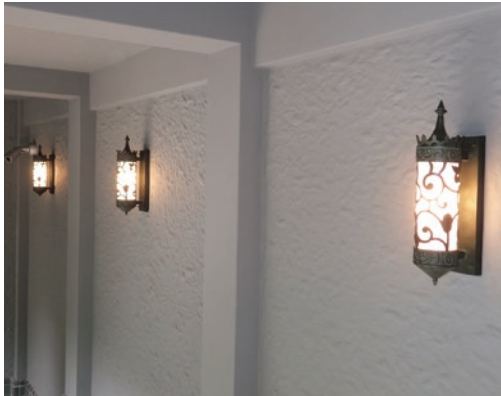
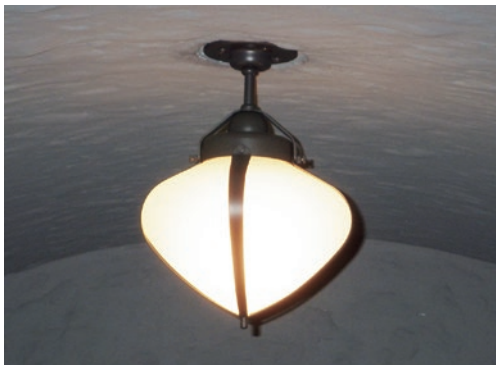
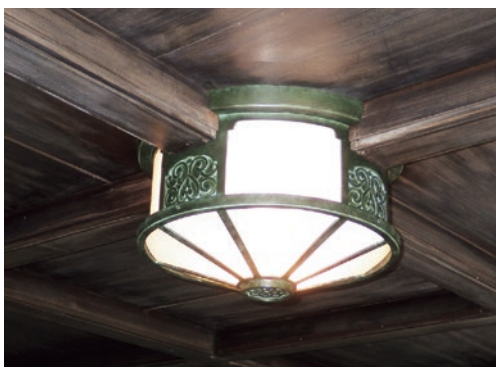
photo Restored brackets in the corridor

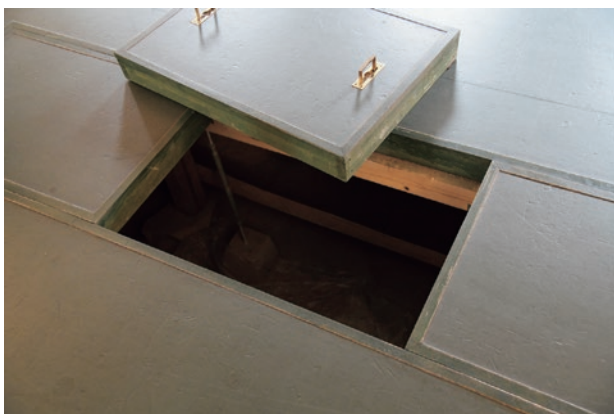
photo Underfloor space, Air-conditioning facilities and others are concentrated here

Toilet and air-conditioning equipment were pointed out in the building utilization questionnaire distributed prior to the preservation and restoration work that started in 2004. The toilet was installed in the newly constructed annex building right next to Kaikosha. However, regarding the air-conditioning equipment, the investigation and maintenance committee established in advance considered a plan to install floor equipment in the hall and air-conditioning equipment in the annex building and place ducts in the same way as toilets. However, considering convenience and economy when using it, air-conditioning equipment space is created under the floor of the hall; the equipment added is devised so that it is not conspicuous by installing it there and providing an outlet near the wall of the floor.

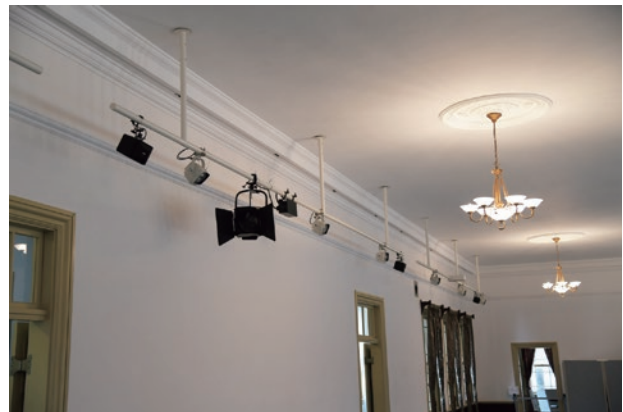
photo Baton installed on both sides of the ceiling wall of the hall, Additional lighting equipment, fire alarms, speakers, etc., are installed on this baton

- Sufficient illumination cannot be secured with the chandelier alone, depending on the usage conditions (meetings, exhibitions, etc.). Therefore, after discussions with the Agency for Cultural Affairs, a fixed baton was installed on the ceiling near the north and south walls, and a spotlight was placed there. The baton is also equipped with emergency lighting equipment, flame detectors, speakers, and security sensors.
