大般若経厨子

平成11年度修復事業

品名：大般若経厨子

所蔵：クリーブランド美術館 アメリカ合衆国

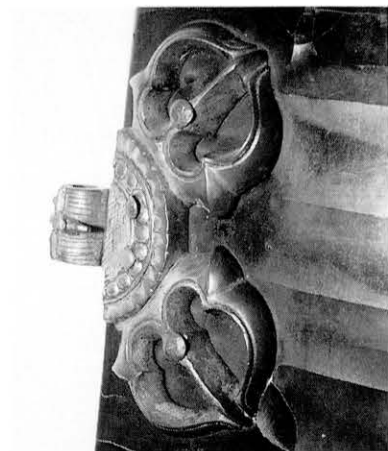
軸部 円筒形屋蓋に接合されていて、縦方向に木目の通った材を数材矧、円弧に削り、穏やかな膨らみを持った形に造る。このような形は平安時代にみられる経塚出土の円筒形の経筒の類似品と思われる。背面の材を柄として、基部に差し込み固定させる。正面は各々縦に三材矧（または数柄）を円弧に削る。各扉の上下四か所に金銅製の羯磨形螺番^{附2}（図34）を打つ。螺番は当初のものと思われるが、右下金具の扉側と左上金具に一部分欠損があり、金具の欠損部に釘が残っている。

図34 羯磨形蝶番
Katsuma-shaped metal fitting

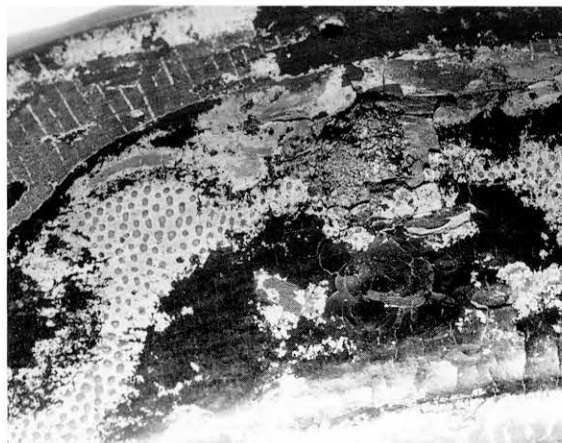
天蓋 素地の矧目に沿って布着せして補強してあった所が割れ、花形の一部分が欠失している。当初は花卉数ヶ所に鉄釘を打ち、それに紐を結び、屋蓋内側から釣り下げていたと思われる、錆びた鉄釘が残っている（図45）また裏面に天蓋を屋蓋に取り付けるために後補鉄製のボルトが取り付けられている（図44）。

図45 天蓋をとり付ける鉄釘
Iron nail used to attach the ornamental canopy

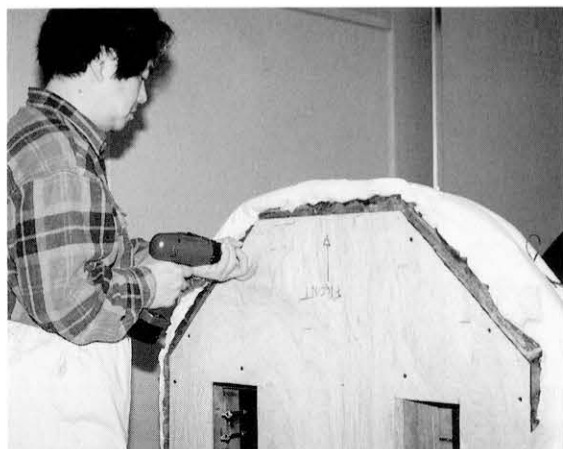
- (1) 修理は日本の国指定文化財に適応される現状保存修復の原則に基づいて行うが、返却時の空輸の衝撃に耐え得る構造上の強度と、同館が文化財のために適切な温湿度条件を保っているものの、日本よりも乾燥する地域である事を考慮して、それに耐え得る構造上の補強を行うこととした。このため、一旦解体し、強度上弱っている所は十分に補強する。解体時に横倒して底に貼られている合板を外した(図49)ところ、全重量を支える井桁部分が永年の湿気の浸透と虫蝕によって、重量を支えるに耐えない状態となっていたため、新しい部材と取り替え、古い材はそのまま返却、保存する事とする。基部の蓮華座を成す框も相当な虫蝕があり、一部空洞化している箇所もあるが、外形の蓮華座のオリジナルな形を残して、適切な方法で補強する。
- (2) 蓮華座 天蓋の花先の欠損箇所の形状復元は行わない。
軸部、扉、内側に描かれた絵画彩色は安定しているので原則的に修理しないが、漆塗膜の欠損、亀裂等で剥落の進行する恐れのある所は適切な方法で剥落止めを行う。
- (3) 金具の欠損は新しく補わない。
- (4) 現在天蓋を取り付けている金属のボルトナットに代わる適切な取り付け方法があれば検討する(図50)。
- (5) 現在取り外す事が出来る宝珠は(奈良国立博物館所蔵の厨子は屋蓋に固定されている)運搬時の便宜上、現状通りの取り外し式とする。

図49 解体のため底部合板を外す
Taking off the plywood board in disassembly

(9) 基部、底から見た解体前の状態。(図49)

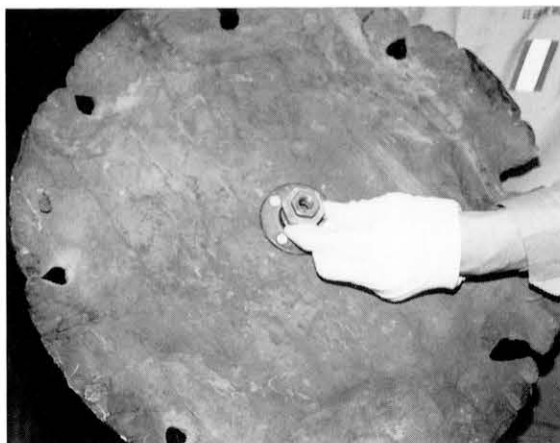
図50 天蓋を取り付ける金属ボルトナット
Metal bolt and nut used to attach the ornamental canopy

この取り付け方法についてはいろいろと検討した結果、現行の方法が取り付けの簡便さ、安定性で最良のため、現在使用されている金具に、漆塗を施して周辺と調和するように仕上げる。(図50)

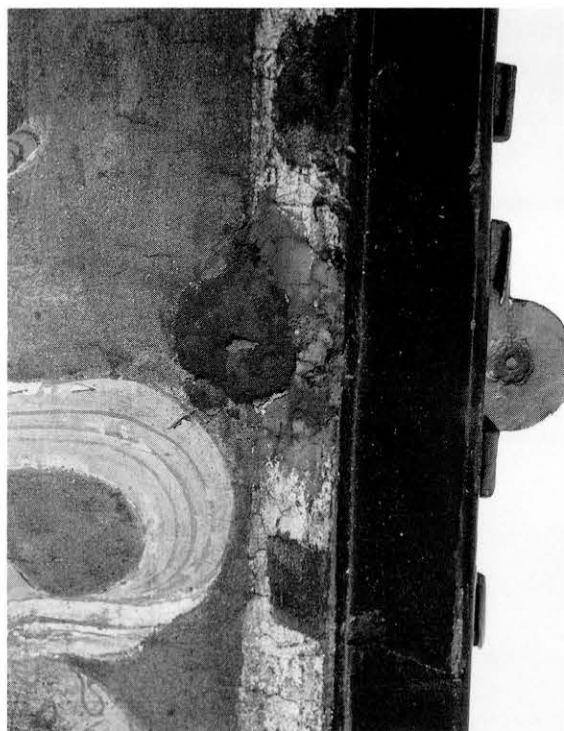
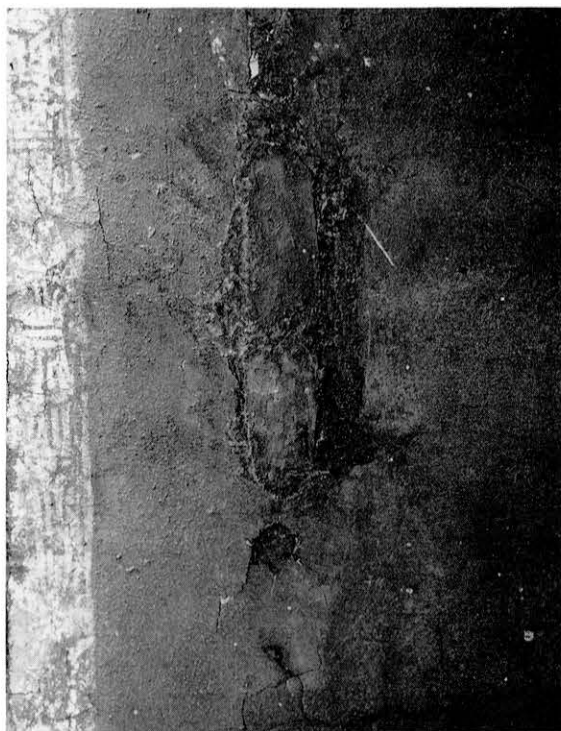
図55 扉の彩色部分と金具回りの破損修復後

Polychroming on the doors and damage to the area around the metal fitting (after restoration)

- (1) 厨子の移動 奈良国立博物館展示室から修理室へ。立合いクリーヴランド美術館 カニンガム氏、奈良国立博物館 梶谷氏、日通。(図53)
- (2) 宝珠 蓮華座の虫蝕状態。(図42)
- (3) 屋蓋 素地の破損と塗膜の破損。(図54)
- (4) 厨子軸部の内面彩色部分の状態、上からの雨水によるとと思われる種字の彩色の汚れ。(図37)
- (5) 扉、彩色部分と金具回りの破損。(図55-1)
- (6) 天蓋の彩色と汚れと変色 (図41)、素地の破損。

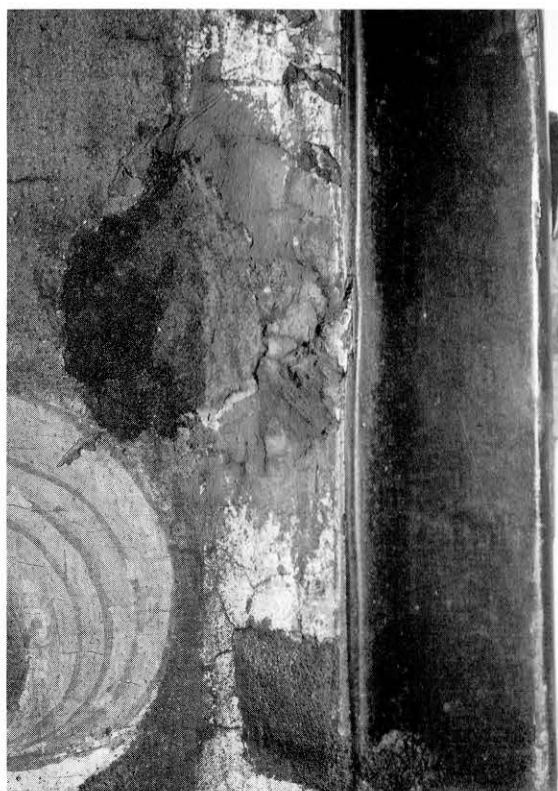
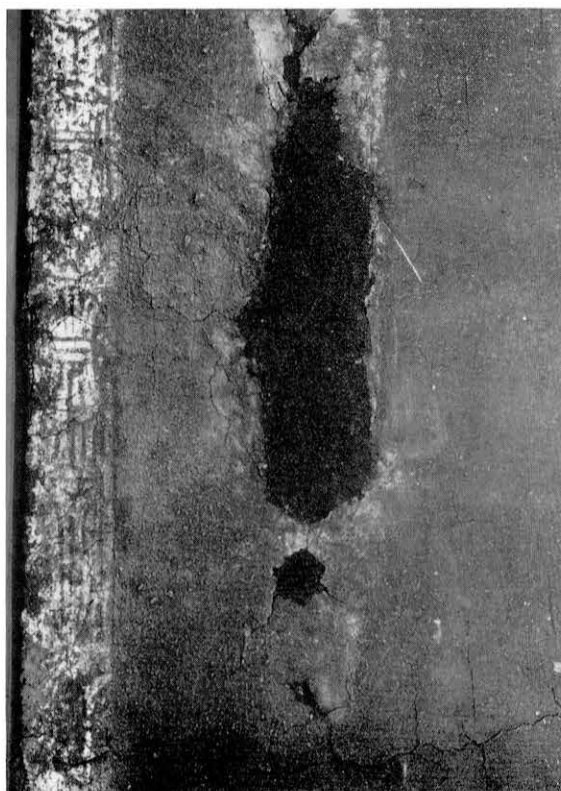
図56 同修復前

Polychroming on the doors and damage to the area around the metal fitting (before restoration)

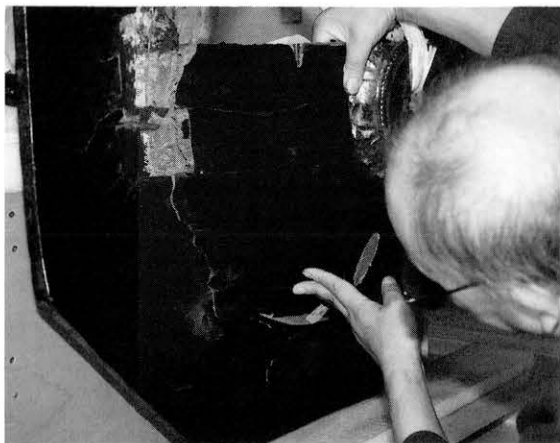
図65 屋蓋の塗膜の剝離解体作業
Removing the urushi coating on the roof

(3) 屋蓋の解体と塗膜の剥離作業。(図65)

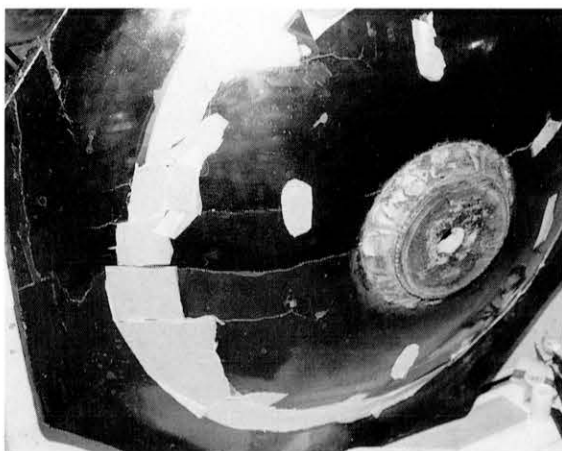
図63 屋蓋の解体の前に塗膜を養生する
Protection of the urushi coating of the roof before
disassembly

(1) 解体前に塗膜を養生する。(図63)

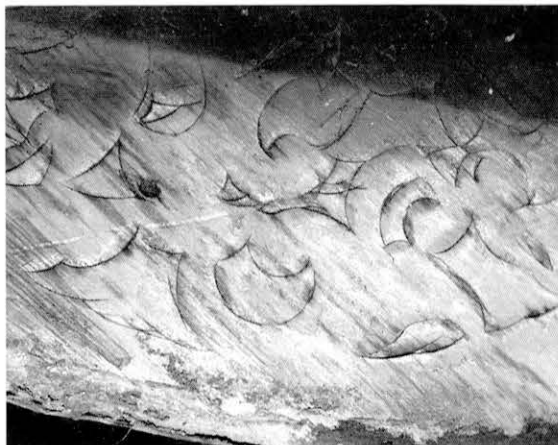
図71 ノミのたたき台として使用された屋蓋
Marks of chiseling on the wooden joint board

(10) ノミのたたき台として用いられた屋蓋板に挟み込まれた六枚の寄木板。(図71)

9. Deteriorated iron nails and clamps (Fig. 70)
10. Roof frame showing chisel marks and 6 pieces of wooden joint boards (Figs. 71)

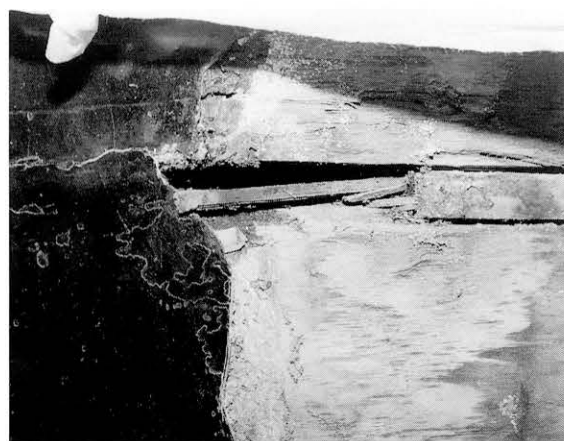
図69 空洞状の素地と隙間にはめ込まれた小木片
Hollowed substrate and wooden fragments in the opening

(7) 空洞状の素地と隙間にはめ込まれた小木片。(図69)

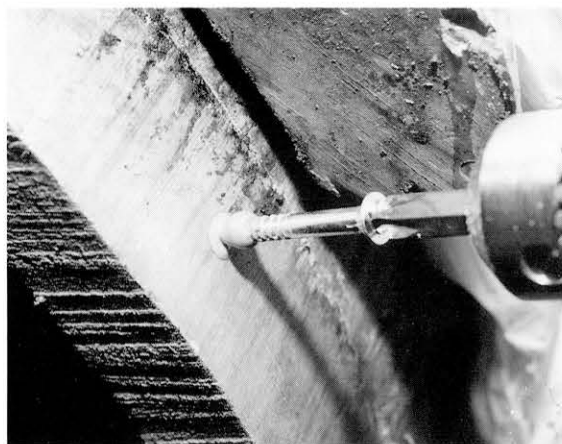
図80 真鍮製の木ネジ
Brass screw

- (2) 大きな欠損部は新しい檜材を木釘と麦漆で接合して補った。(図78、79)
- (3) 軸部と基部天板との間には大きな隙間があり、非常に不安定であるため、軸部の側面から基部板に真鍮製の木ネジ(図80)をねじ込んで支持し、その隙間に木片や木屎漆を充填して補強した。(図81、82)
- (4) 基部及び蓮華座の組み立て作業。(図83)
- (5) 基部の欠損部に木屎漆を充填する作業。(図84)
- (6) 基部の上段蓮華座の仰蓮の框の接合部分に打ち込んだ新しい鍔。(図85)
鍔の成分表(薬師寺金堂復元に用いられたものと同材質)(図86)
- (7) 取り外した虫蝕のある古い井桁と新しく檜材で作られた井桁(図88)、新しい井桁には元の井桁と同様に柄を作る。(図87)
- (8) 下段蓮華座(反花)の接合。(図89、90)
- (9) 下段蓮華座の框の底にも新しい鍔を打つ。
- (10) 井桁の組込み作業。(図91、92)

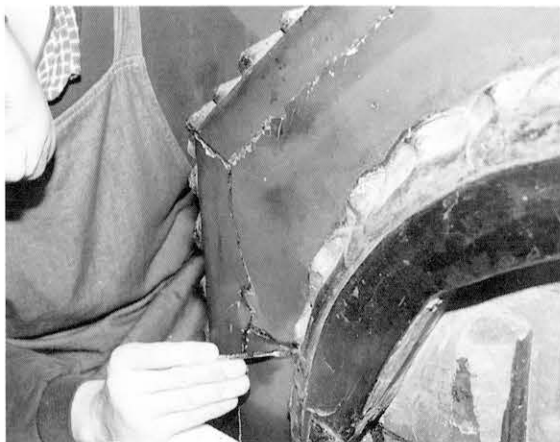
図84 基部の欠損部に木屑漆を充填
Filling *kokuso* to missing parts on the base

5. Filling the missing portions of the base with *kokuso* (Fig. 84)
6. A new clamp that was driven into the joined parts of the framework of the curving-up petals of the upper lotus pedestal of the base (Fig. 85); a table of components of the clamps (the same materials as in those clamps used for reconstructing the Golden Pavilion of Yakushiji Temple, Nara Pref.) (Fig. 86).
7. Old *igeta* with insect damage that was removed and a new replacement made of Japanese cypress (Fig. 88). Mortises were made on the new *igeta* members as on the old ones (Fig. 87).
8. Joining the curving-down petals of the lower lotus pedestal (Figs. 89 & 90)
9. Driving new clamps into the downside of the framework of the lower lotus pedestal
10. Building the *igeta* frame (Figs. 91 & 92)

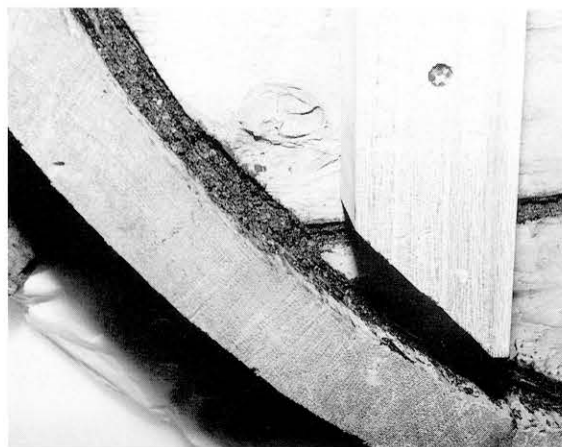
図82 木屑漆を充填
Filling *kokuso* to the base

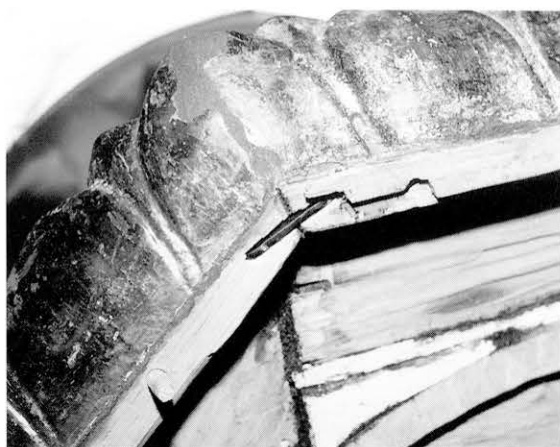
図85 上段蓮華座の接合部に新しい鉋を打つ
Placing an iron clamp to the upper lotus pedestal

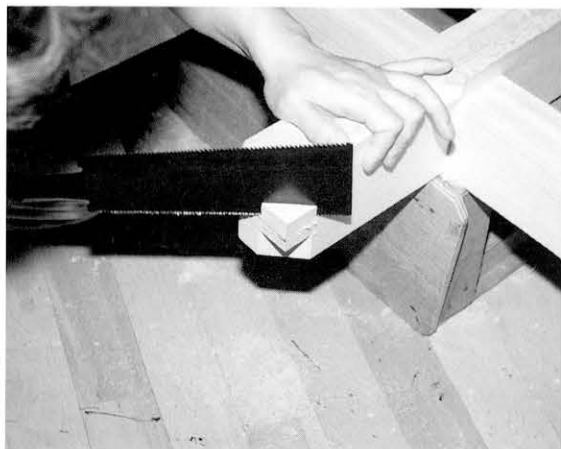
図87 枘の作成
Making a mortise on the new *igeta*

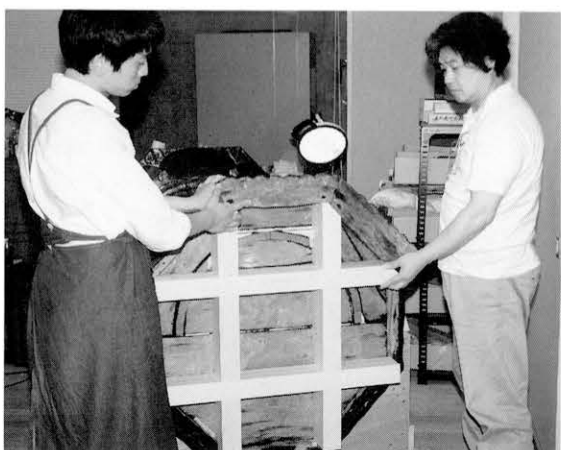
図91 新調した井桁の仮組み作業
Assembling new *igeta* into the base

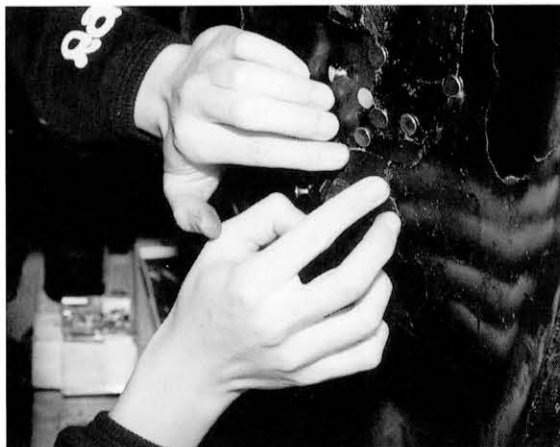
図95 剝離した塗膜を麦漆で貼りつける
Re-fixing exfoliated coating film

- (1) 解体した屋蓋を元の位置に麦漆と木釘を打って接合した。接合方法としてまず各部材に麦漆をつけ貼り付けた後に木ネジで数箇所を締め付ける(図93)。麦漆が乾いて接着した後に木ネジを抜きその穴に麦漆を入れウツギの木釘を打ち込んだ。(図94)
- (2) 剥離した塗膜を元の位置に麦漆で貼り付けた。(図95)
- (3) 貼り付けた塗膜の隙間に漆下地を付けた。(図96)
- (4) 漆下地が付けられた屋蓋。
- (5) 屋蓋の修復部分に漆を塗る。(図97)
- (6) 修復された屋蓋全体。(図98)
- (7) 修復された屋蓋部分。(図99)
- (8) 扉の漆塗膜の亀裂。(図100)
- (9) 大きな亀裂の欠損部分には木屎漆を充填、漆下地、漆塗を行う。また細かい塗膜の割れ目には生漆を浸透させ補強する。(図101)
- (10) 修復された扉。(図102)
- (11) 扉内面の蝶番金具足の周辺の漆塗膜の欠損部分に木屎漆を充填し補強する。
- (12) 木屎漆の色の黒さを和らげるためにダイヤモンド リューターで木屎漆の表面を研磨する。(図103)
- (13) 基部蓮華座の花先を保護するための拭漆をした檜材の置台を組み込む。この置台は、底面2ヶ所に木ネジで井桁に装着し、取り外す事ができる。
- (14) 修復された基部蓮華座と置台との状態、厨子の全重量は新しく組み込まれた井桁に掛かるようにし、空輪時に蓮華座に負担が掛からないように置台より少し浮かしてある。(図104)
- (15) 修復された基部 上面。(図105-1)
- (16) 修復された軸内十六華蓮華座円盤 表 裏 部分。(図59-2)

2. Pieces of peeled-off urushi coating were re-fixed to the original positions with *mugi urushi* (Fig. 95).
3. Urushi foundation was applied to the openings between the coating film (Fig. 96).

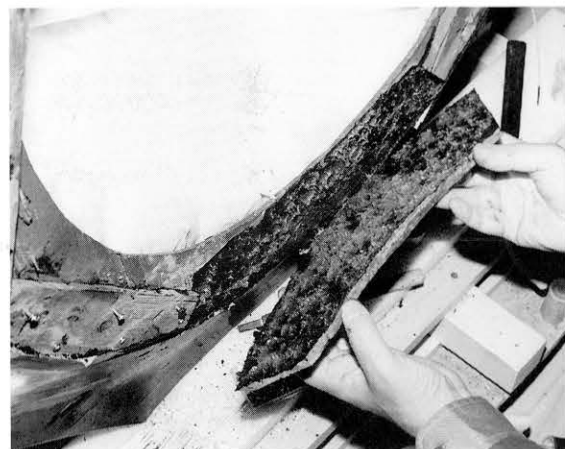
図93 麦漆で貼り付け木ネジで締めつける
Using *mugi-urushi* and screws for fixing

1. The disassembled roof was reassembled as before with *mugi urushi*, wooden nails and brass screws (Fig. 93). After the *mugi urushi* had hardened, the wooden nails were pulled out and *mugi urushi* was filled into the holes; wooden pegs made of deutzia were driven in (Fig. 94).

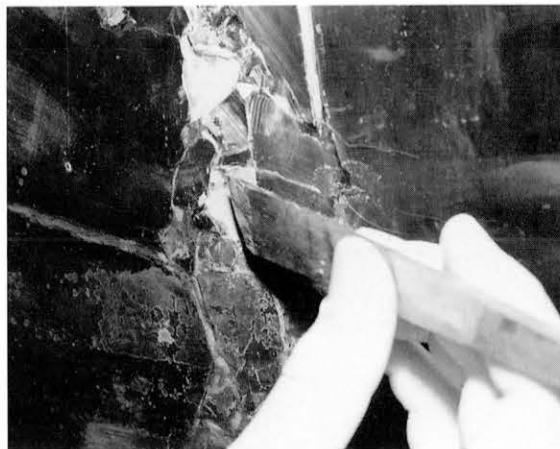
図96 貼り直した塗膜の隙間に漆下地を施す
Filling *urushi* foundation into openings

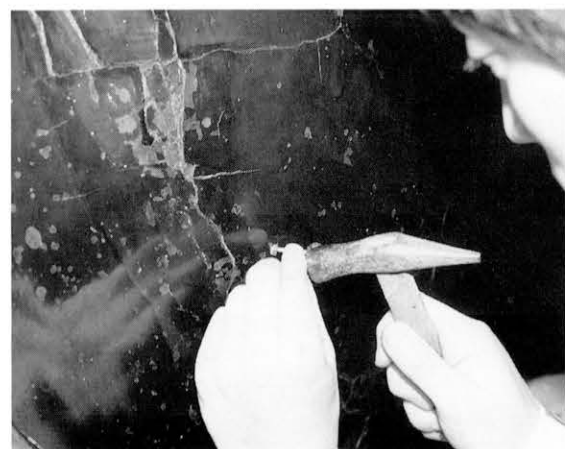
図94 木釘の打込み
Driving wooden nails

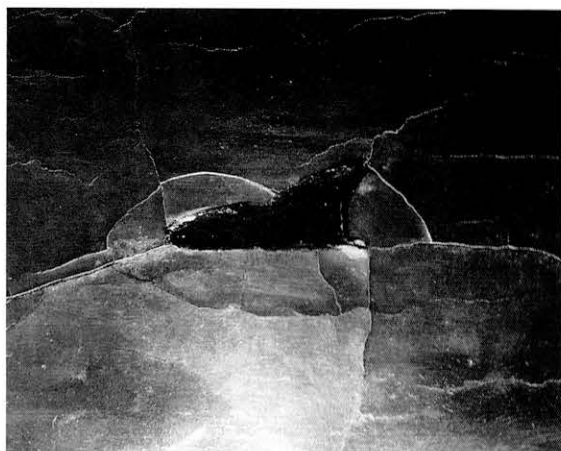
図101 塗膜割れ目の補強
Reinforcing cracks on the coating film

8. Cracks on the urushi coating of the doors (Fig. 100)
9. Large cracks were filled with *kokuso*, and then after urushi foundation was applied, those places were coated with urushi. Raw urushi was impregnated into the small cracks for reinforcement (Fig. 101).

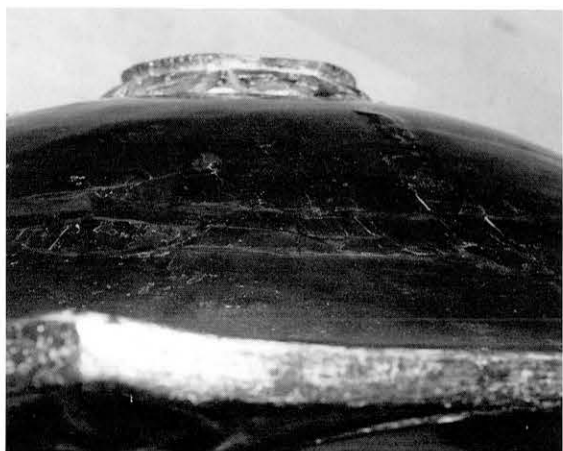
図99 修理された屋蓋部分
Roof after restoration

4. Roof with urushi foundation applied
5. Applying urushi to the repaired places on the roof (Fig. 97)
6. The restored roof (Fig. 98)
7. Restored part of the roof (Fig. 99)

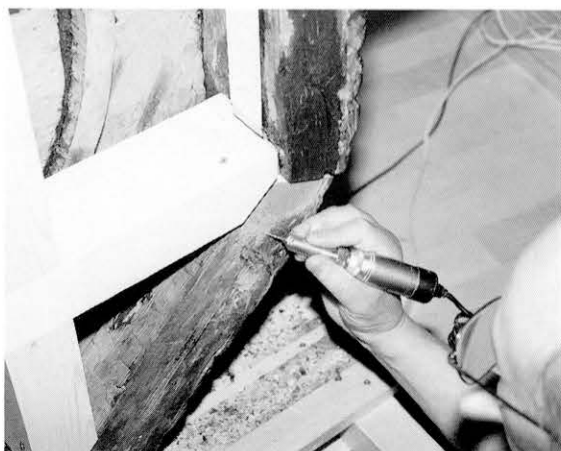
図103 木屎表面の研磨
Polishing the surface of kokuso

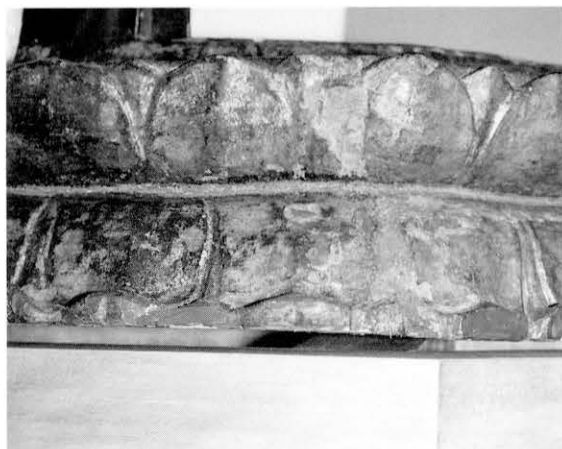
図104 基部と置台のすきま
Opening between the base and the receptacle

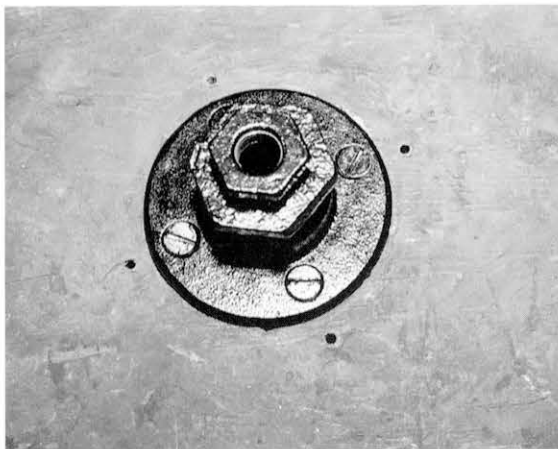
図106 金属ボルトにも漆を塗る
Applying raw urushi on the metal bolt

(17) 修復された天蓋 表裏部分 金属製のボルト ナットには漆を塗る。(図106)

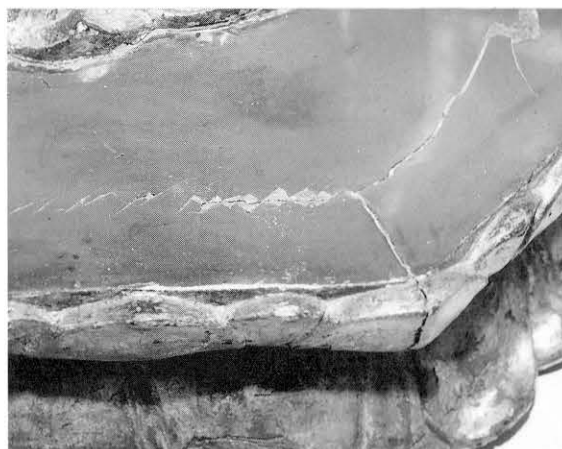
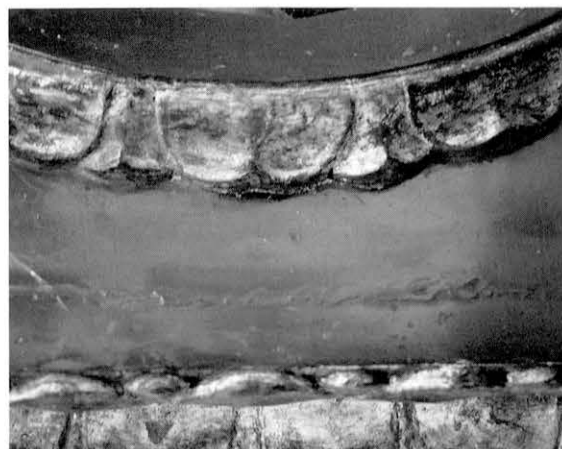
図105 修復された基部
Base (before restoration)
Base (after restoration)

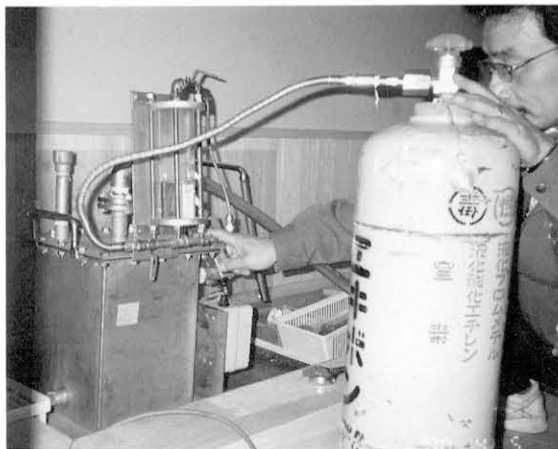
図107 修復後のエキボンガスによる殺虫
Killing insects with Ekibon gas after restoration

(19) 修復後のエキボンガスによる殺虫。(図107)

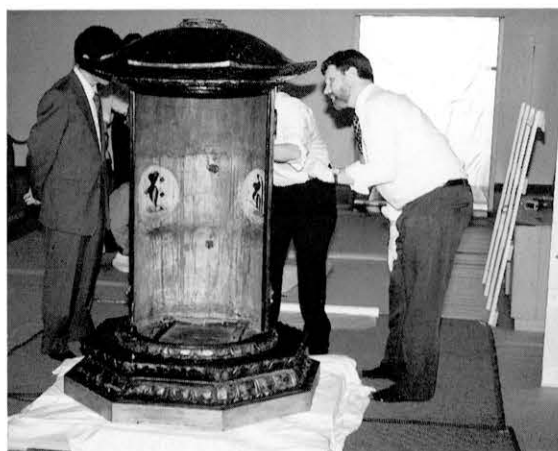
図108 修理完了の確認
Examining the shrine after restoration work

この厨子は、修理完成后、クリーブランド美術館修復部クリスマン氏と加藤寛氏、奈良博工芸担当内藤栄室長、伊東哲夫氏によって修理完了を確認された後(図108)、2000年4月29日より5月21日まで、奈良国立博物館に於て、奈良博所蔵の同形厨子と共に展示公開された(図109)。展示終了後、直ちに日通によって梱包、空論された。(図110)
