花卉螺鈿ライティングビューロー

平成 18・19 年度修復事業

株式会社 小西美術工藝社
岩本 元・表 美幸・共田鈴香

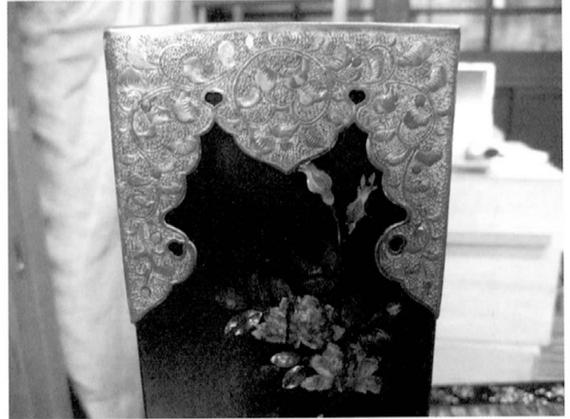
修復後
After restoration

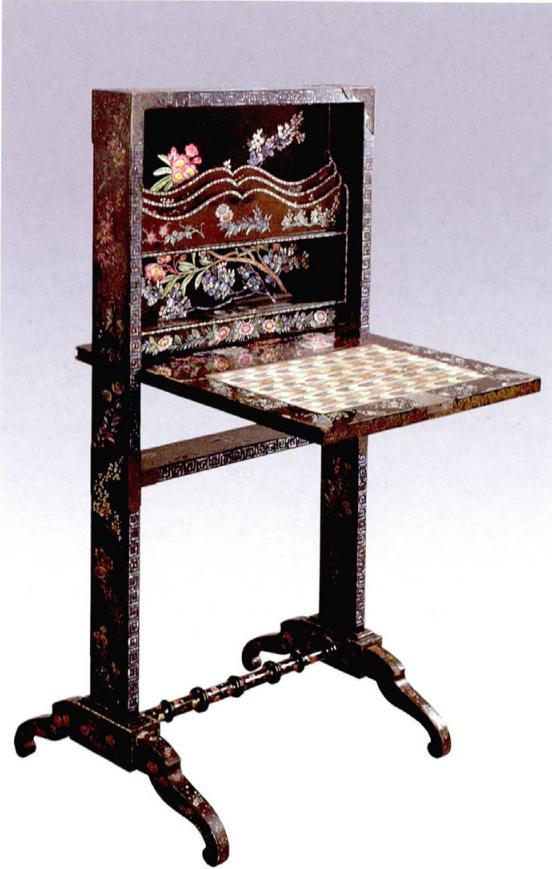
修復前 全景
Before restoration, overall view

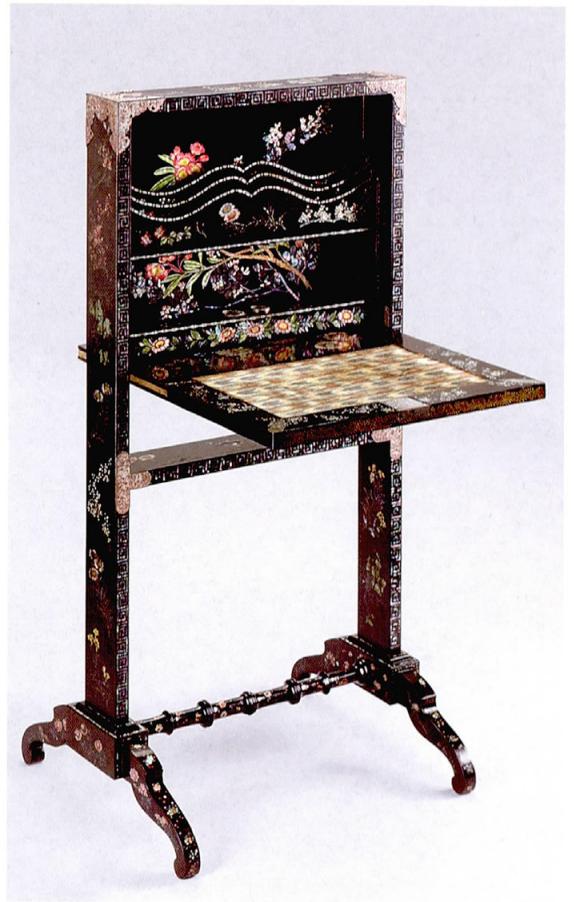
修復後 全景
After restoration, overall view

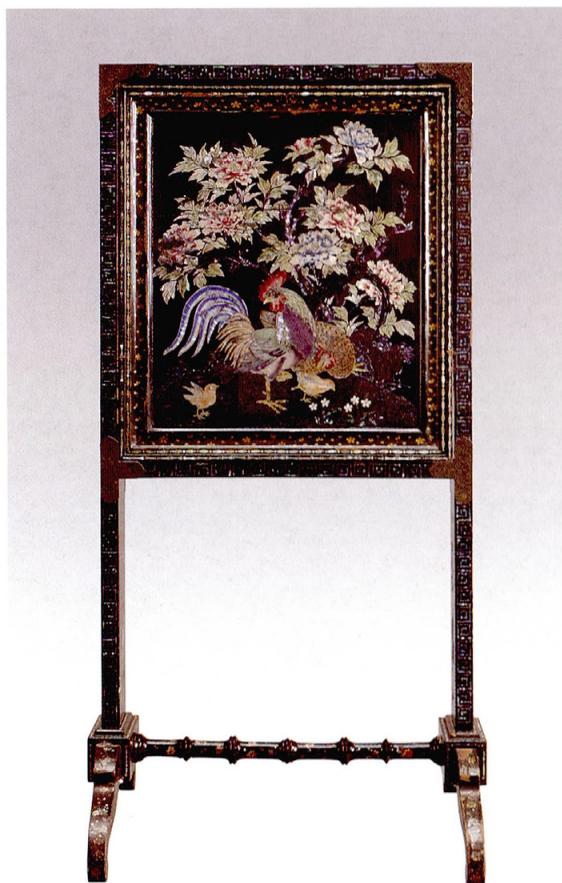
修復前 正面
Before restoration, front

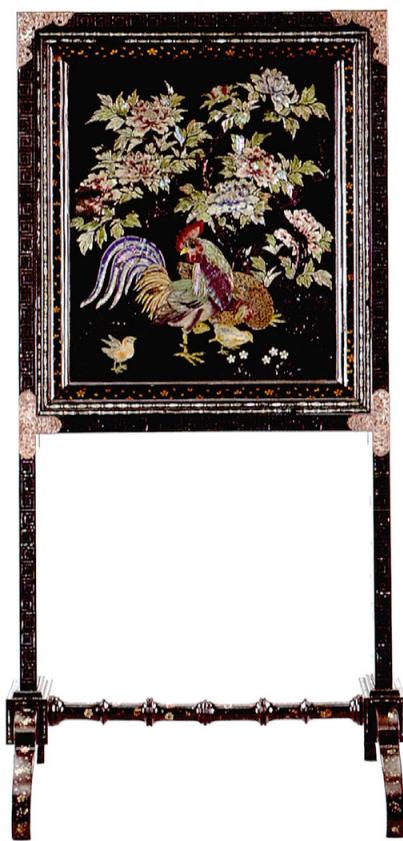
修復後 正面
After restoration, front
