花樹鳥獸蒔絵螺鈿洋櫃 (ケルン東洋美術館)

*Ornamental Coffin*

Museum für Ostasiatische Kunst, Köln

平成18・19・20年度（3年計画の3年目）修復事業

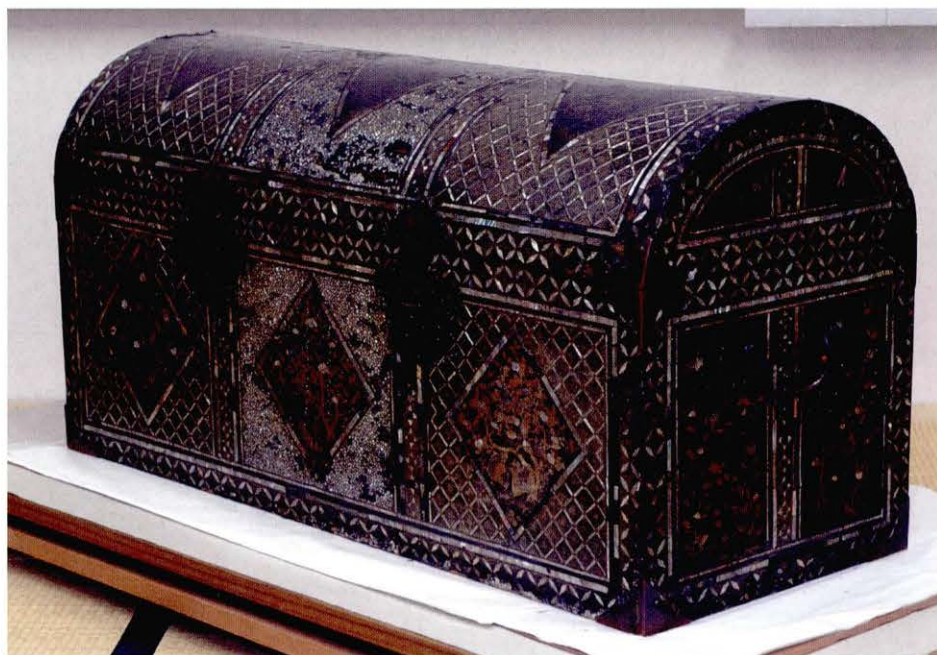
修復前 全景

Before restoration, overall view

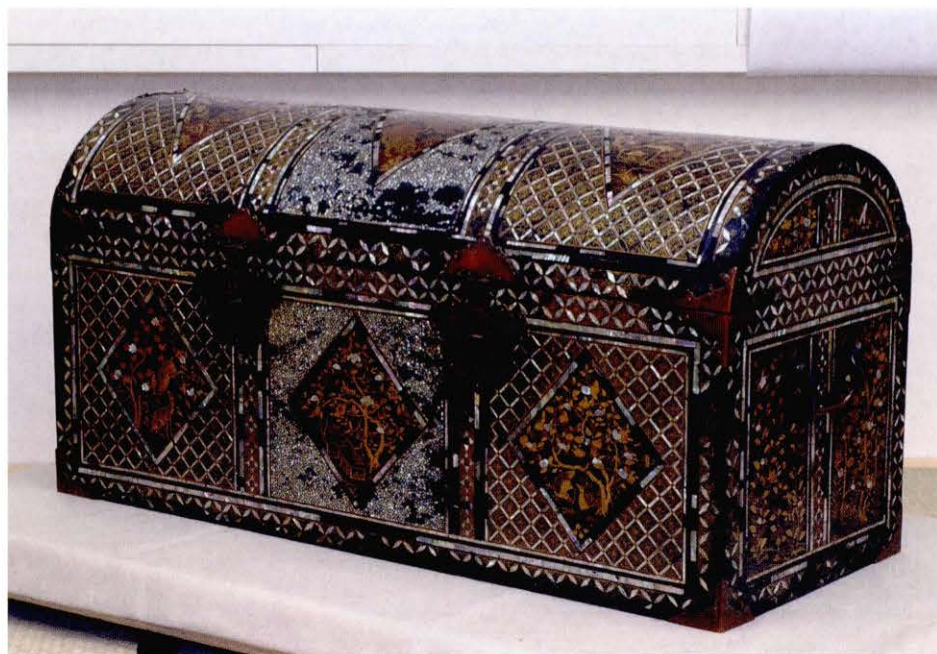
修復後 全景

After restoration, overall view

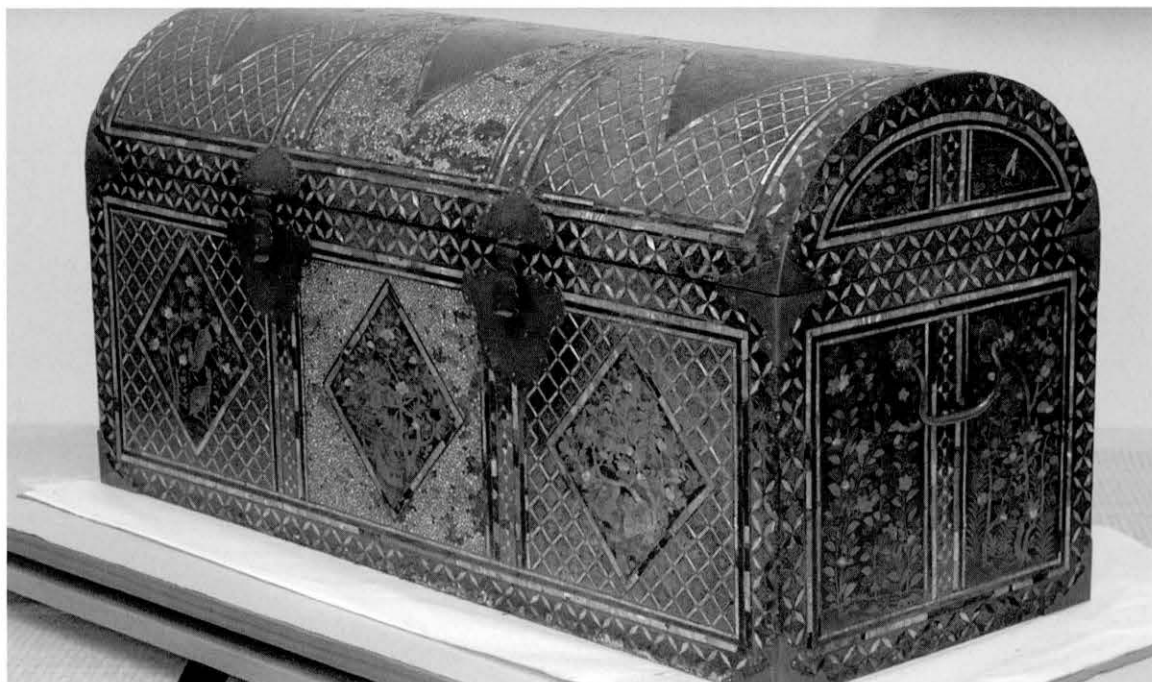
修復前  
Before restoration, 2006

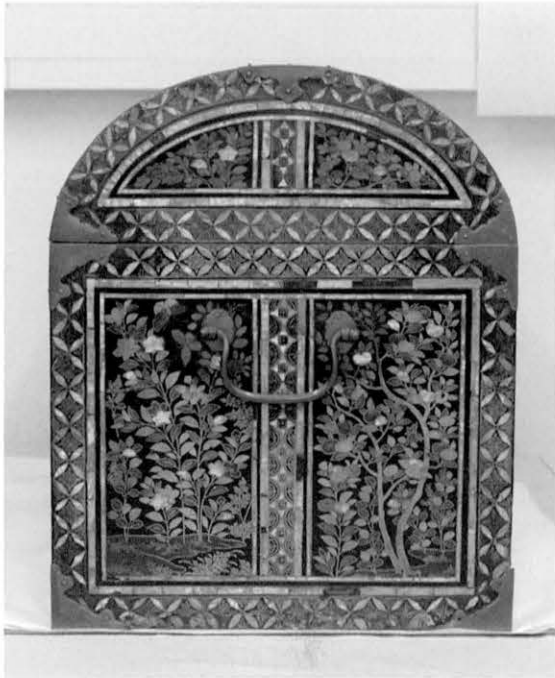
- ・側面の表面塗膜には、塗られた塗料の影響で全体に黒ずみ、特に提鑲周辺の塗膜は状態が悪い。
- ・蓋の角部分の塗膜及び螺鈿は剥離剥落が多く、貝の剥落した部分には銀色の塗料が塗られている。
- ・身の側面下には木地の接合部に亀裂があり、その周辺塗膜は剥離剥落が多くある。

右側面 修復前  
Right side before restoration, 2006

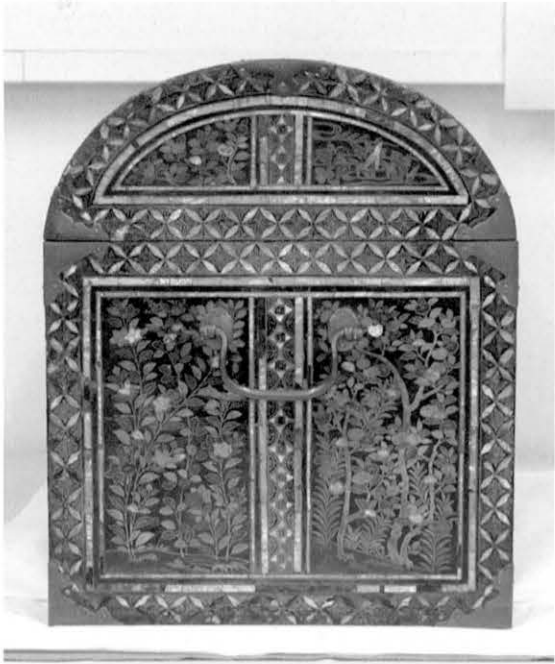
- ・表面塗膜は、何層も塗られた塗料の影響で蒔絵の金色が黒味を帯びている。
- ・塗膜及び螺鈿は剥離剥落が多く目立ち、対面の右側面より状態が悪く、触れるだけで剥落しそうな危険な状態である。
- ・側面下の塗膜は殆ど剥離し、木地接合部には亀裂を生じている。

左側面 修復前  
Left side before restoration, 2006

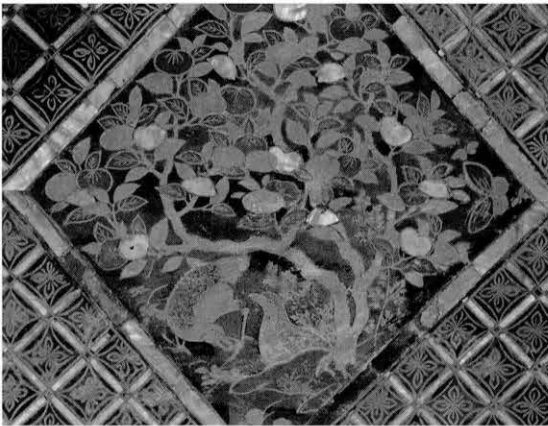
後補塗料の除去前  
Before cleaning

昨年度にクリーニング作業の終わっている左右側面、正面蓋の一部と正面身の一部を除いて、全面にわたり可能な限り後補塗料の除去を行った。なお、除去作業においては表面漆塗や螺鈿の剥落しそうな危険な場所は慎重に塗料除去作業を進めた。

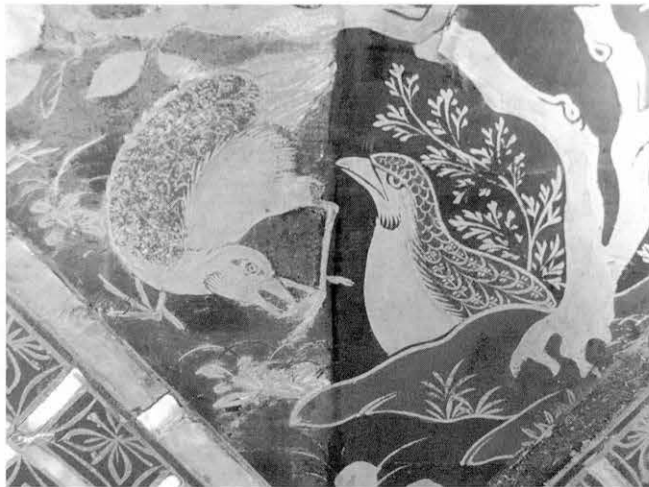
後補塗料の除去前  
Before cleaning, 2006

後補塗料の除去後  
After cleaning, 2008

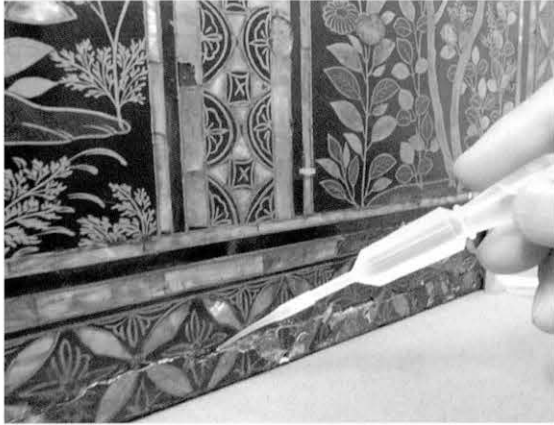
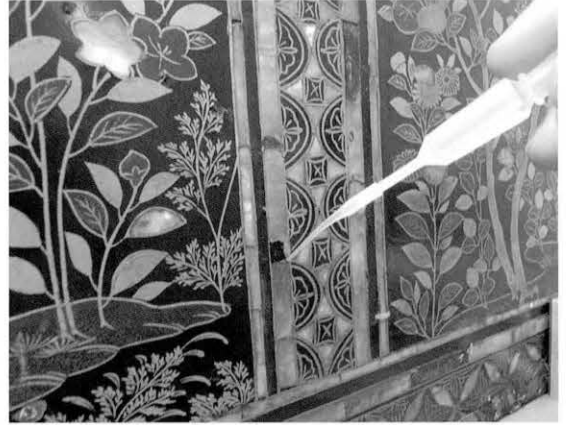
エタノール含浸  
Impregnating ethanol

洋櫃の表面漆塗膜や螺鈿はかなり多く剥離剥落が生じている。本来であれば後補塗料の除去を行った後で剥離した漆塗膜や貝の圧着を行うべきであるが、現状では後補塗料の除去作業によって剥離した部分の損傷を拡大する恐れのある箇所が多かった。したがって、損傷を与えてしまう箇所は先に剥離部分を膠で接着して安定を計り、その上で後補塗料の除去作業を行うことにした。圧着作業は昨年度と同じく、洋櫃を木枠内に設置し、竹ひごの弾力を利用した芯張りによる方法を用いた。先ず、剥離した漆塗膜下や螺鈿の下にエタノールを含浸して膠の浸透を良くしてから、筆に含ませた膠を含浸した。なお、膠にも少量のエタノールを加え浸透力を良くして剥離部分に含浸し接着を行った。

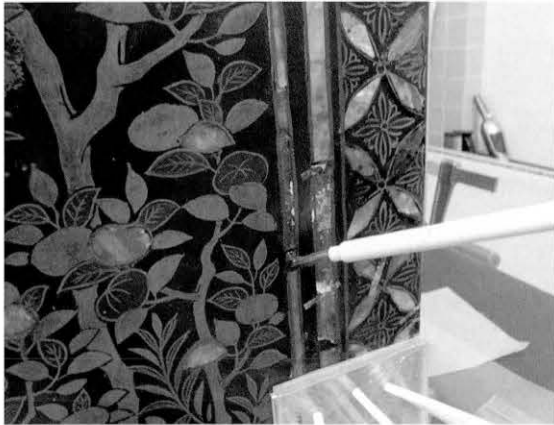
膠含浸  
Impregnating animal glue

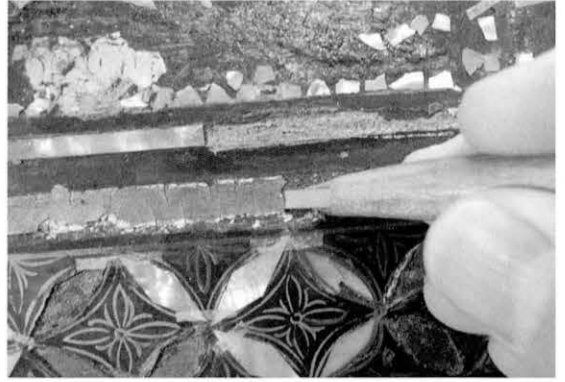
後補充填の除去  
Removing filler from past restorations

螺鈿の欠損部に充填されていた後補の充填部のうち、粗雑であったり色調が合わなかったりしたものは、慎重に刃物などを使用して除去した。除去した後補充填材の一部はサンプルとして保管した。

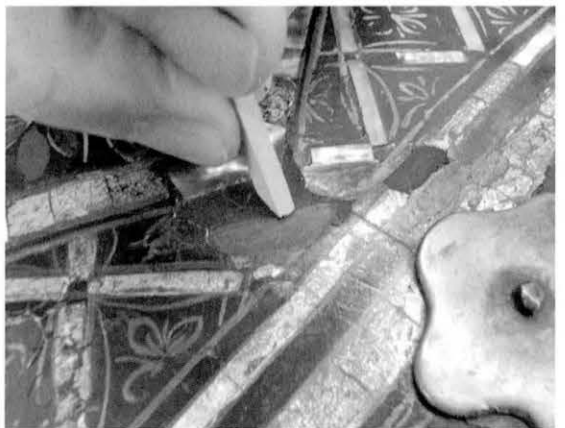
刻字部分の研ぎ  
Polishing *kokuso*

麦漆に炭化させた松の木粉（惣身粉そうみこ）と珪藻土を炭化させた地の粉（輪島地の粉三辺地）を混合して作った刻苧を塗膜欠損部や素地の露出部分に充填した。

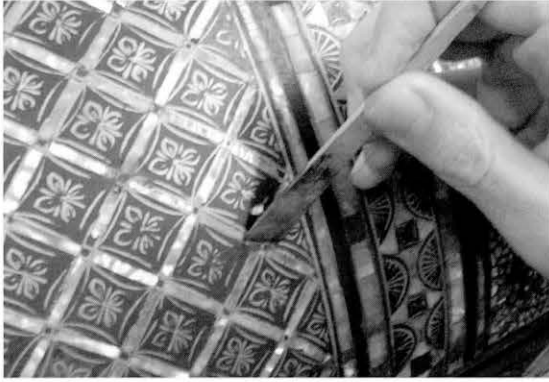
際錆  
*Kiwasabi*

輪島地の粉四辺地を水練りし、生正味漆を混合して作った錆漆で刻苧充填部や漆塗膜や螺鈿の細かな破損部に際錆を施した。

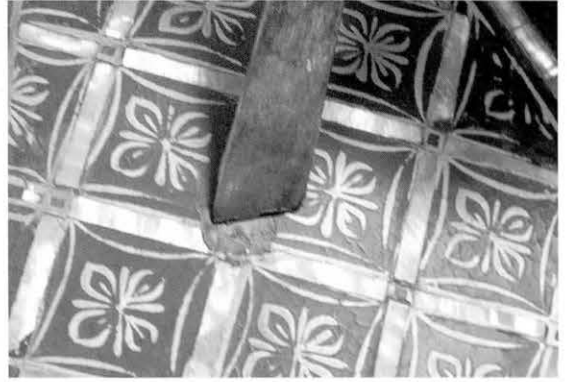
際錆  
*Kiwasabi*

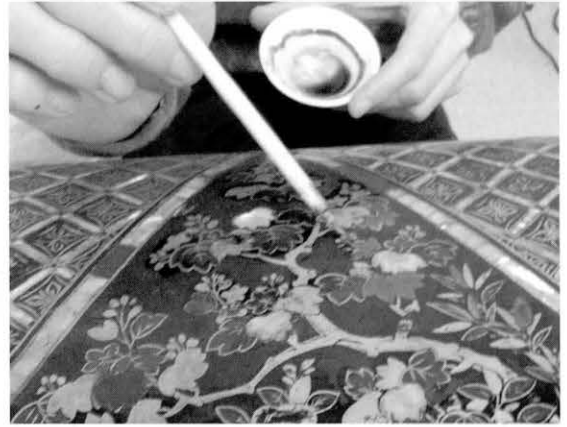
漆固め  
Consolidating urushi

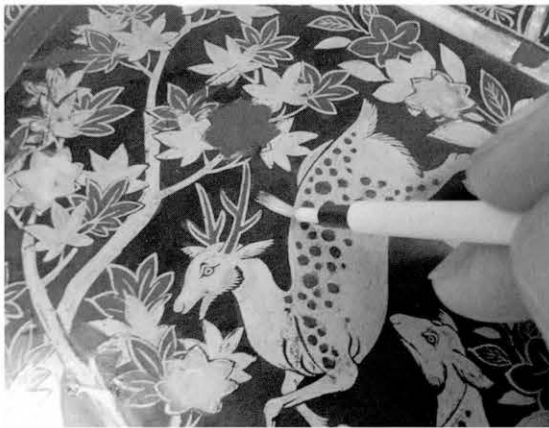
漆固め (黒漆部分)  
Consolidating urushi (black urushi portion)
