Conservation and Restoration of Internal Features

Tokyo National Research Institute for Cultural Properties
Center for Conservation Science, Restoration Techniques Section

Foreward	Saito Takamasa	3
Introduction	Nakayama Shunsuke	5
Chapter1 Conservation and restoration of internal features in the Bank of Iwate (Former Morioka Bank) Main Office Main Building	Tsumura Yasunori	9
Chapter2 Restoration lighting historic house	Fukuda Kazuya	33
Chapter3 Painting repair of graining in Meiji-mura - Case study of restoration of No.25, Nagasaki Foreign Settlement -	Matsushita Michio	75
Chapter4 Case study of conservation and restoration of internal features	Nakayama Shunsuke	89

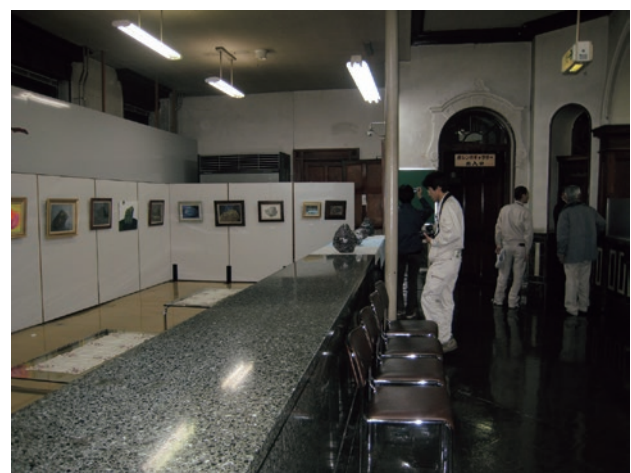
photo 7 Civic gallery before conservation (photographed in 2008)

exterior wall finish (**photos 5 and 6**). In addition, the brick wall of the partition between the civic gallery on the first floor and the west side public space and the brick wall of the former general meeting room on the second floor, which was lost due to remodeling in later generations, were restored to their old states as structural reinforcement (**photo 7**).

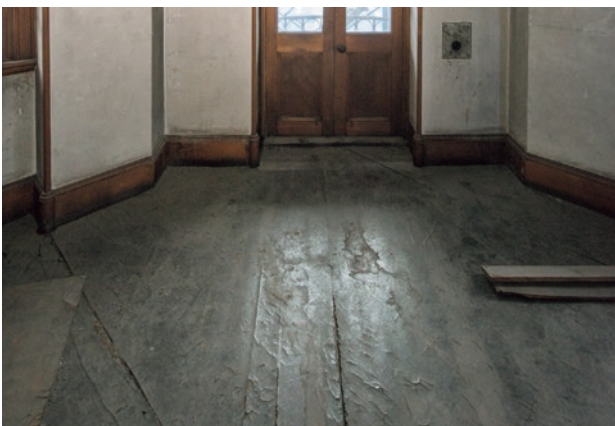
The floor finish linoleum of the warehouse (octagonal penthouse) had a linen base, a width of approximately 1,800 mm, a thickness of 2.5 mm, and a dark brown

color (**photo 10**). From its state, it seems it was the original material, and it is assumed that it was made from natural materials (linseed oil, etc.), but the ingredients were not tested. Iron nails were hammered in as appropriate, but it is believed that they were made in later generations to prevent the base from rolling up. This room will not be open to the public; therefore, we decided to maintain its current status.

photo 10 Linoleum with floor finish of warehouse (octagonal penthouse)

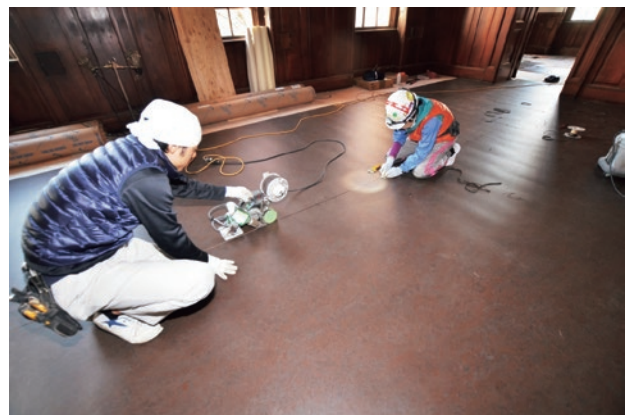
photo 11 Linoleum finish

The pre-repair finishing material, which was significantly damaged, was removed and unified with a linoleum sheet (Forbo, Germany). The linoleum sheet was made by applying a chloroprene solvent type adhesive and an acrylic resin emulsion type adhesive to the base before laying it down, bleeding air with a roller, and crimping it. The ends were cut with a cutter, and the joints were grooved with a U-shaped cutter and welded with a heat welding rod. Finally, wax was applied to the surface (**photo 11**).

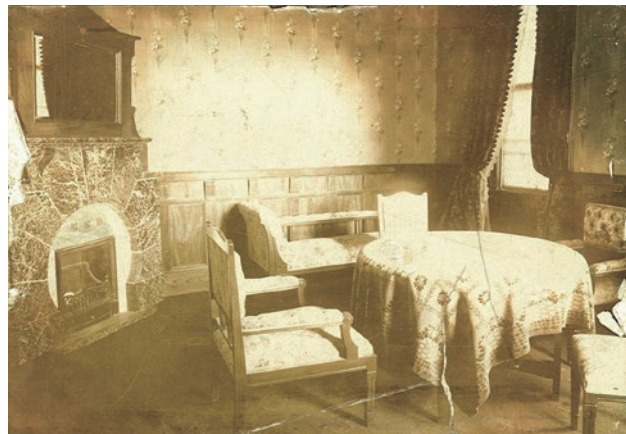
It can be inferred that the gift room (formerly the first reception room) was carpeted with a slightly regular pattern on the floor of the old photos. However, currently, it has a tiled carpet on the floorboard. No fragments or traces of the carpet were found (**photo 13**).

photo 13 Old photo of first reception room (Bank of Iwate collection)

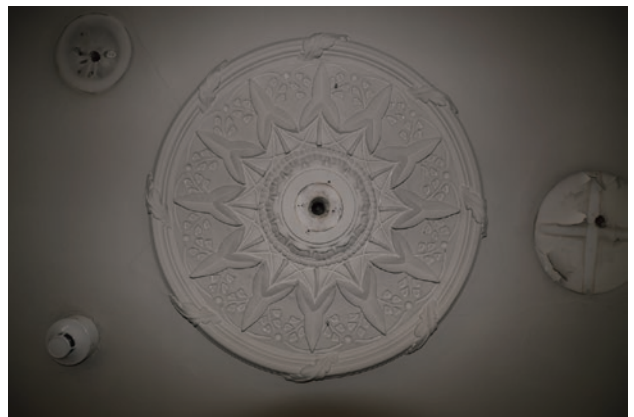
Most rooms with plastered ceilings have plaster decorations (central decorations) at the base of the hanging light fixtures (**photo 19**). Several layers of water-based paint were applied on top of the plaster finish. Although the edges lacked their sharpness from the original design when it was made, it was still present in all rooms except the civic gallery. There are several types of designs and many with botanical patterns. As with the balustrade decorations, there is no description of whether each design has a meaning related to the use of each room. Therefore, it is not clear, but the intentions of the designer or the client are reflected in the design. The central decoration was painted several times in later generations. It was maintained to preserve the current situation because there were concerns that the corners and edging of the original decoration would become dull if painted further.

photo 19 Central decoration of the first reception room

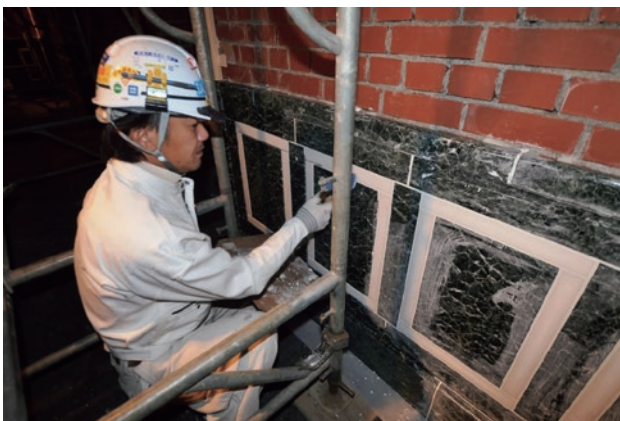
have been removed, resulting in the loss of serpentine and marble on the west side public space side waist-high wall partition. A stone material was pasted on the waist-high part of the restored wall partition in accordance with the old regulations (**photo 20**). The serpentine was from Greece, and the marble was from Macedonia.

photo 20 West side public space waist wall stone construction

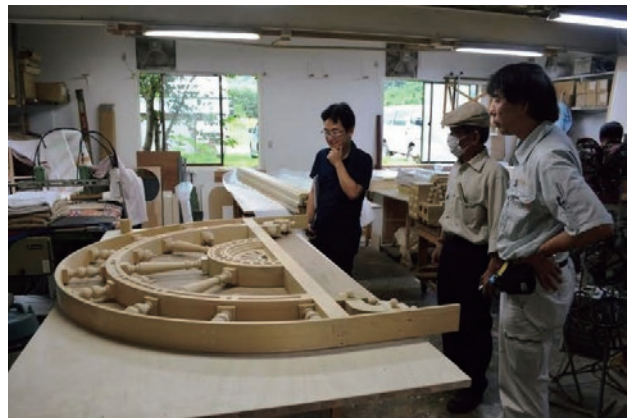
photo 23 Model of decoration of transom

photo 24 Production of decoration of transom

The wooden decorative portion of the exterior windows in the southwest public space was restored by taking a plaster mold from the same design and carving the wood to match. The wooden decoration section above the entrance between the south side public space and the east side windbreak room was restored following the “Architectural Plan.” The wooden decoration of the petals on the removed interior fixture frames was also restored in the same manner as above, by plaster molding the remaining parts and carving them out of wood (**photos 23 and 24**). All were finished with the same paint as the other wooden parts.

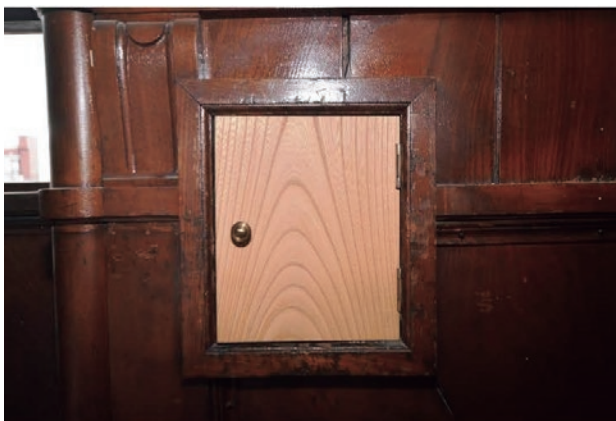
photo 25 Shutter winder lid supplement

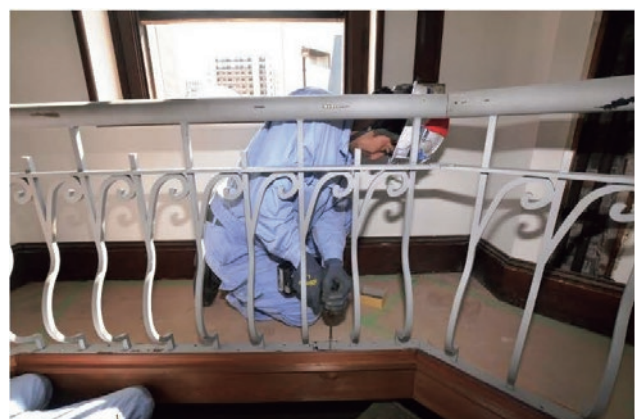
photo 30 Handrail installation

Both the southeast and east corridors were brought to the site after being painted in the factory to prevent rusting (**photos 30 and 31**). The support material for the eastern corridor handrail was installed in advance, and a 20 mm wire was inserted into the joint between the cross rails to penetrate the handrail and fix it. For the joint part of the handrail, a receiving round pipe, which is smaller than the round pipe of the handrail, was installed to fix both handrails. The support material and the gallery were carefully fixed with hexagonal nuts after inserting all the screws, and the joint part was puttied to complete the installation. Finally, synthetic oil paint was applied, with a Munsell value of 2.5G3/4,

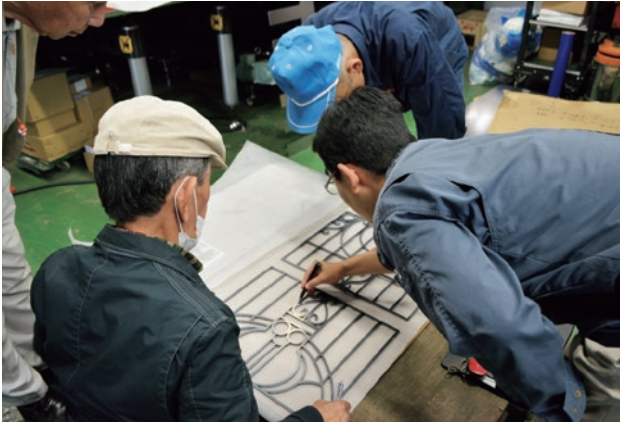
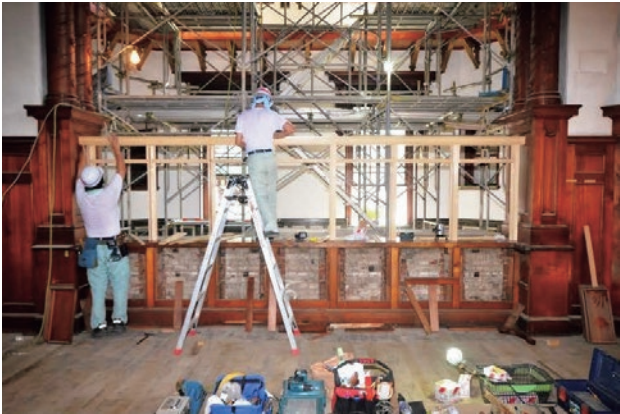
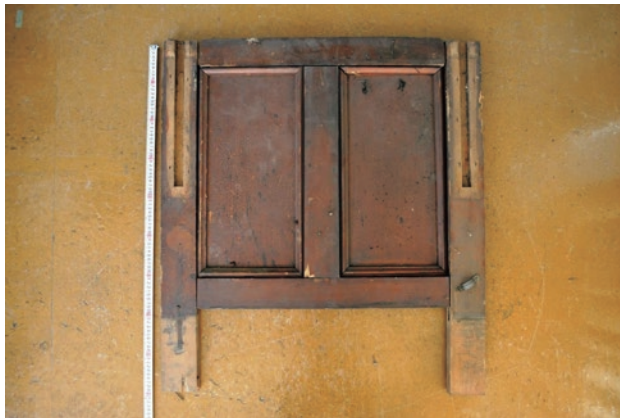
photo 36 Screen hardware factory inspection

photo 37 Screen hardware laser cutter processing

photo 38 Screen frame mounting

photo 39 Screen hardware installation

photo 40 Counter remaining parts

Both the wooden decorative sections and the screens that could be raised and lowered, which had been above the counters in the southeast and east public spaces and the southeast public space but had been lost, were restored (**photos 36-40**). After removing the buried wood on the top plate and the artificial stone polishing finish that were buried in the support position of the original support, the support was fixed to the top plate, the pulley was attached to the mullion, and the joinery frame was painted in advance. Subsequently, the fittings

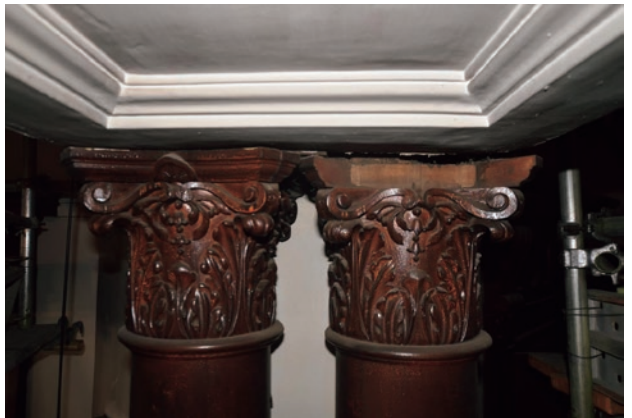
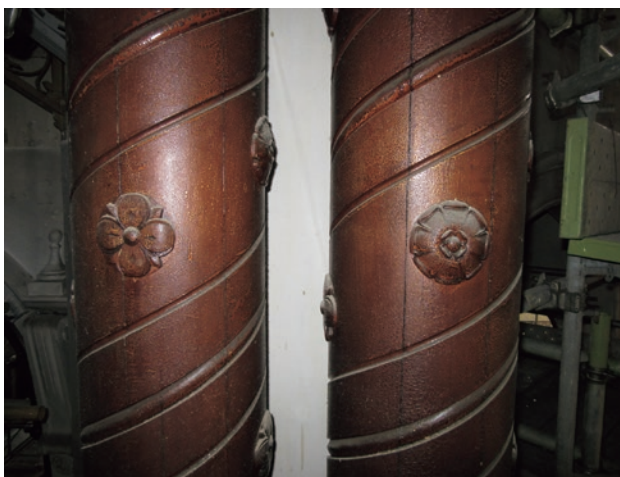
photo 41 Decorative pillar stigma

photo 42 Decorative pillar decoration

On both sides of the sales table, which separates the east side from the south side of the public space, there are two cupped columns with Corinthian capitals (**photos 41** and **42**). Two types of relief petals were attached to the bottom of the pillar. The wooden part of the column head ornament on the sales table facing the south side public space was missing, but a piece of wood that appeared to be the part was stored in the storeroom. When it was checked, it matched, so it was installed.

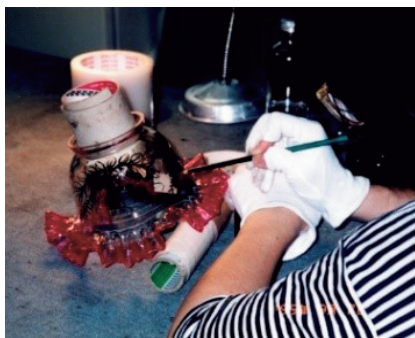
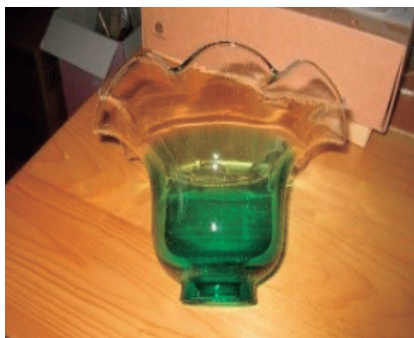
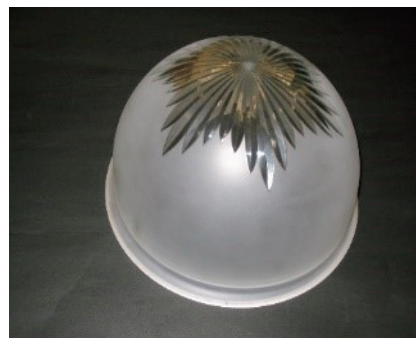
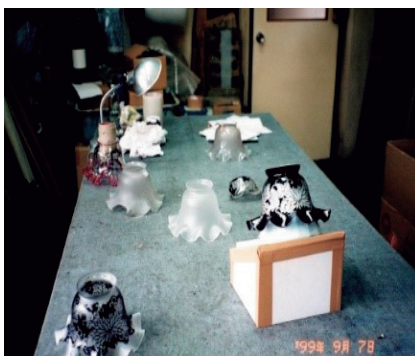
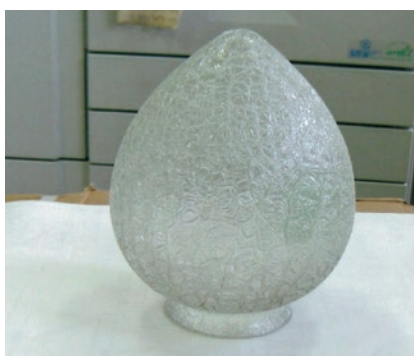
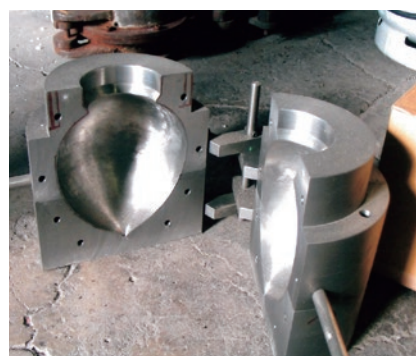
The attraction of glass called “ruri”, “hari”, “giaman”, “vidro”, crystal, etc., is light—it is the presence of the reflected light, the refracted light when passing through, and the presence of light emitted from the glass itself. The glass restoration of the lamps is an important task (**photos 28–33**). First, it is necessary to confirm the original glass. Various confirmations are required for restoration production, which requires the same glass even if there is an original, according to the age of the equipment. It is necessary to check the material, molding method (molding, air-spraying, or pressing), processing method (erasing glass, internal erasing, or external erasing), pattern (cutting face or acid etched), and polishing of the finish. Therefore, the production drawing is extremely important, and it is a prerequisite to give the manufacturer the one in which the fitting with the lighting equipment is clearly indicated in addition to the fine dimensions such as angle and radius.

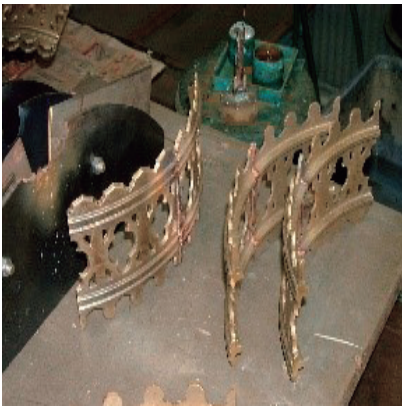
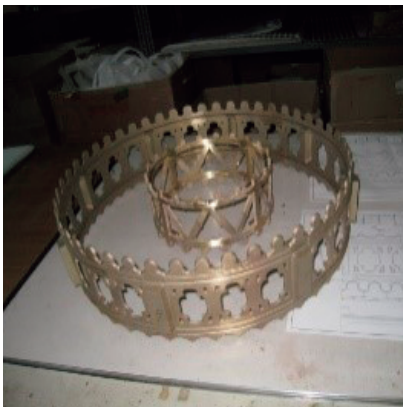
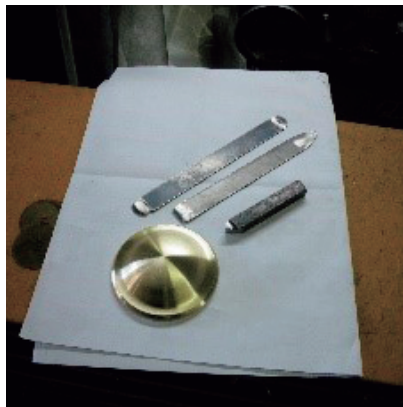
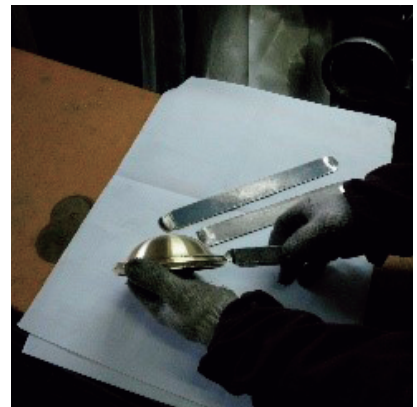
photo 34 Welding work

photo 35 Welding work

photo 36 Welding work

photo 37 Welding work

photo 38 Raising

photo 39 Raising

photo 40 Raising

photo 41 Raising

* Sheet metal processing (**photos 34–41**)

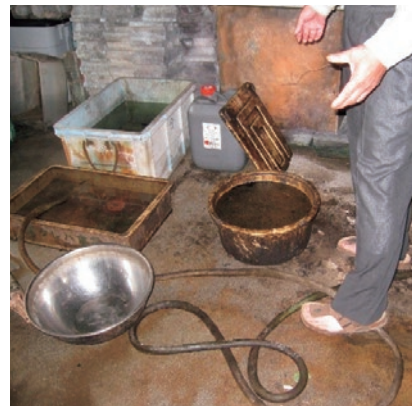
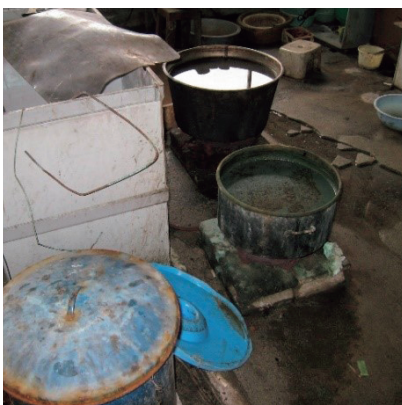
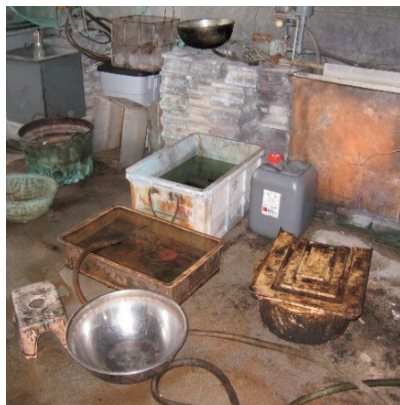
photo 42 Boil-washing

photo 43 Boil-washing

photo 44 Boil-washing

The initial product is a high-grade material such as bronze or copper alloy, which turns green-blue or black in response to oxygen and humidity. Basically, dirt is removed to avoid damaging the fabric. First, the socket cord is removed. Caustic soda is then boiled and used for washing (boil-washing) (**photos 42–44**). The rusted part is removed with a brush using acid or the like. After removal, it is finalized through either the coloring method or the plating method, but when following the

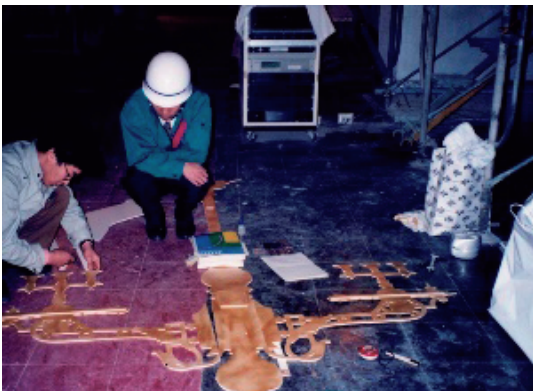
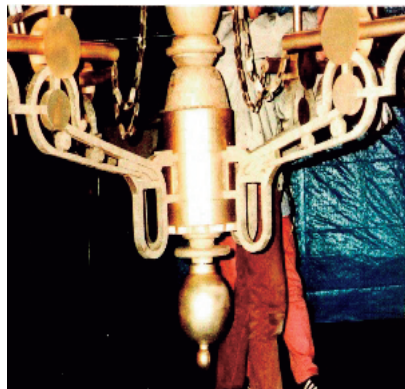
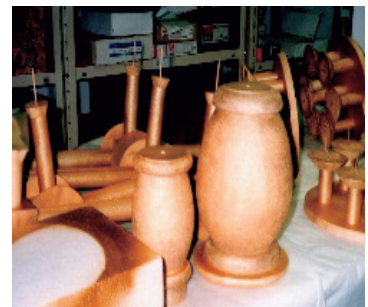
photo 48 Modeling at 1/1

photo 49 Hang on site

photo 50 Full-scale model (whole)

photo 51 Full-scale model (parts)

photo 52 Full-scale model (parts)

A model was made as an overall drawing and examined (**photos 48–52**). The height of the individual parts of the luminaire, the shape and size of the arm, and the balance in the center were mocked up in 1/1 and lowered to the actual position. The balance of the entire lighting equipment and its lowered state on the dome were confirmed.

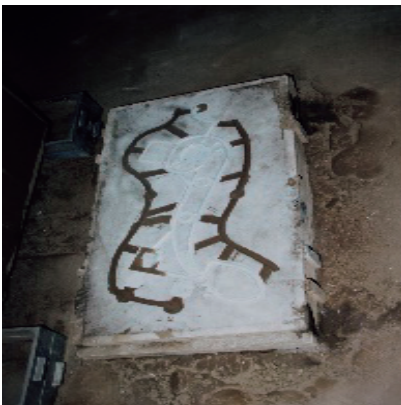
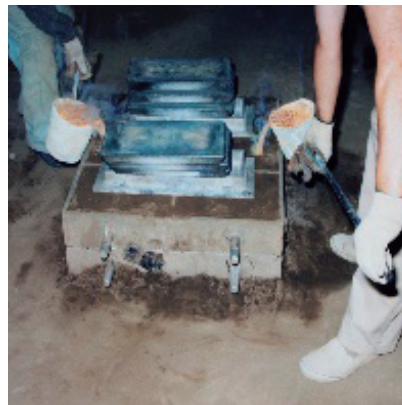
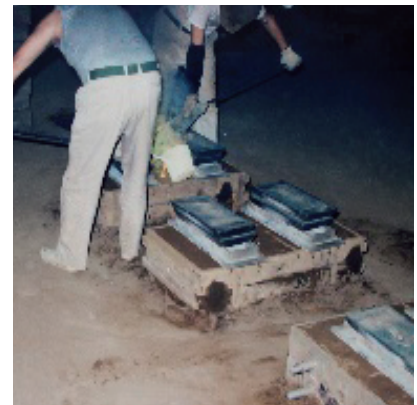
photo 56 Pair of arm wooden patterns

photo 57 Arm sand mold

photo 58 Arm pair sand mold

photo 59 Sand mold

photo 60 Cast pouring

photo 61 Casting

reduce weight), ground metal fittings, and cast metal molding. There are three types of casting methods, depending on what is being molded. In this case, we decided to use all three methods. However, as there are different factories for different molding methods, we requested a different factory for each part (**photos 56–64**).

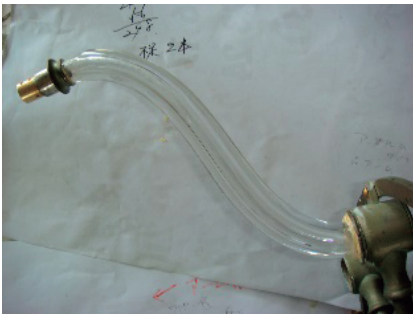
photo app.1-8 Glass arm metal fittings on both ends

This is a chandelier for a total of 10 lights with
a socket on a glass arm of five lights each with an
S-shaped length. The repair was done in a state where
the metal fittings to be attached to the main body metal
fittings were required at both ends of the glass arm,
and the metal fittings to attach the socket were required
at the tip of the arm, and all the metal fittings at both
ends were loose and not fixed. As the socket remained
unstable in the candle cup, the cord was twisted and
broken, and the modified socket was broken and was
not energized. The socket is a Swan base (European
specification B type) with an Edison socket (E type)
added and is covered with a white cylindrical cover that
looks like a candle. All the wire replacement sockets
were repaired, and the metal fittings at both ends of the
arm were fixed with plaster by removing all the adhesive
from the original parts and setting a new jig. The glass,

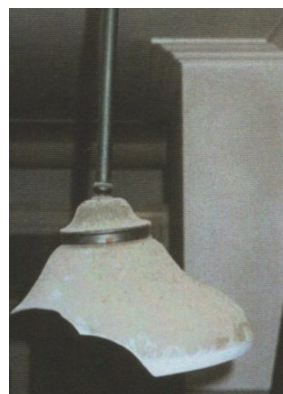
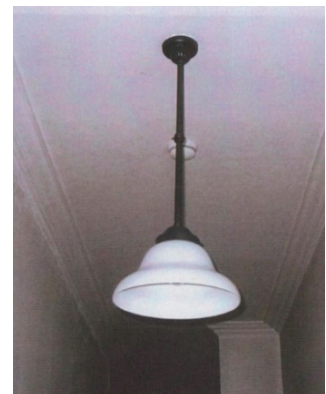
photo app.1-21 Pipe pendant, before and after repair

Restorations and manufacturing were conducted for the uneven glass decorations, the replacement of all bead joints with copper pins, insufficient decorative glass, the production of missing octagonal diamond type parts, and glass globes. The cracked metal pipes, that act as the support of the instrument, were welded and repaired. During the era the original product was manufactured in, the flat plates were still made into

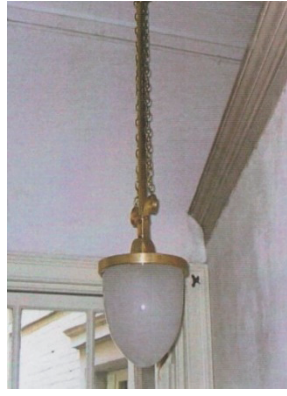
photo app.1-22 Before and after repair

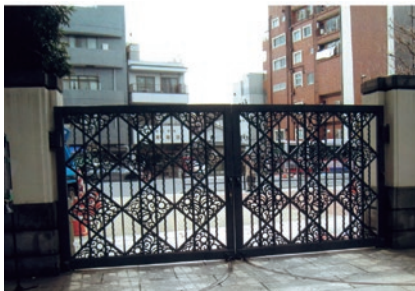
photo app.2-1 Main gate

There was considerable damage to the front gate, which was installed during the construction of the building in 1933. It was made of cast iron. The rails were damaged, and the roller of the gate was found to

be rusted when the gate was opened and closed. It was in a state where it could not serve as the sheaves. There was a crack in the pattern and support parts of the main body, so it was removed from the gate pillar and repaired. The cracked part was widened, and the mouth was closed with a stainless steel welding rod. The sheaves was restored in accordance with the design of the original one. A zinc metallikon finish was sprayed over it.

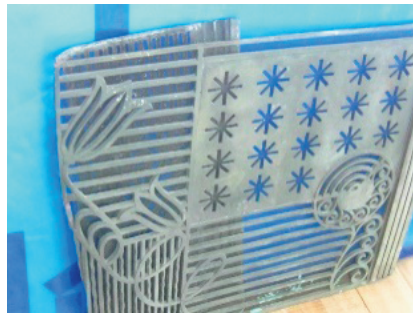
photo app.2-10 Bent in two

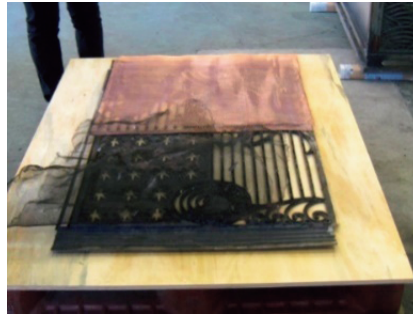
photo app.2-13 Bend returned to original state

pattern design were also damaged. Therefore, the bend was restored, and the patterned part was corrected. The damaged frame was fitted with metal fittings and welded. The patterned portions were welded with back-up fittings.

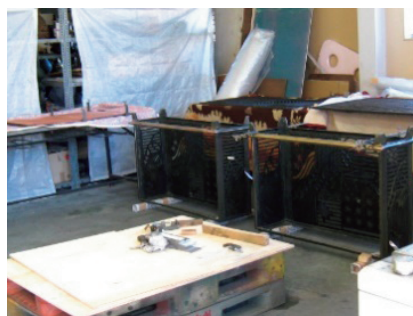
photo app.2-22 Frame adjustment

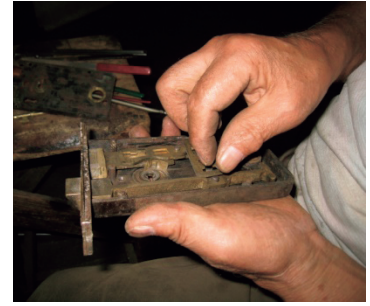
photo app.2-30 Box lock adjustment

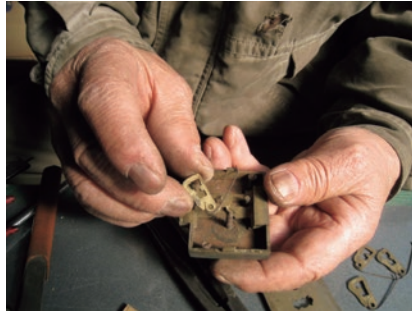
photo app.2-32 Box lock adjustment

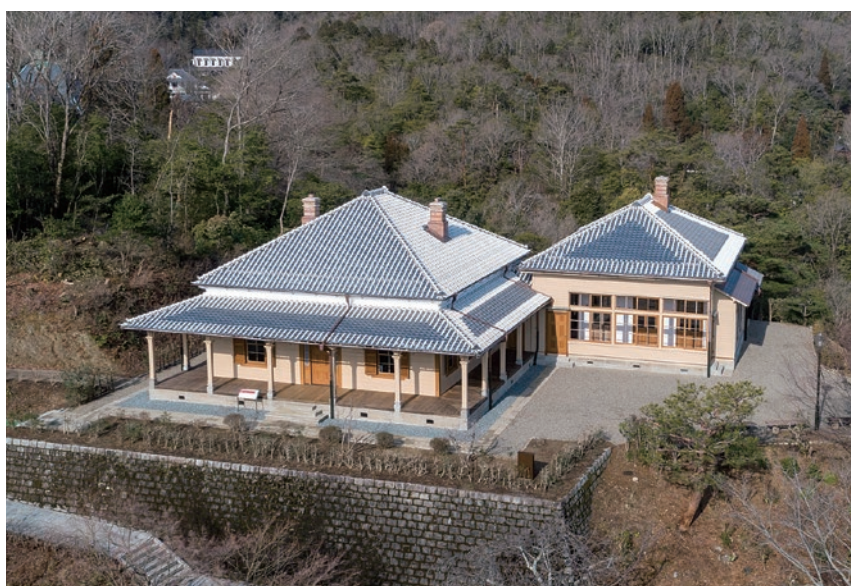
Building No. 25 is a wooden Western-style house located at 25 Minamiyamate, the former Nagasaki Foreign Settlement. The building consists of the main building and an annex connected to the rear corner of the main building, both of which are wooden one-story buildings, hipped roofs, and tiled roofs, and the outer walls are clapboard-painted. In the main building, the lean-to veranda rounds the front and both sides of the building, and the eaves girder of the lean-to is supported by an independent pillar. The annex features a high window that opens between the three pillars on the front and a Japanese-style room on the back, with a veranda. The main building was constructed in 1889, and the annex was constructed in 1909. Both these buildings were relocated to Meiji-mura in 1966 (**photo 1**).

photo 1 Panoramic view of No. 25, Nagasaki Foreign Settlement, after repair completion

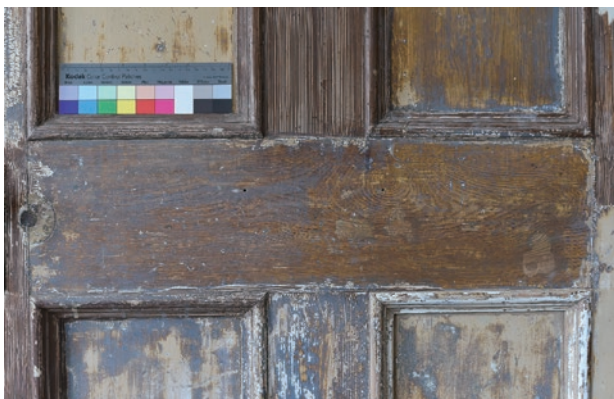
ed on the panel board of each door, and eyeball figured grain was used for the figured grain. We can also see the basic regularity of the door stiles, door and window frames, picture frames, skirts, etc., which are coated with fine grain (photos 5–7). However, as seen in the annex building, fine, straight lines similar to baseboards were drawn on the panel boards of the doors. Thus, there was a clear difference between the main building and the annex regarding the depiction and classification of the figured grain in the various parts of the doors.

photo 5 Bottom graining-eyeball figured grain (Main building No. 4 room door middle stile)

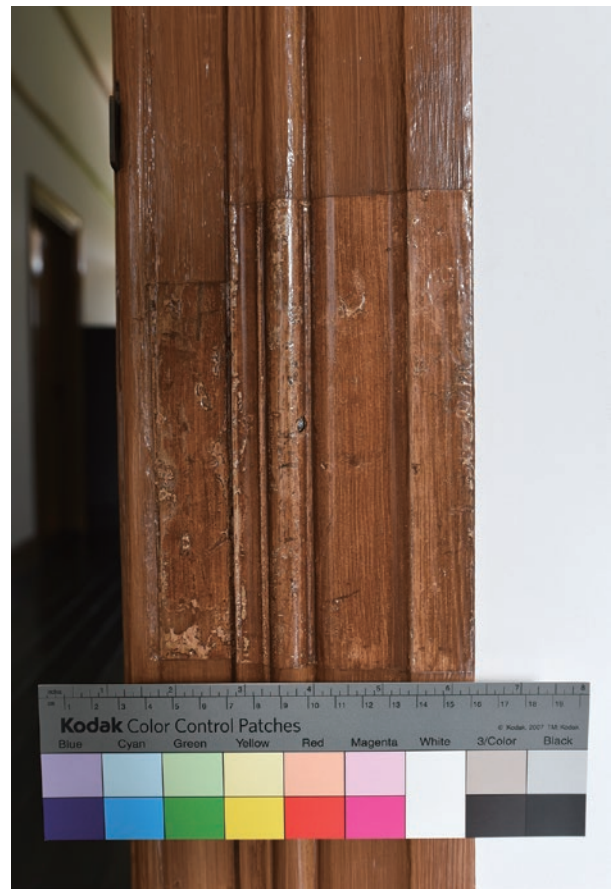
photo 7 Bottom graining-straight grain (Main building No. 4 room door frame)

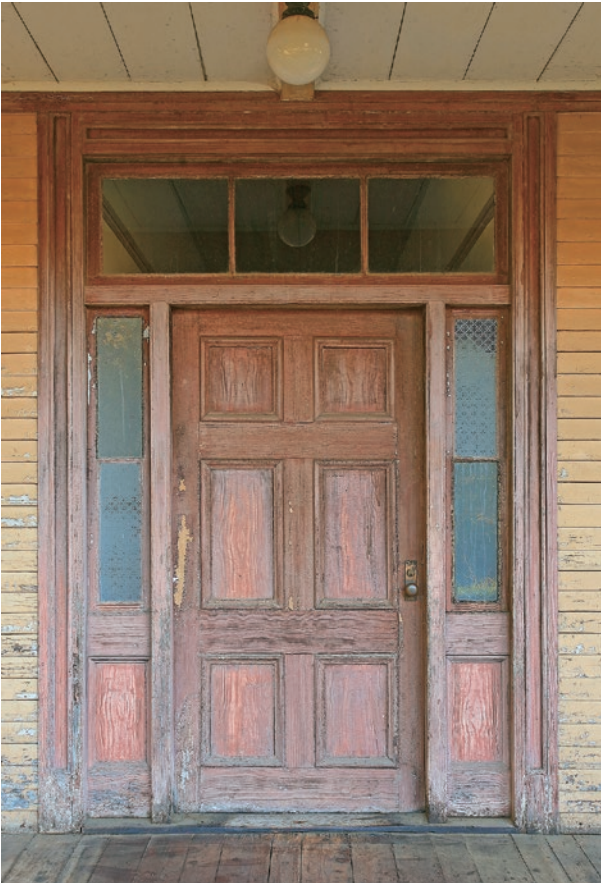
Before repairing this, the painted wood grain film had peeled off significantly over time, and the exterior graining was noticeably discolored (**photo 8**). The planning of the preservation repairs, including the seismic retrofitting of Building No. 25, as well as the repair of the wooden parts, the roof replacement, and full-scale paint repair, required careful consideration regarding the kind of repairs to be made to the graining part—a major feature of the building.

photo 8 Main building front door (before repair)

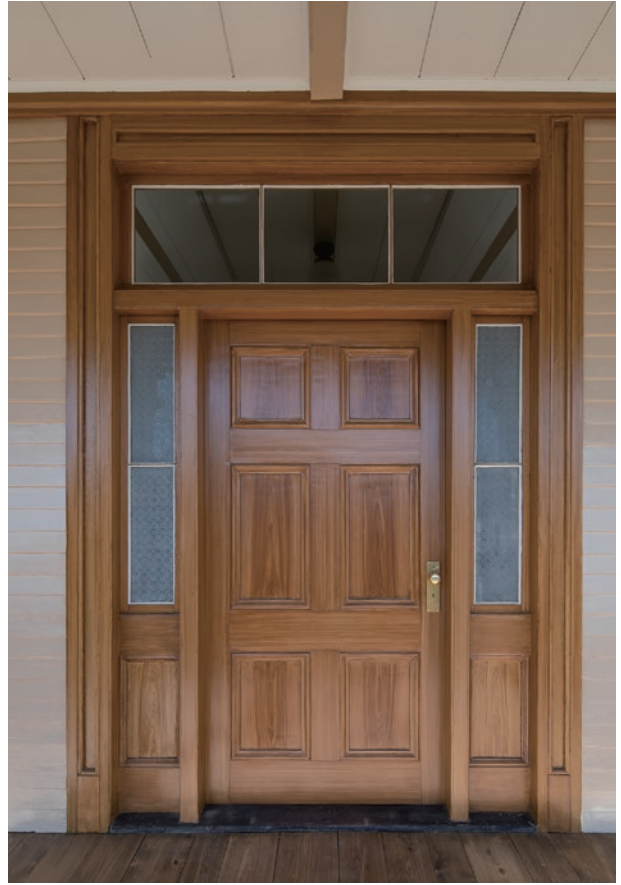
photo 9 Main building front door (after repair)

duced with high accuracy (**photos 8–13**).

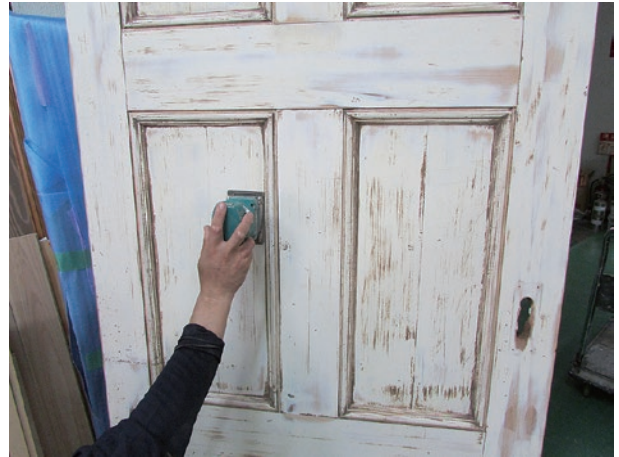
photo 14 Graining process ① sander scraping

Taking the graining of the main building door where medium figured grain is painted on the panel board as an example, the main points of the painting process are summarized as follows (**photos 14–26**): (1) sander scraping; (2) base material adjustment by keeping put-

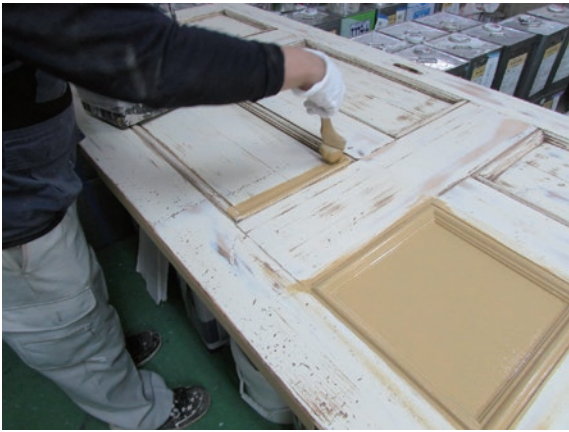
photo 16 Graining process ④ intermediate coating

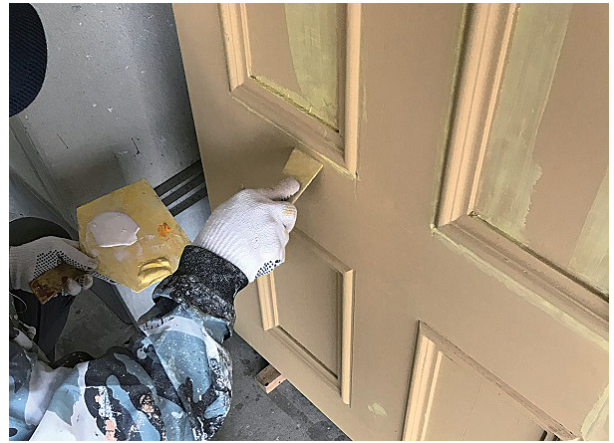
photo 17 Graining process ⑤ putty application

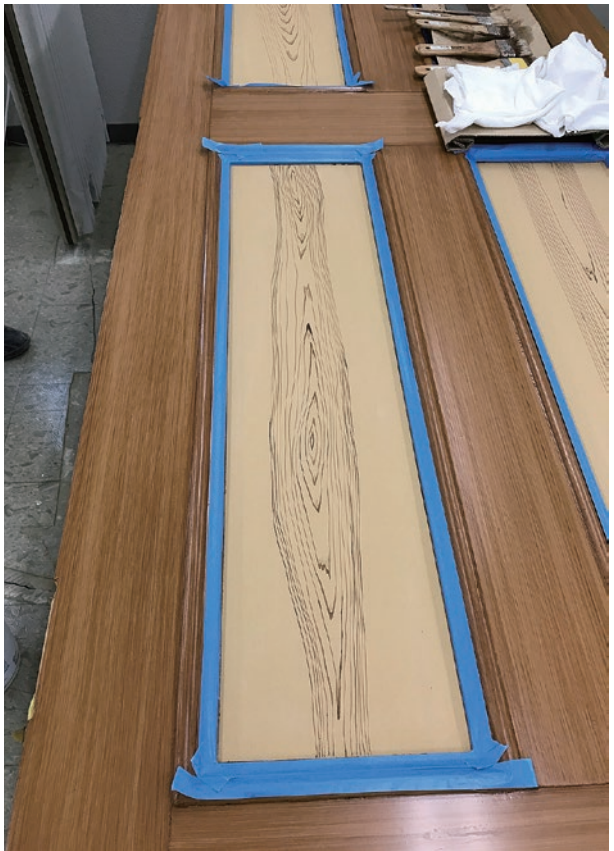
photo 20 Graining process (medium figured grain) ⑥ -3 panel board medium figured grain-2

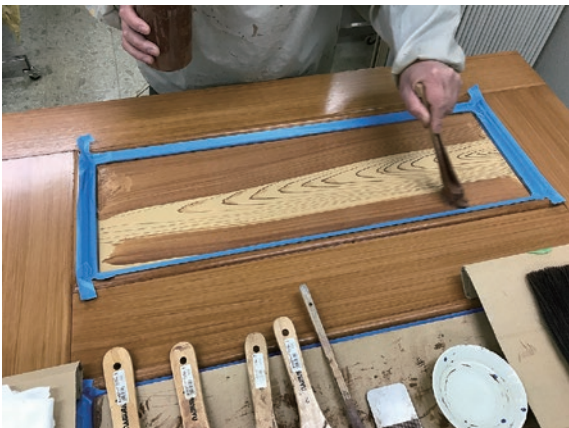
photo 21 Graining process (medium figured grain) ⑥ -4 panel board medium figured grain-3

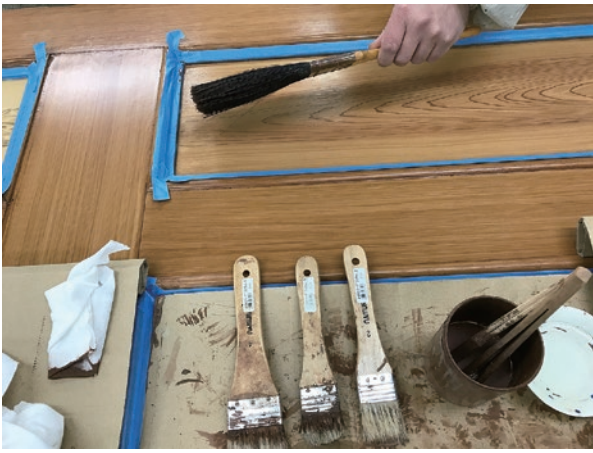
photo 23 Graining process ⑥ -6 panel board brush blur

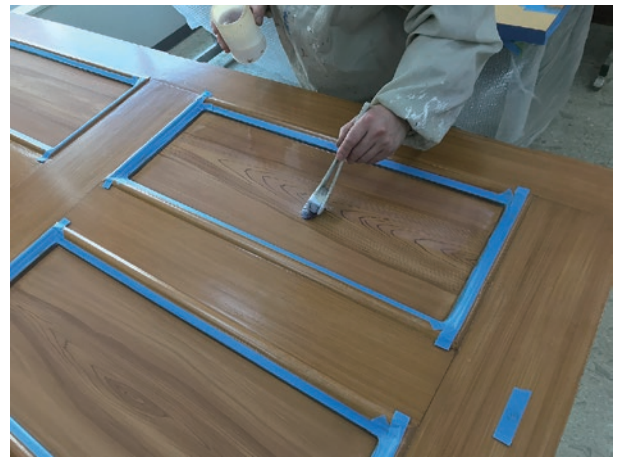
photo 24 Graining process ⑦ clear finish

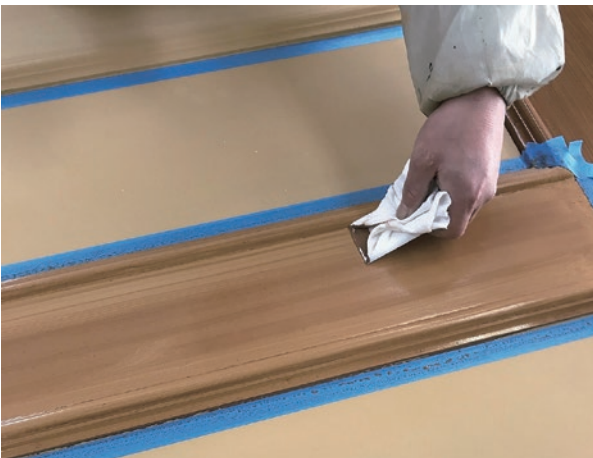
photo 27 Graining process (straight grain) combing

Omit step (5) above for the graining applied to the top and bottom of the door, stile, window sill, fitting frame, skirt, molding, etc. In other words, after drying the intermediate coating film as the foundation, the top coating should be applied, straight lines should be drawn with stainless steel combs, and appropriate undulating expressions are to be added (**Photos 27–29**).

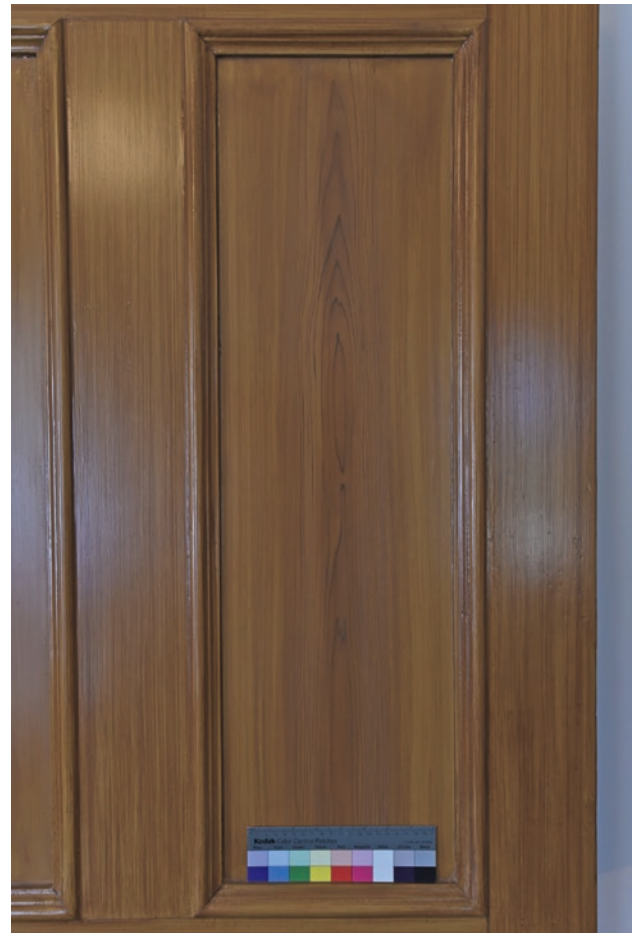
photo 31 Graining completed (medium figured gain) - panel board

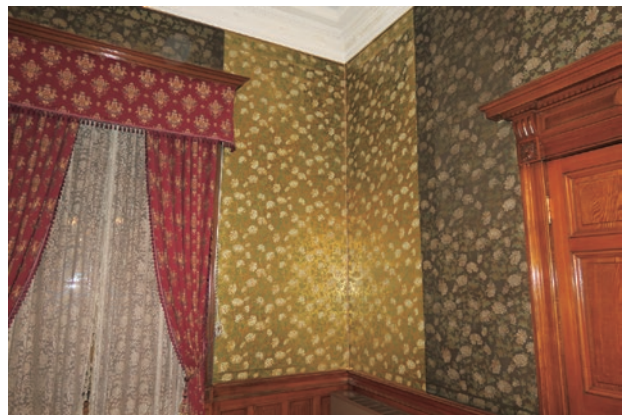
photo 2nd floor Honored Guest Room- Restored curtains and wallpaper

In this repair, there were almost no curtains left around the windows, but most of the rods and boxes for the curtains remained; therefore, restoration is done based on old photographs. In addition, although a steel shutter was installed, the lower part of the guide rail was corroded due to salt damage, and the operation chain and gears were missing; thus, it did not work. Therefore, it was disassembled and maintained, and the missing parts were replenished. Some shutters are now inoperable again.

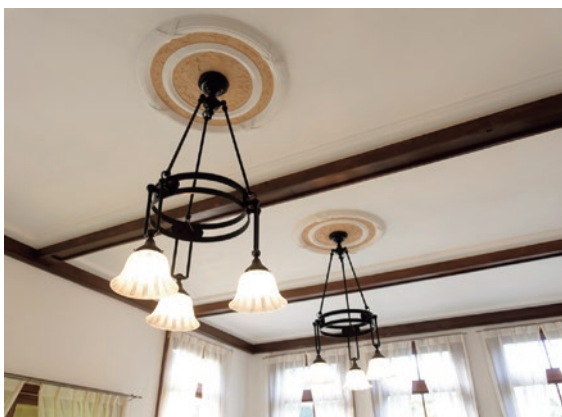
photo Central decoration and ceiling in the billiard room, 1st floor

The central decoration of the ceiling was significantly disassembled and restored after the foundation was repaired. The area around the center decoration that connects with the existing plaster (the surrounding flat ceiling) is finished by exposing each layer of the undercoat, middle coat, and top coat to prevent cracks and plastering each layer.

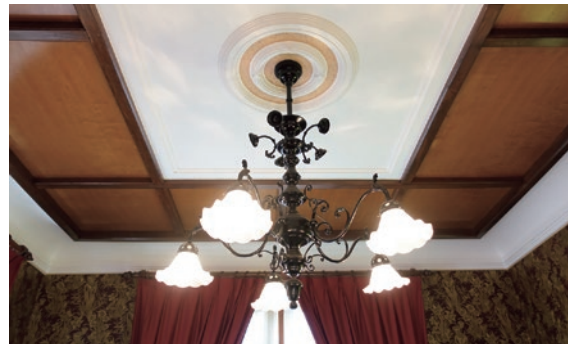
photo Central decoration in the dining room/ music room, 1st floor

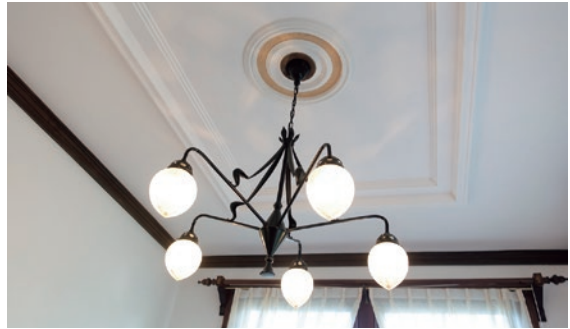
photo Central decoration in the reading room, 1st floor

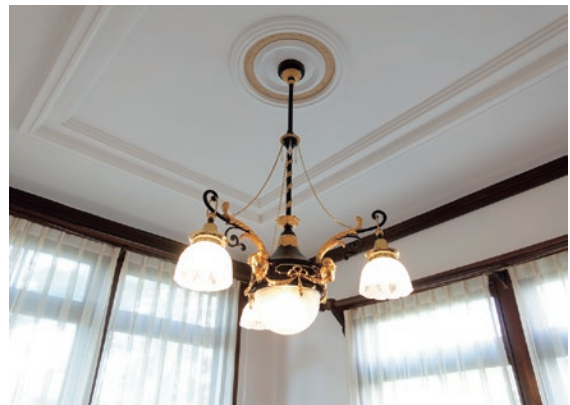
photo Central decoration in the reading room, 2nd floor

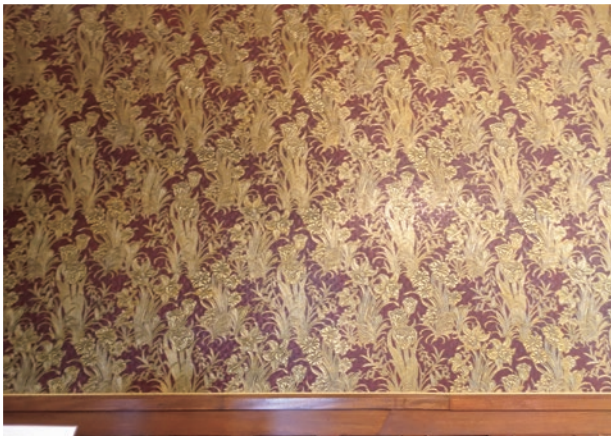
photo Restored wallpaper in dining room/music room, 1st floor

In addition, it was confirmed that the Gold-embossed wallpaper "Kinkara-kawashi" ^{*1} in the dining and music rooms on the 1st floor was a design registered with the Japan Patent Office and a spare roll, and a woodblock roll could be created based on the design. The dining room on the 2nd floor is used because it was found to be a woodblock roll in the "Paper Museum" (Kita-ku, Tokyo) (same lot number).

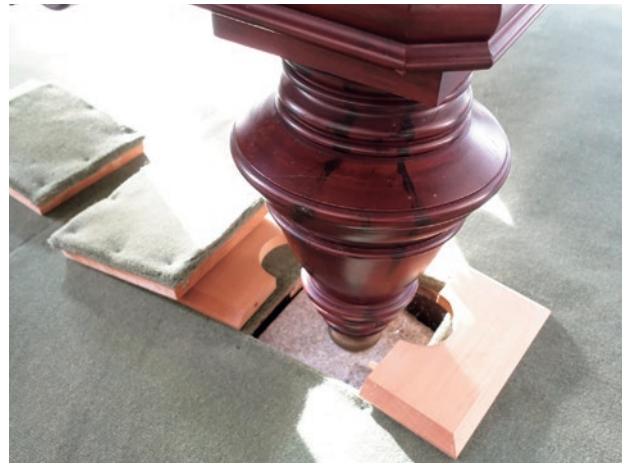
Linoleum remained under the carpet in the billiard, and the engraving on the back indicated that a product made by Toyo Linoleum was used. Further, based on the results of a detailed examination of the floorboards of each room, the specifications of each room are determined, and carpets, linoleum floors, or floorboards are determined and constructed.

photo Floorboard in billiard room, 1st floor

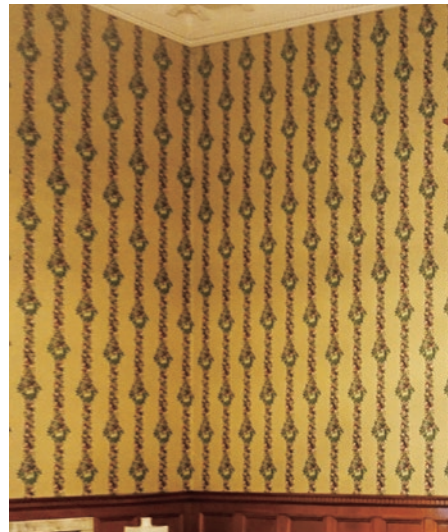
photo Restored wallpaper of the governor's office

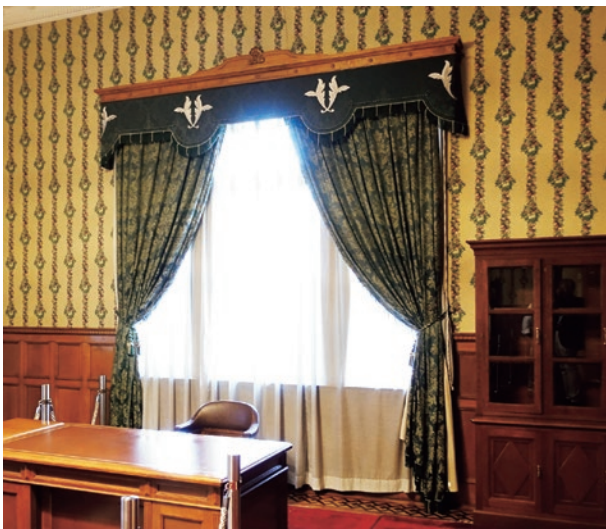
photo Restored curtains in the “governor’s office”

This time, the curtain device and curtains have been restored based on old photographs and literature. However, regarding the fissure, there is no specific description in the design documents at that time. Thus, in this repair, the unit price per room is known. Therefore, based on that, we the rooms were ranked considering the character of each room and the hanging form of the curtains and selected the following fissures while referring to the construction examples of the Former Prefectural Assembly Building.

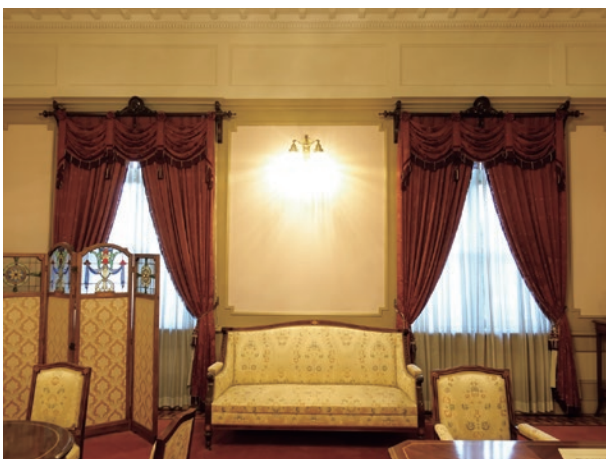
photo Restored curtains in the “honored guest room”

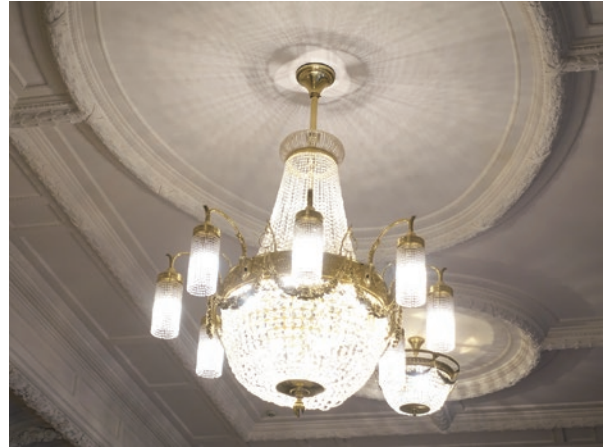
photo Restored chandelier in the “main hall”

A restoration model was made based on the old photographs, and when it was actually installed in the room, it was compared with the old photographs. When adjusting the details while verifying how it looked, the shape of the lighting equipment to be restored was decided.

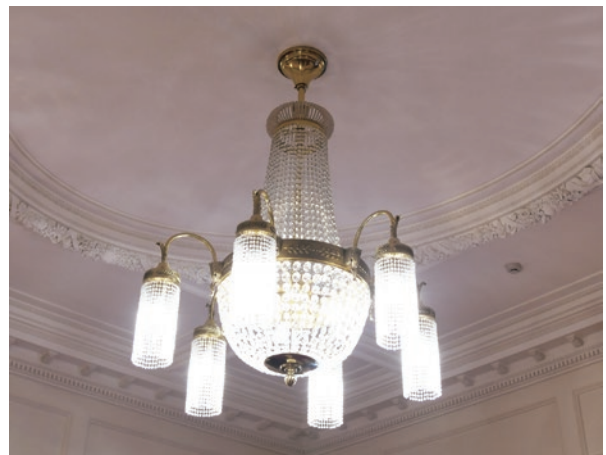
photo Restored chandelier in the “honored guest room”

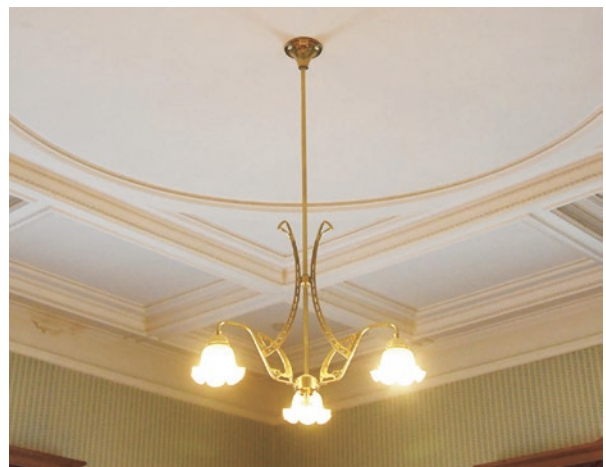
photo Restored chandelier in the “police director office”

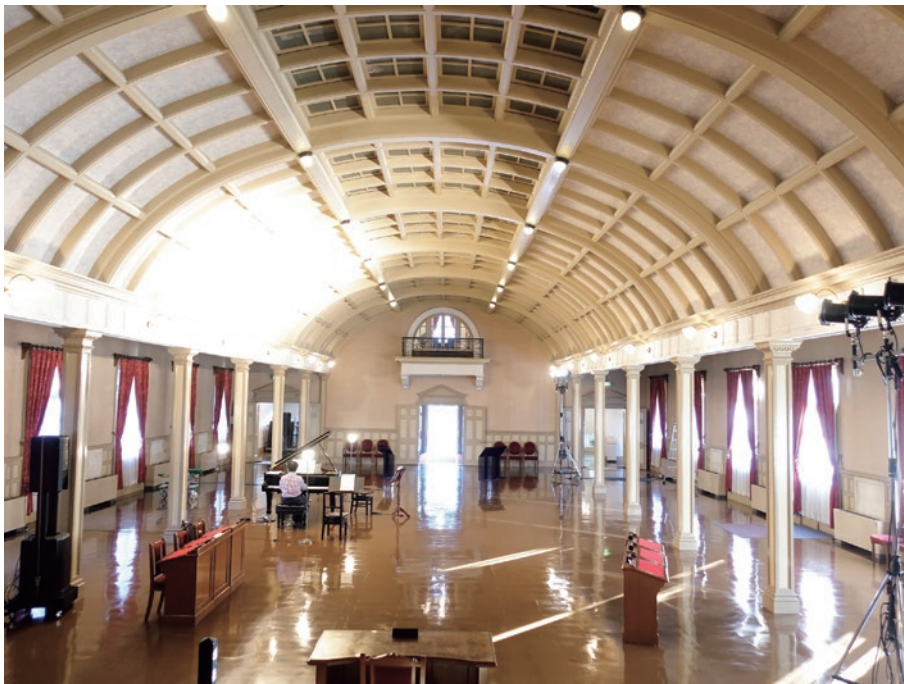
photo Inside the restored assembly hall and vault ceiling and floor

- From the ground cover remaining near the north side of the assembly hall floor and the ground cover fragments found under the floor, it was considered that there was an overhanging platform with a maximum diameter of 1.5 m and a diameter of about 6.54 m from the north wall of the hall. Further, it was confirmed that the extension on both sides of the hall had an overhang that appeared to be a side platform up to the east and west walls of the hall. The details of the design of the front of the podium and the side platform can be determined from the photographs, and the stairs and handrails can be established from the photographs and the old materials found, and they have been restored.
