Conservation and Restoration of Internal Features

Tokyo National Research Institute for Cultural Properties
Center for Conservation Science, Restoration Techniques Section

Foreward	Saito Takamasa	3
Introduction	Nakayama Shunsuke	5
Chapter1 Conservation and restoration of internal features in the Bank of Iwate (Former Morioka Bank) Main Office Main Building	Tsumura Yasunori	9
Chapter2 Restoration lighting historic house	Fukuda Kazuya	33
Chapter3 Painting repair of graining in Meiji-mura - Case study of restoration of No.25, Nagasaki Foreign Settlement -	Matsushita Michio	75
Chapter4 Case study of conservation and restoration of internal features	Nakayama Shunsuke	89

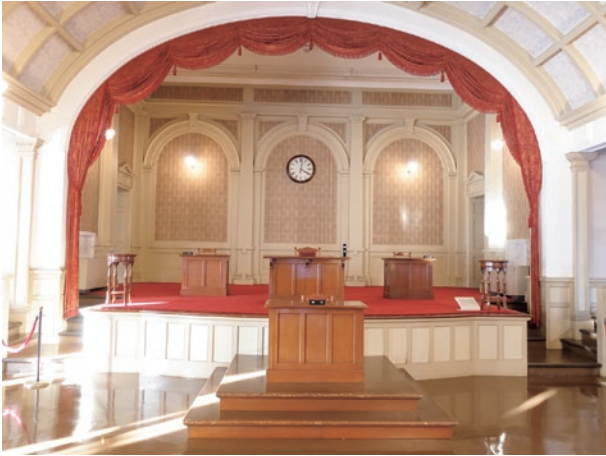
photo Restored podium in the assembly hall

- Details can be found from the bellows template, wood shavings, bellows plaster, flat ceiling plaster found from the top of the rear ceiling, and the hollow plaster left on the surrounding walls. Therefore, the wooden plaster ceiling and bellows have been restored on the podium.

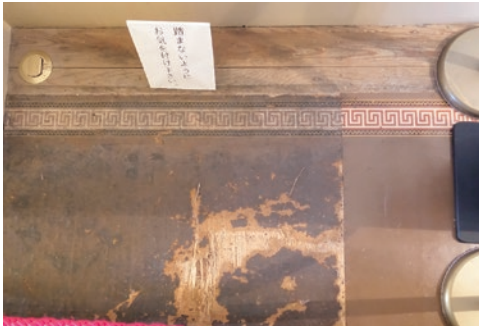
photo Original linoleum

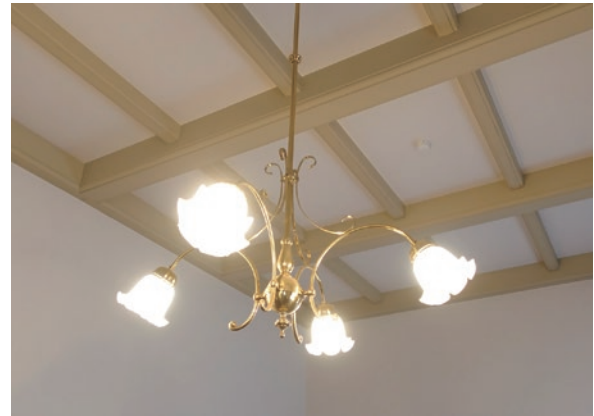
photo Honored Guest Room- Restored Chandelier

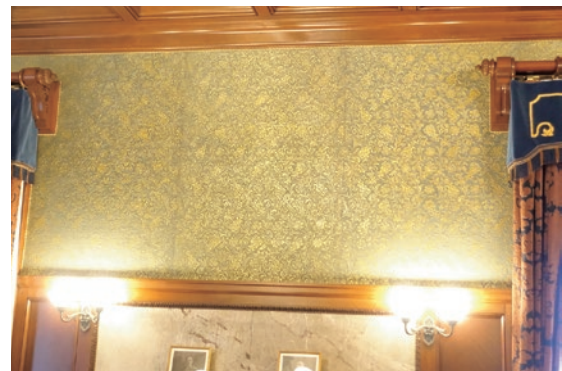
photo Restored wallpaper in the study

The photographs of the study and the wall surface of the anteroom were enlarged and investigated. These were Gold-embossed wallpaper "Kinkara-kawashi" ^{*1} with the same pattern as the woodblocks left in the Paper Museum, and they were restored using the

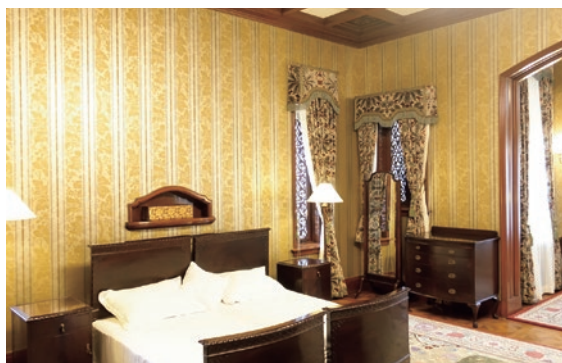
photo Restored wallpaper in the bedroom

Regarding the wallpaper used in the bedroom, the wallpaper sample book held by the Cooper Hewitt Smithsonian Design Museum in New York contains a sample of the same pattern as the old photographs and a construction example. Although the design of the entire pattern was revealed, the technique and color information of the striped pattern shown in the old photos were unknown. A piece of paper was found in the bolt hole of the fitting frame in the bedroom during the construction. The details of the pattern (reflective embossing), color, and stripe pattern were confirmed with almost no fading, so it was decided to restore the wallpaper. However, as it was difficult to manufacture a reflective emboss with the same pattern, it was restored by silkscreen.

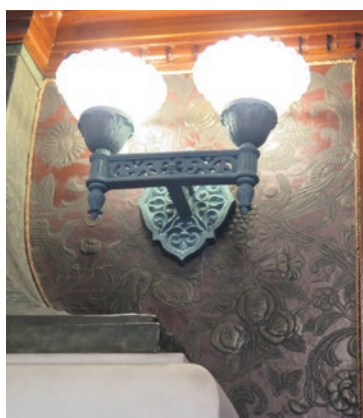
photo Original wallpaper beside the fireplace in the large dining room

The Gold-embossed wallpaper "Kinkara-kawashi" *1 of the Marquis Maeda residence period stuck on the side of the fireplace in the large dining room was the only one left unpeeled. However, the pattern of the entire motif was not clear because it was originally a small area. Nevertheless, in the exhibit of "William Morris and the British Wallpaper Exhibition" held during the construction, the same pattern of Gold-embossed wallpaper "Kinkara-kawashi" *1 made by Sanderson in the United Kingdom was confirmed, and the whole pattern was clarified. In this repair, the existing wallpaper is repaired, and a woodblock is created and restored to make up for the missing part.

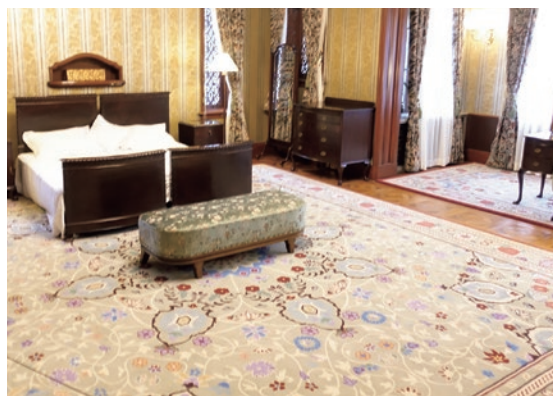
photo Restored carpet in the bedroom

After deciding the design and color with reference to the old photographs of Maeda's house period, it was restored as a hand-prodded cotton rug.

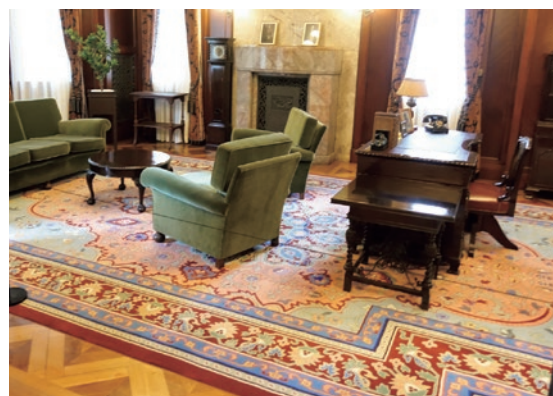
photo Restored carpet in the study

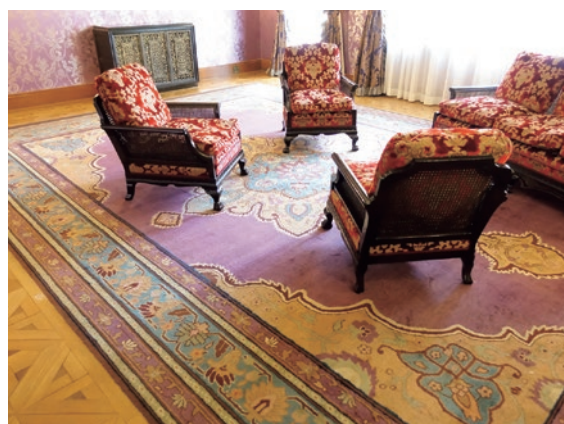
The carpet during the construction of the lady's room stored in the western style house had stains on the whole and defects in various places on the edges. However, after cleaning, the defective part was repaired and reused.

photo Original carpet in the lady's bedroom

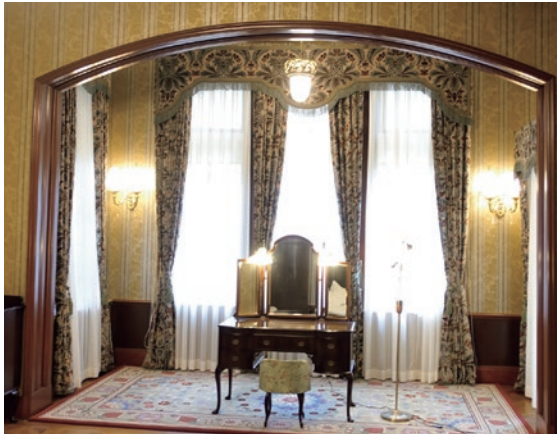
photo Curtain in the bedroom

1) The bedroom, study, and the anteroom in the western style house have been restored based on the curtains and tassel that were stored in the building and the public interest incorporated foundation Maeda Ikutokukai. Further, for newly produced items, we refer to the stored items, old photographs, and the results of trace investigations.

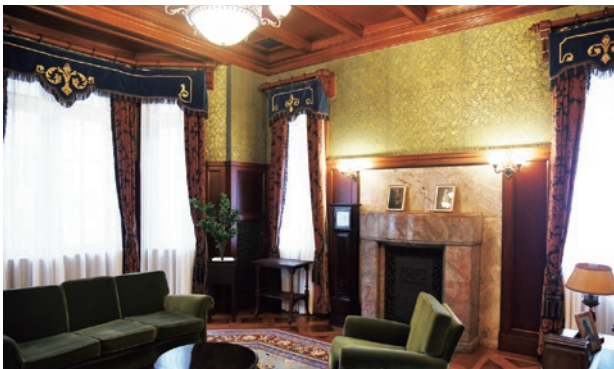
photo Curtain in the study

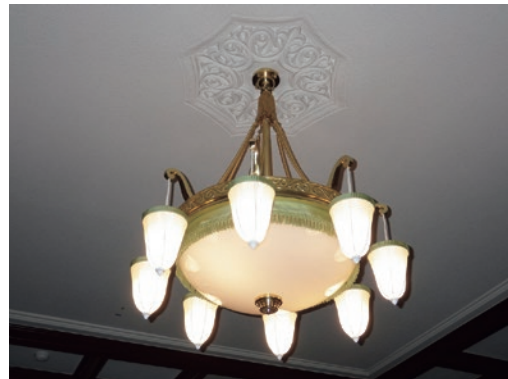
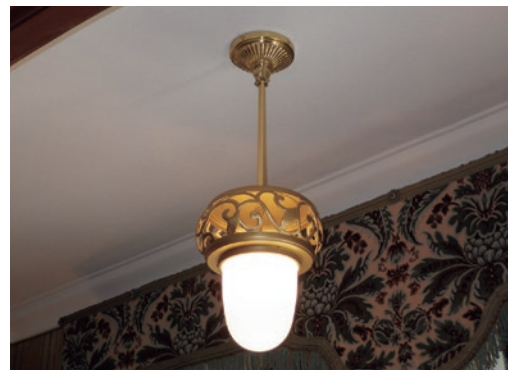
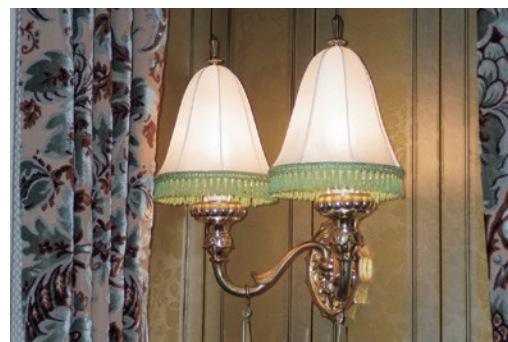
The lighting equipment in the bedroom before the repair had a chandelier in the center, one ceiling near the window, and two brackets. However, as they were all modified from the old photo, the chandelier and bracket were restored based on the old photo. As the one in the next bedroom was diverted, it was returned to its original location, and the pendant reflected in the old photo was restored.

photo Restored chandelier in the bedroom

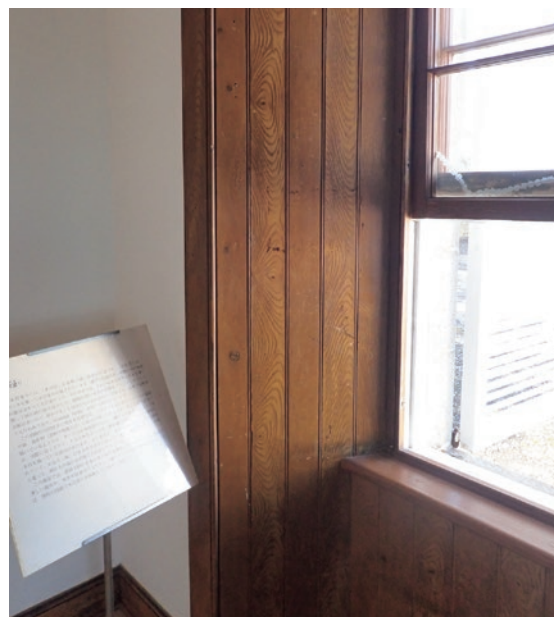
photo Graining that remains on the window frame, probably original

photo Enlargement of the previous photo

This was restored to other parts that had deteriorated, with reference to the graining that was partially left in the room during the dismantling and storage work that began in 1995.

Moreover, for the part where the initial graining was left, the oil of the paint was removed and faded. Thus, the oil of the paint was applied from above to protect the remaining graining.

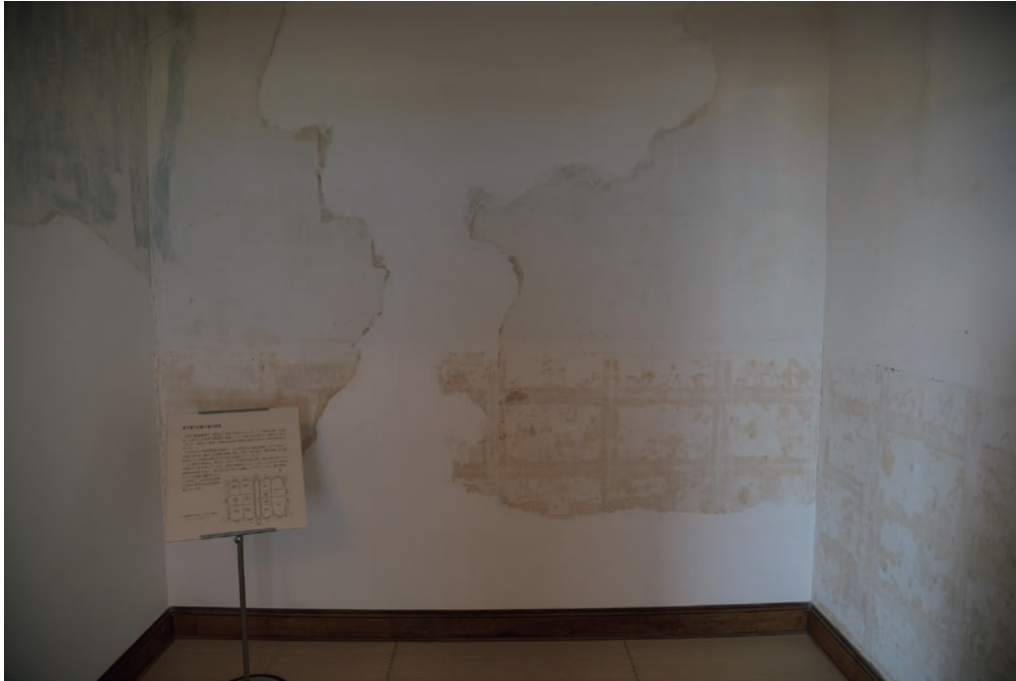
In the process of dismantling, old documents from the period were discovered on the surface of the plaster walls, which had been covered with bags as a base for painting. As a result of sorting, 200 documents related to the lighthouse business written in ink on 306mm x 217mm Japanese paper were found. The contents of the documents were a logbook and an equipment ledger from that time, and the date of the logbook showed that they were from 1872 to 1876. Therefore, the documents were carefully peeled off and preserved before being stored. Furthermore, regarding the plastered wall of the room where the old document was pasted, the are

photo Old documents left in the plastered wall
